SERVICE BULLETIN

SERVICE BULLETIN		No.: ESB-97E54-503	
		Date: 1997-09-26	<Model> (EC,EXP) CARISMA
Subject: CLOCK REMOVAL AND INSTALLATION			<M/Y> 97-10
Group: CHASSIS ELECTRICAL			
CORRECTION

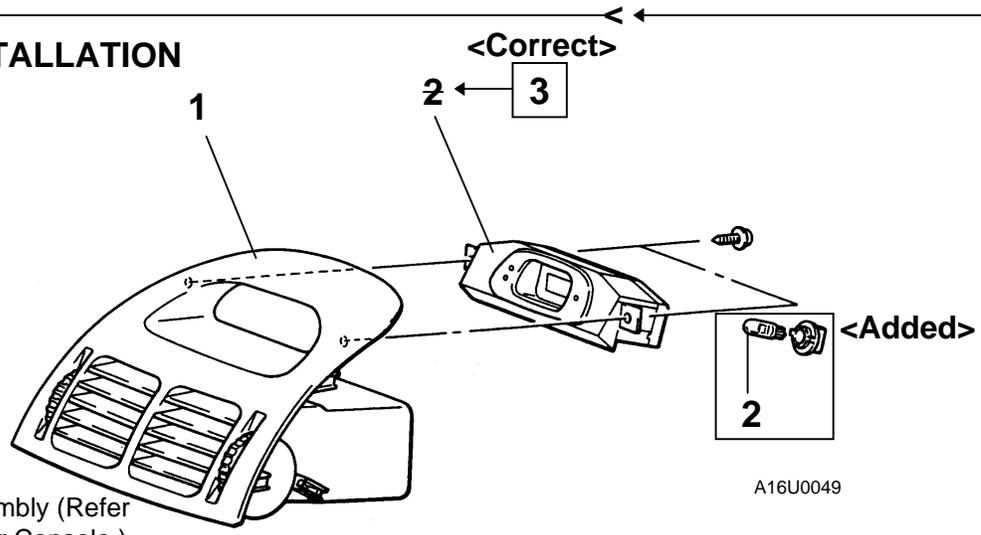
This Service Bulletin informs you of addition of "TROUBLESHOOTING" under CLOCK and of "2 Bulb" under Removal steps, in the Workshop Manual.

Symptom	Probable cause	Remedy
Does not indicate time	Connector improperly connected	Repair
	Harness broken	Repair or replace
	Bulb burnt	Replace
	Malfunction of clock	Replace

Removal steps

1. Center air outlet assembly (Refer to GROUP 52A - Floor Console.)

2. Clock
