SERVICE BULLETIN

SERVICE BULLETIN		No.: MSB-97E17-501	
		Date: 1997-07-15	<Model> (EC,EXP)GALANT <M/Y> 97-10 (EA0)
Subject: CORRECTION OF ERRORS IN REGARD TO ACCELERATOR PEDAL POSITION SENOR BRACKET			
Group: ENGINE & EMISSION CONTROL		Draftno: 97-JY-001	
CORRECTION	OVERSEAS SERVICE DEPT	<i>R. Usami</i> R. USAMI - MANAGER QUALITY INFORMATION ANALYSIS

ACCELERATOR PEDAL POSITION SENSOR REMOVAL AND INSTALLATION

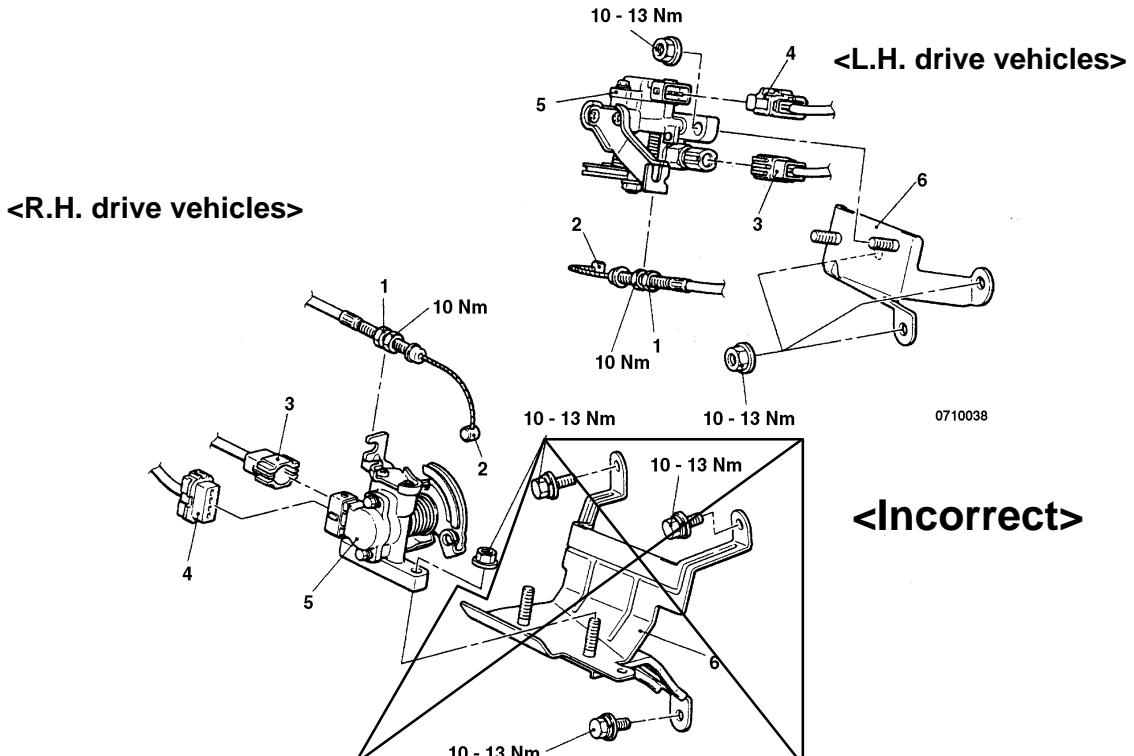
This Service Bulletin informs you that errors have been corrected in regard to the accelerator pedal position sensor bracket (on RH drive car).
