SERVICE BULLETIN

SERVICE BULLETIN		No.: MSB-99E55-503	
Date: 1999-12-15		<Model> (EC,EXP) L200	<M/Y> 97-10 (K00)
Subject: OMISSION OF DISASSEMBLY / REASSEMBLY OF A/C COMPRESSOR ASSEMBLY			
Group: HEATER, A/C & VENTILATION	Draft No.: 99SY060115

Omission has been rectified of a description of the disassembly / reassembly of the A/C compressor assembly under Compressor and Tension Pulley.

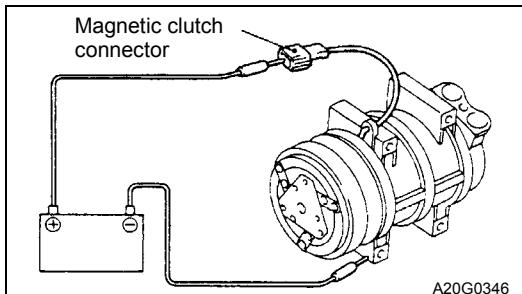
**INSPECTION****COMPRESSOR MAGNETIC CLUTCH OPERATION CHECK**

Connect the battery (+) terminal to the compressor side terminal, and earth the battery (-) terminal to the body of the compressor. The condition is normal if the sound of the magnetic clutch (click) can be heard.

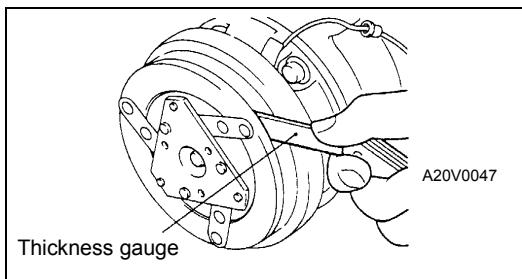
**COMPRESSOR MAGNETIC CLUTCH AIR GAP CHECK**

Check whether or not the air gap of the clutch is within the standard value.

Standard value: 0.3 – 0.6 mm
