TECHNICAL SERVICE BULLETIN

SUBJECT:		No: TSB-08-54-005	
FOGLAMP/DAYTIME RUNNING LAMP MOUNTING BOLT DELETED - SERVICE MANUAL REVISION		DATE: April, 2008	
MODEL: 2007 -08 Outlander			
CIRCULATE TO:	<input type="checkbox"/> GENERAL MANAGER	<input checked="" type="checkbox"/> PARTS MANAGER	<input type="checkbox"/> TECHNICIAN
<input checked="" type="checkbox"/> SERVICE ADVISOR	<input checked="" type="checkbox"/> SERVICE MANAGER	<input checked="" type="checkbox"/> WARRANTY PROCESSOR	<input type="checkbox"/> SALES MANAGER
TSB Revision TSB-07-54-005

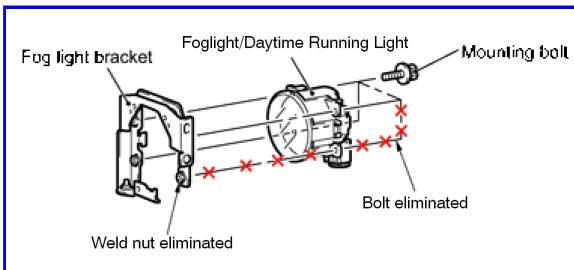
Effective with November 1, 2007 production, one of the four (4) mounting bolts for mounting the fog lamp/ daytime running lamp (DRL) to it's bracket has been eliminated. The corresponding weld nut on the bracket has also been eliminated.

This Technical Service Bulletin announces the changes and provides an illustration showing which fasteners are eliminated.
