## **TECHNICAL SERVICE BULLETIN**

SUBJECT:		No: <b>TSB-08-54-007</b>	
<b>NEW ANTENNA BASE SECURING METHOD - SERVICE MANUAL REVISION</b>		DATE: <b>May, 2008</b>	
MODEL: <b>2007-08 Outlander</b>			
CIRCULATE TO:	<input type="checkbox"/> GENERAL MANAGER	<input type="checkbox"/> PARTS MANAGER	<input checked="" type="checkbox"/> TECHNICIAN
<input checked="" type="checkbox"/> SERVICE ADVISOR	<input checked="" type="checkbox"/> SERVICE MANAGER	<input type="checkbox"/> WARRANTY PROCESSOR	<input type="checkbox"/> SALES MANAGER
<b>TSB Revision TSB-08-54-007</b>

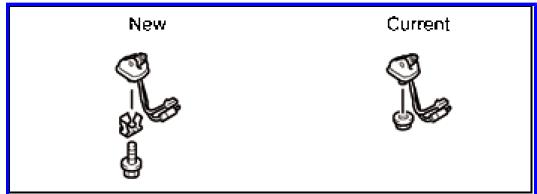
The method for securing the radio antenna base to the vehicle has been changed in production effective August 1, 2007. The securing nut has been replaced with a bolt and spring (see illustration).

Due to this change, the removal and installation steps have been changed in the applicable Service Manual. This Technical Service Bulletin advises those changes. These changes apply to Affected Vehicles and vehicles where the antenna base is replaced with a new part.
