Front End "Pop" Noise

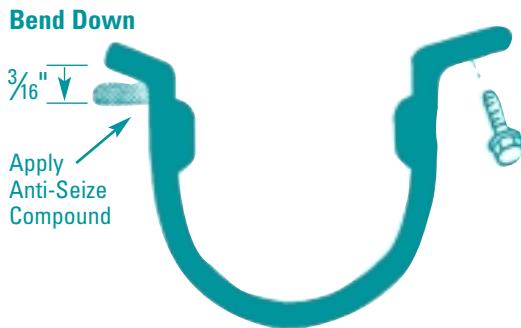
If you encounter a customer complaint of a noise coming from the front end when turning on all Legacy models (similar to a small stone hitting the floor pan), pivoting front stabilizer bar bushing clamps may be the cause. Use the following information to adjust the clamps:

- Remove both right and left bushing clamps. Use Section 4-1 of the applicable Legacy Service Manual.
- To correct the popping noise, bend the tab hook approximately 3/16-inch. Refer to the illustration on this page.
- Coat the underside of the hook with anti-seize compound.
- Re-install in reverse order of disassembly.
