Prevention Of Repeat Planetary Gear Failure

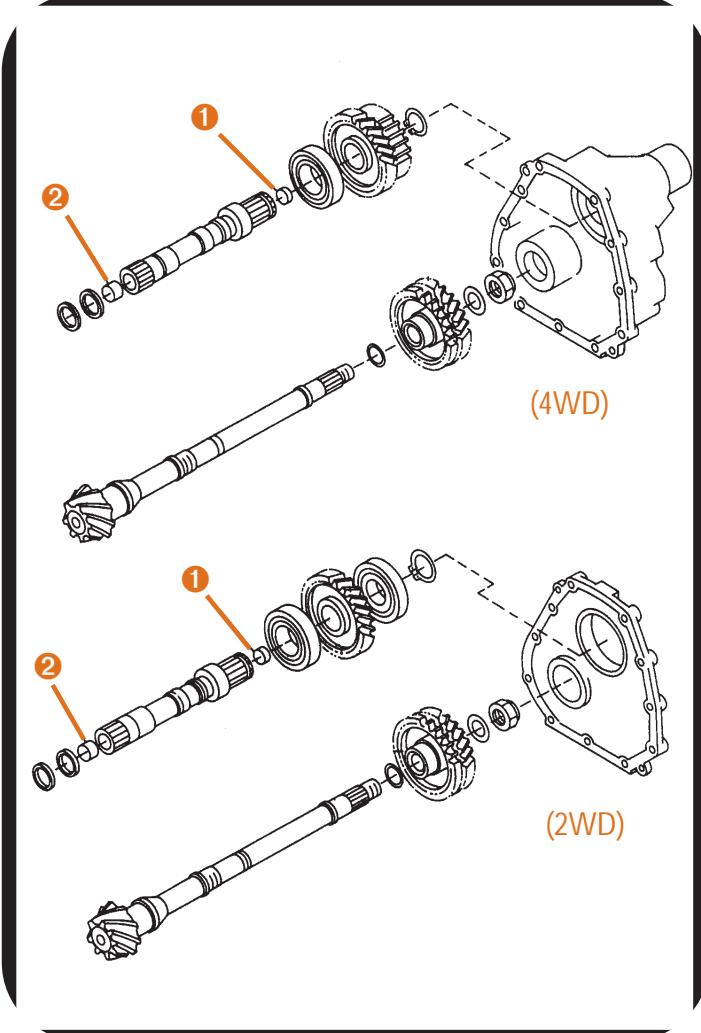
When performing a repair to the rear planetary gear section of the 4EAT, you are repairing an effect. For every effect, there is a cause which must be found. The following are causes for rear planetary failure which have been documented:

- Restricted flow through the radiator cooler.
- Kinked or obstructed radiator cooler lines.
- Improper filter kit installation or hose routing. Refer to Subaru Service Bulletin number 16-56-93 for filter kit installation procedures.
- Debris restricting ATF flow through the input shaft or its oil feed holes.
- Reuse of a heat-damaged input shaft (where the internal seal has become deformed).
- Orifice plug missing from the rear of the reduction shaft (refer to Item 1 in the illustration that accompanies this bulletin).
- Bushing missing from the front of the reduction shaft (refer to Item 2 in the illustration).

In addition to replacing any damaged parts and making all of the required precision measurements, a thorough inspection of the failed parts, replacement parts, and the affected circuit must be performed to determine the cause of the failure and to ensure that it does not happen again. Back flushing of the oil cooler and lines must also be included as part of this procedure.

By ensuring that the above items are checked on the vehicle and on the parts being reinstalled into the transmission case (both new and used), you are ensuring a quality finished product.
