SERVICE BULLETIN

ALL LEGACY MODELS EQUIPPED WITH 4EAT

SUBJECT:**MANUAL VALVE STOPPER RETROFIT**

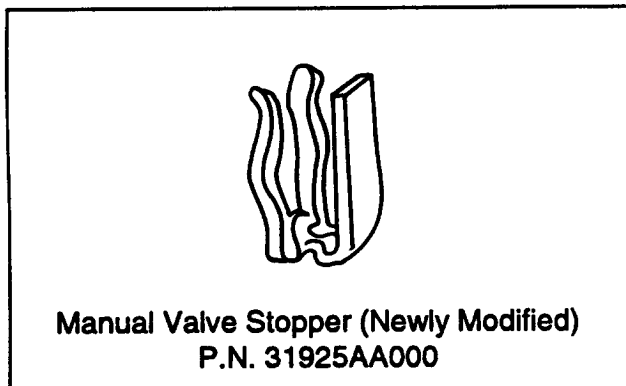
Figure 1

Should you encounter a 4EAT equipped Legacy that exhibits a resistance or possibly binds when shifting from manual 2 or 1 range, towards park position, a manual valve stopper or possibly a modified manual valve lever may need to be installed. These parts have been incorporated in production since 11/89, starting with Transmission Number 135220. See Figures 1 and 2 below.

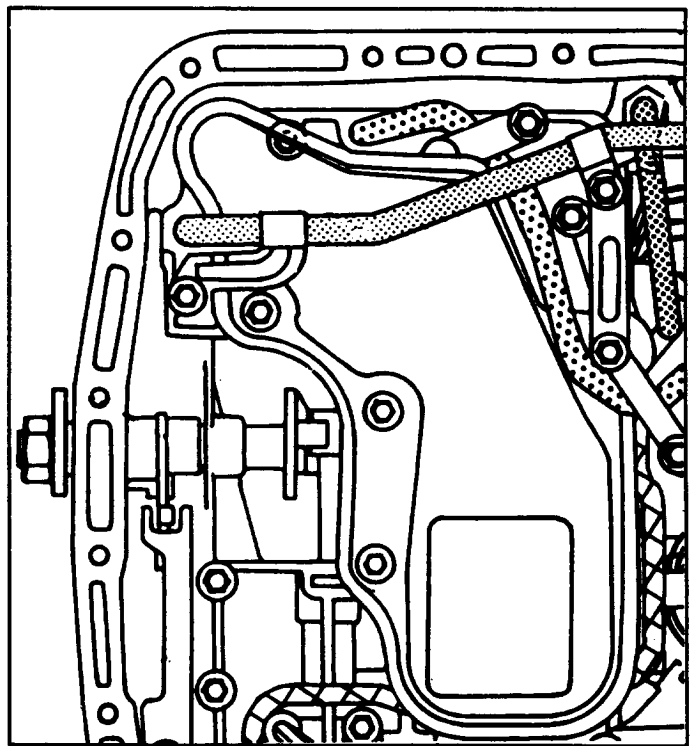
Figure 3

Bottom view of manual valve and lever after modification

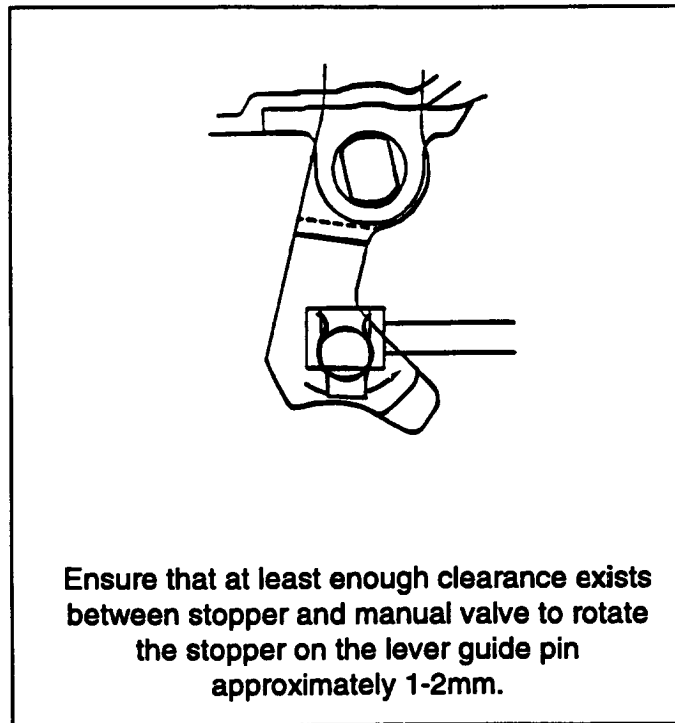
Figure 4

Checking Manual Valve Stopper Freeplay

NOTE: IF THERE IS NO PLAY BETWEEN STOPPER AND MANUAL VALVE, IT MAY CAUSE PREMATURE WEAR OR BINDING OF MANUAL VALVE.
