Crankshaft failure analysis of a boxer diesel motor

Article in *Engineering Failure Analysis* · April 2015

M. Fonte, V. Anes, P. Duarte, L. Reis, M. Freitas

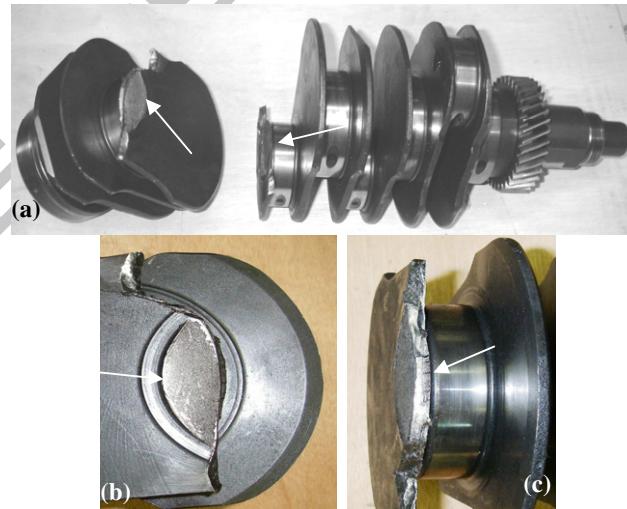
The crankshaft was found broken at crankthrow No. 3. Verified all spares of motor, they were found in good use conditions without any abnormalities. All surface journals and shell bearings were free of any scratches or injured parts. Except the damage crankshaft and two main journal bearings, all parts of diesel engine were found as new ones. Fig. 4 shows the failed crankshaft at the crankweb n° 6. In Fig. 4 (c), close to crack initiation, are observed ratchet marks which are an indication of high stress concentration [2,4] at the crankpin-web fillets.

Fig. 4. (a) Failed crankshaft showing the morphology of the surface crack; (b) and (c) the crack initiation sites at crankweb No. 6.

The first finding of damage is that the crankshaft failed on the crankpin-web No. 6, see Fig. 4 (a) and (b). Under the crankshaft, two central support steel shells were broken, as is shown in Fig. 5 and Fig. 6, from where two samples 1 and 2 were removed to analyse. These steel shells support the shell bearings on the bedplate aluminium bridges. Observing the surface crack morphology it is clear that the mechanism of failure was fatigue by bending, under mode I. Therefore if the crankshaft was under severe bending probability means that the bedplate yielded due to weakness.

It is clearly shown that fatigue is the dominant mechanism of failure. All fractured parts resulted from the weakness of two main journal bearings as a consequence of the crack initiation on back side of the support steel shells and cracking of the bedplate bridges. During this fatigue process and after failure of steel shells, the bedplate bridges came under cyclic bending, with significant amplitude level, until the complete fracture. As result the crankshaft suffered an amplitude bending increasing which is also shown by the ratchet marks left on the crack initiation zone, see Fig. 4 (c).

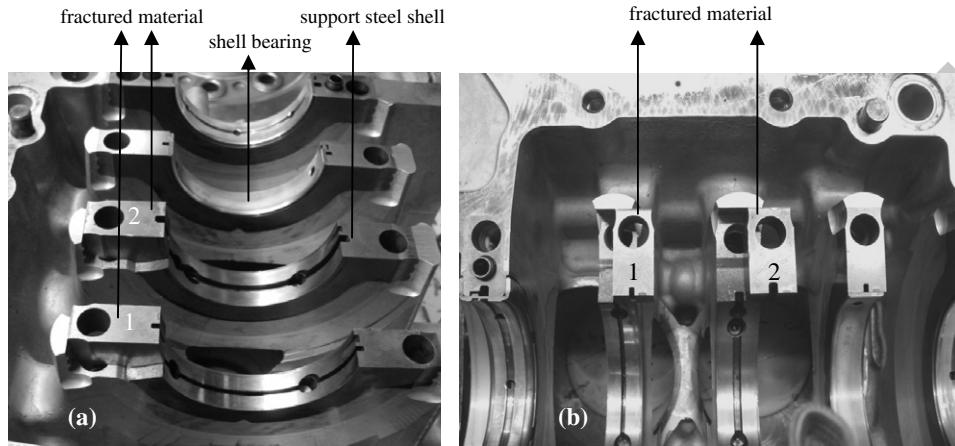
bearings are based. All support steel shell halves are brazed to the bedplate by a hybrid foundry for supporting the shell bearings. Two of those steel shells, in the bedplate middle, were found broken close to the bolts for tightening of two motor block halves. Furthermore, under both steel shell halves, the bridges of the bedplate in aluminium alloy appeared with transversal cracks, one crack in each bridge, and close to the side of the mentioned broken pieces, as is shown in Fig. 5.

Fig. 5. (a) Fractured samples (No.1 and No. 2) and (b) the same samples in detailed view.

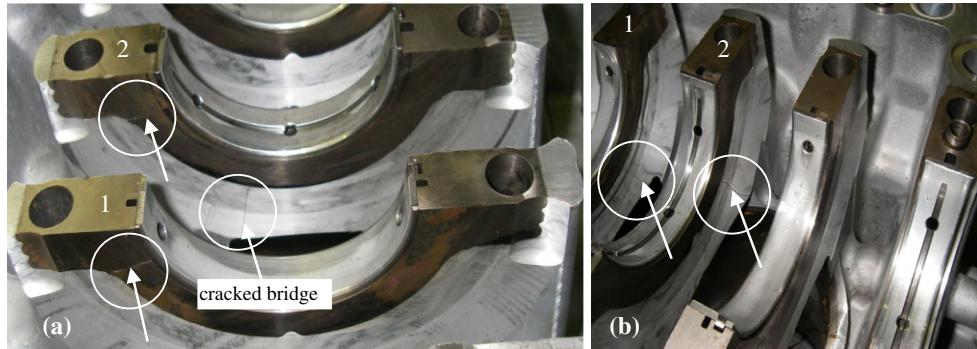
Fig. 6 shows in (a) the found cracks at two thrust steel shells (No.1 and No. 2) and in (b) the found cracks in the bedplate aluminium bridges. On the steel shells are also shown the shell bearings.

Fig. 6. (a) Steel shells based on the bedplate bridges the white arrows showing the found cracks; (b) the aluminium bridge cracks under the support steel shells.

The bedplate yielded as a consequence of the fatigue cracks found on the support steel shells and bedplate bridges, see Fig. 6. It seems clear that cracks have started at the sites pointed out by the white arrows on surface, from where samples No. 1 and n° 2 were collected, see Fig. 7 (a). Therefore the crankshaft fatigue process is after the cracking of the support steel shells and bedplate bridges. These steel shells were placed into the aluminium casting mold. Cracks have

The boxer motor failure presents a poor design of the steel shells back side and bedplate bridges. If the manufacturer correct the geometry of steel shells and also reinforce the bedplate bridges structure, the problem can be overcome.

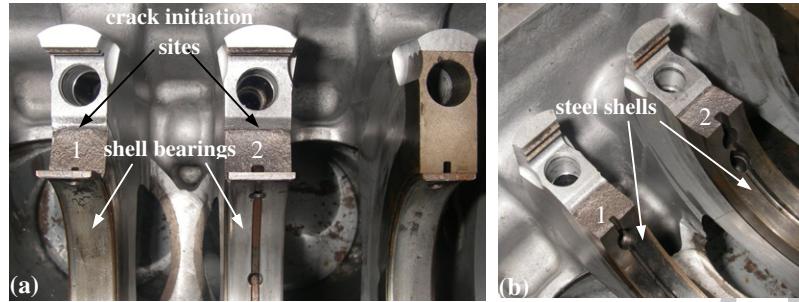
Fig. 7. (a) Places left by two fractured pieces with the screw bores of two block halves, and (b) the support steel shells.

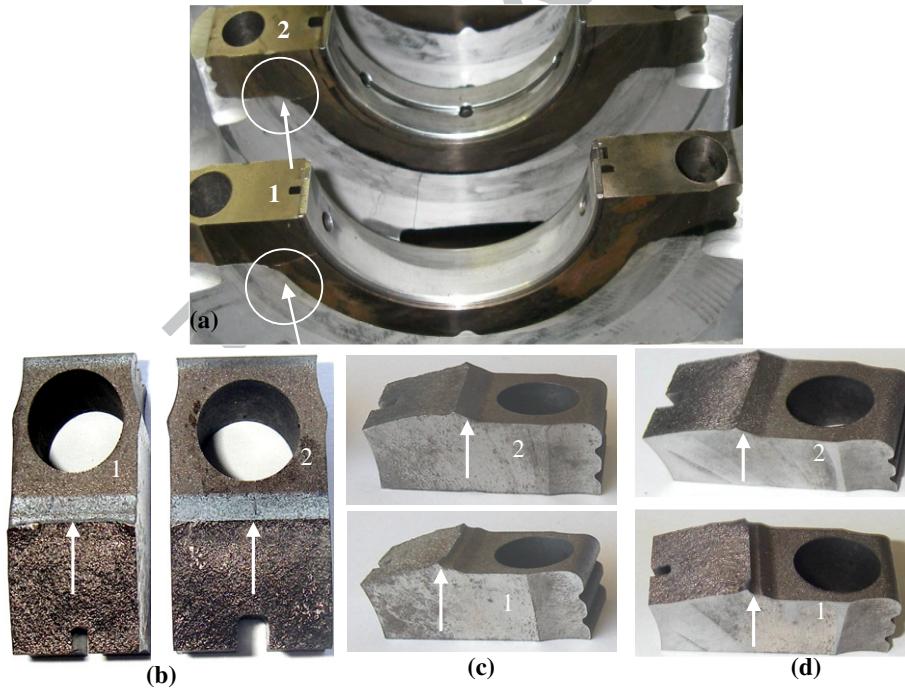
started there because the fillet radius of back side of steel shells was not adequate (close to the crack initiation, the fillet changes to a surface like a step) as is seen in Fig. 8 (a), (c) and (d) pointed by the white arrows. Therefore these broken pieces present zones that create the necessary conditions to initiate the cracks, and this can be the root cause of failure.

Fig. 8. (a) Broken material (samples) from the support steel shells; (b) crack initiation sites; (c) and (d) the two samples No. 1 and No. 2 at different positions, showing the zones without smooth concordance radius.

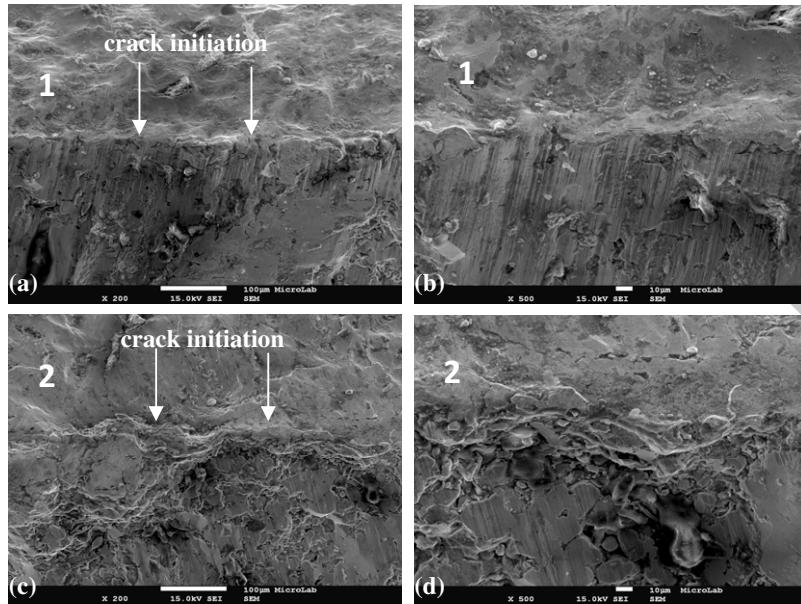
Samples No. 1 and No. 2, Fig. 8 (b), were observed by SEM on the crack initiation sites. Fig. 9 shows the SEM micrographs at 200X and 500X magnification. Material defects and abnormal wear were not found. On the fatigue surface morphology were not observed any beach marks, but the crack initiation sites seem to be evident being a consequence of high stress concentration at the back side of the support steel shells, with a geometry that changes like a step, see Fig. 8 (c) and (d).

Fig. 9. (a) and (b) SEM micrographs showing sample No. 1; (c) and (d) SEM micrographs showing sample No. 2.
