### 16 SLOPE CONTROL CHANGE FOR 2003~2004MY VEHICLES

### 10 H6 A/C COMPRESSORS CUTTING OUT

### 01 FADED OR GHOSTED FLUKE ORIGINAL 80 SERIES DISPLAY

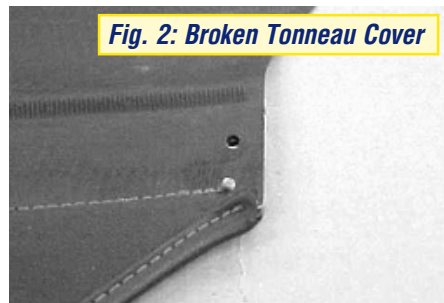
**Fig. 2: Broken Tonneau Cover**

Please be advised of specific part ordering, pertaining to the Legacy’s tonneau cover (00MY-03MY). If a customer complains about the hook ends loose or missing, it is not necessary to order a complete tonneau

cover assembly. Simply order the hook ends, damper and rivet (see figure 3 for part number applicability).

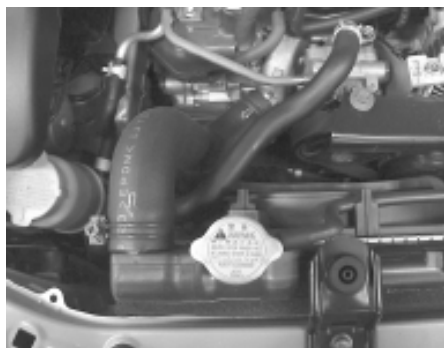
If coolant is found on the clinching plate of the upper radiator tank, it is occasionally misjudged that the coolant has leaked from the radiator. (See image below).

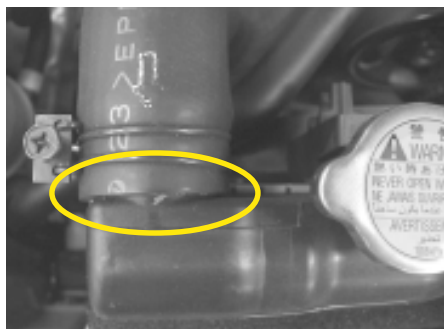
However, it is actually that the coolant has leaked out of the radiator hose connection. So you must first try to trace the coolant leakage from the upper radiator hose as shown in the picture below:

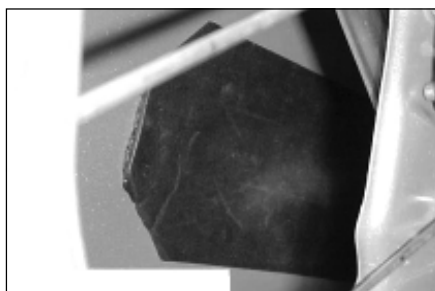
**Pad Properly Installed**

door shell and applying adequate pressure over the entire surface of the pad will solve the problem. In the event that the pad is severely distorted or will not adhere to the door shell, the sound-dampening pad will need to be replaced. The dampening pad part number is 90841AC000, and is applicable to 2000 to current Legacy, Outback and Baja vehicles.

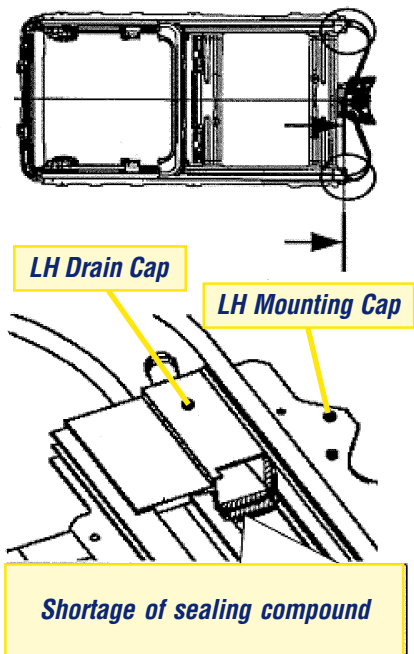
Cross-section view. Dashed line indicates area that should be resealed.

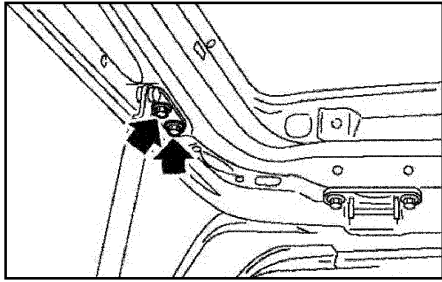
Pay special attention to Forester vehicles built during July and August of 2004 for a potentially loose Rear Gate Damper Stay (both driver and passenger side). If this condition is found during PDI please torque the two identified bolts as specified (5.5 ft.lbs.) in the Subaru Service Manual.

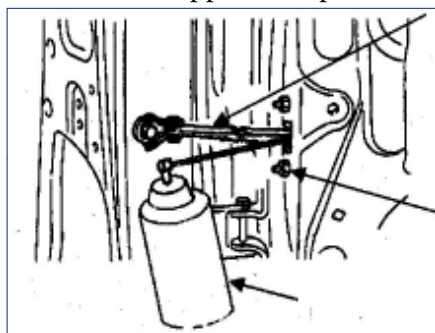
The following procedures address the creaking noise from the door checker and details an approved repair.
