SERVICE BULLETIN

APPLICABILITY: 2017-20MY Impreza
2018-20MY Crosstrek
2018-19MY Legacy and Outback
2019-20MY WRX and WRX STI
2019-20MY Ascent
2018-20MY BRZ
2019-20MY Forester

NUMBER: 15-221-18R

SUBJECT: Harman Audio / Infotainment: Harman Generation 3.0 and 3.1 Operating Tips

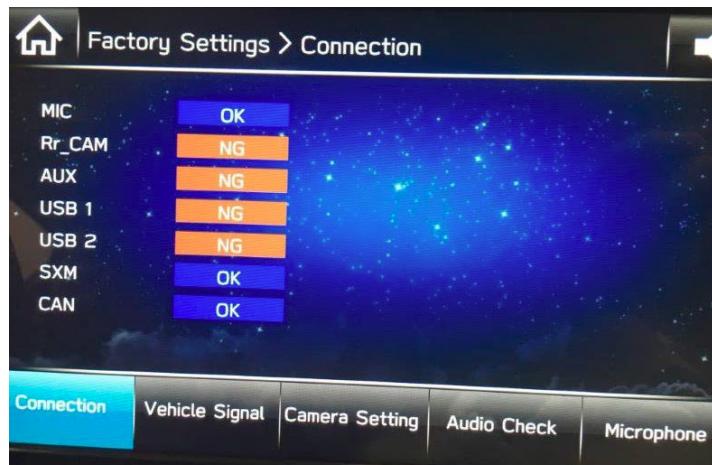
CONDITION# 1: Backup camera inoperative after head unit replacement or battery disconnect (2016 Dec TechTIPS).

CAUSE: Whenever the Audio / Navigation head unit requires removal on a 2017 Impreza, it is **important** the Service Manual procedure be followed. The Service Manual advises to disconnect the battery before servicing the audio unit. Failure to follow this instruction, can result in a customer concern of the backup camera becoming inoperative since the service. The reason, when connecting power to the unit, a self-check is performed. If the backup camera has not been connected yet, the unit assumes there is no back up camera and renders it inoperative.

Below is an image of what the screen will look like if a line check is performed before the issue is corrected:

RECOMMENDATION: A quick fix for this condition is to remove and reinstall the transit (PDI) fuse or remove and reinstall the negative battery terminal. The situation can be avoided completely by following the Service Manual and disconnecting the battery **before** starting the service.

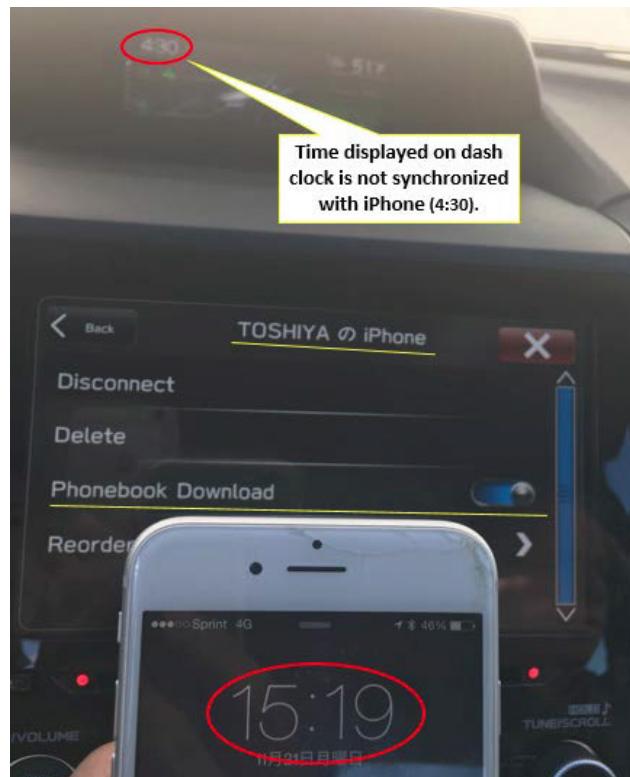
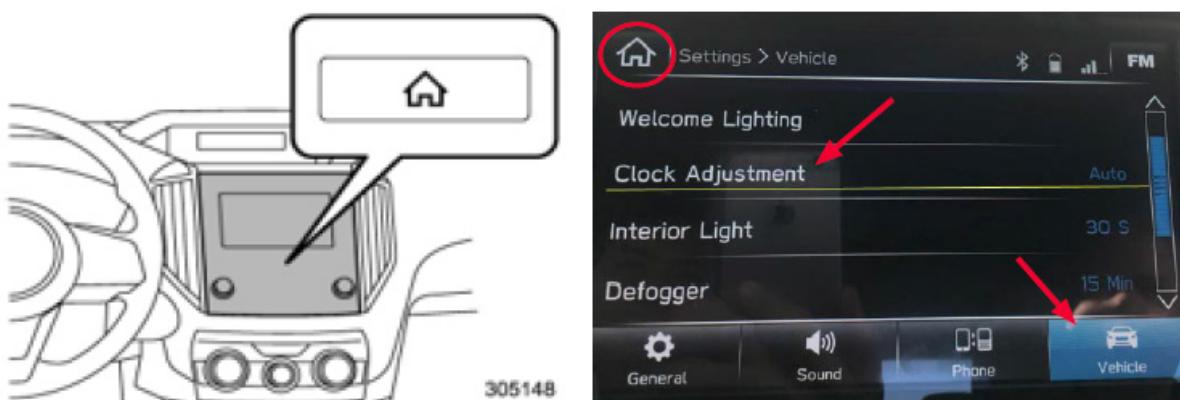
CONDITION# 2: Display Audio (non-navigation units), clock not synchronized with paired iPhone. (December 2016 TechTIPS).

CAUSE: NOTE: This information is applicable to iPhone (iOS) users only. If a customer states the time displayed on their iPhone is not synchronized with the instrument panel clock display, the information below provides an easy solution. Always ensure the latest software version is installed.

RECOMMENDATIONS: First, select the setting mode for the clock by following these steps:

- Press the “Home” button on the audio unit display.
- Press “Settings”.
- Press “Vehicle”.
- Select “Clock Adjustment”.
- Select “Auto”.

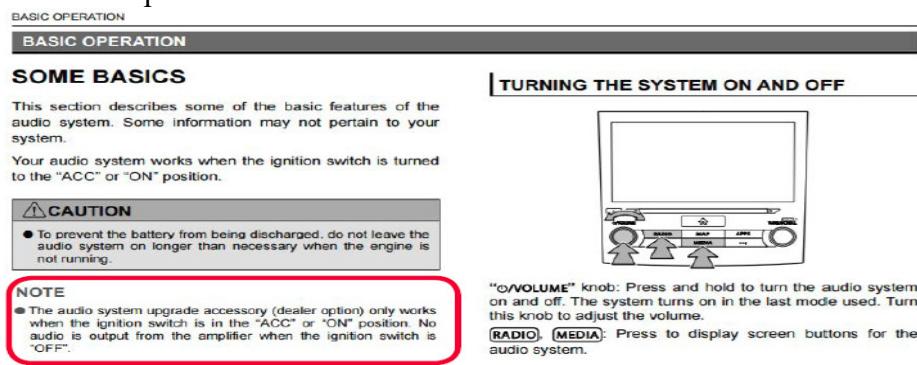
CONDITION# 4: Audio unit stays powered up after ignition switched to Off (February 2017 TechTIPS).

CAUSE: All the new 2017MY Impreza audio systems include a feature where the audio system stays powered for a period of time after the ignition is switched OFF. If the vehicle has been equipped with the accessory Rockford Fosgate audio amplifier, some confusion may arise when comparing audio unit operation of one Impreza to another. Although the audio unit will continue to operate after the ignition is switched OFF on all models, the power supply for the accessory amplifier is switched off along with the ignition resulting in the loss of audio output. This may cause confusion for customers when seeing the audio unit appear to be operating but not hearing any audio output.

Be advised, this is a normal operating characteristic and no attempt should be made to repair or replace any of the system components. **This operating characteristic is also briefly described on pg. 118 of the Multimedia System guide contained in the Owner Information Kit as shown here.**

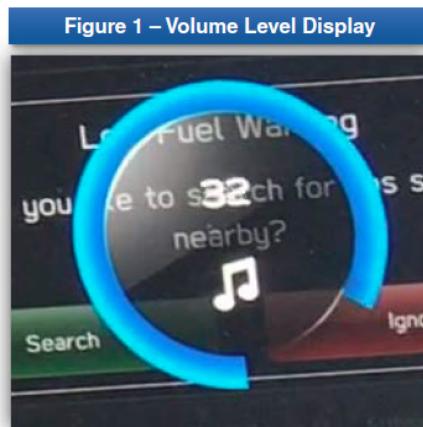
CONDITION# 7: Audio Volume is turned to MAX when monitoring infotainment data monitor (March 2017 TechTIPS).

CAUSE: If you are monitoring the Infotainment System Data Monitor and the volume level display (see image below) appears showing the volume level increasing but the sound level remains the same, this is a normal operating characteristic of the Harman audio units.

RECOMMENDATION: When a Technician accesses the Infotainment System Data Monitor, the unit enters “Diagnostic Mode” and the volume level will be displayed in this manner. No repairs should be performed to address this concern as it is a normal operating characteristic.

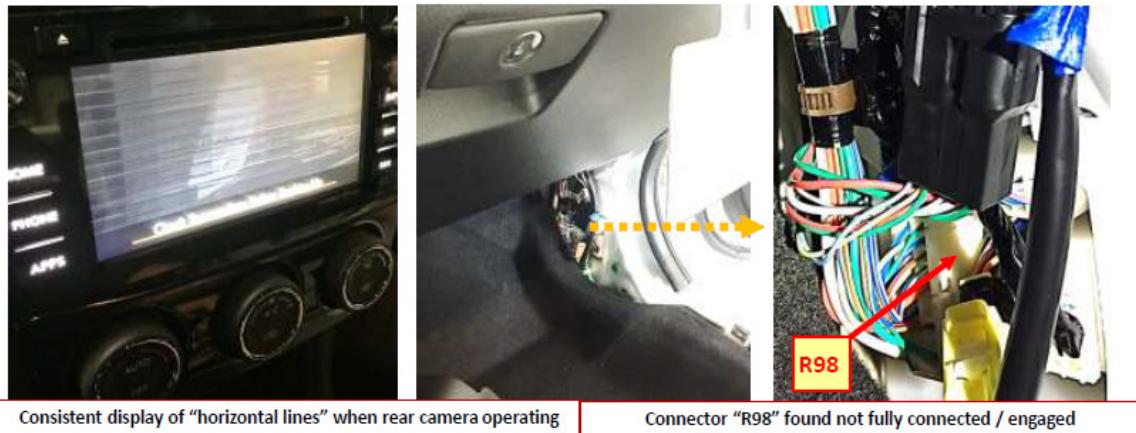
CONDITION# 8: Subject vehicle consistently displays multiple horizontal lines across the display screen each time the backup camera feature is operated. **NOTE:** This applies to **2017MY Impreza ONLY.**

CAUSE: Investigation found the cause of this condition to be connector R98 not fully connected / engaged.

RECOMMENDATIONS: Access and disconnect R98 and examine closely for any bent or displaced terminals. If OK, firmly reconnect and ensure a solid connection. Retest backup camera operation and confirm a consistent, high-quality image is displayed.

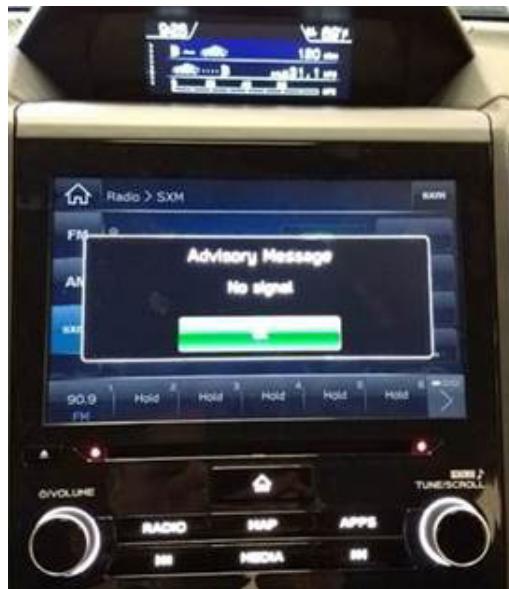
CONDITION# 9: Harman Gen 3 Audio/ Navigation head unit shows an “Advisory Message- No Signal” notification on the display.

CAUSE: In areas of poor or no SXM coverage, the head unit will display the message as shown above. It is not a failure condition assuming SXM service is not available.

RECOMMENDATION: No action should be taken to correct this condition.

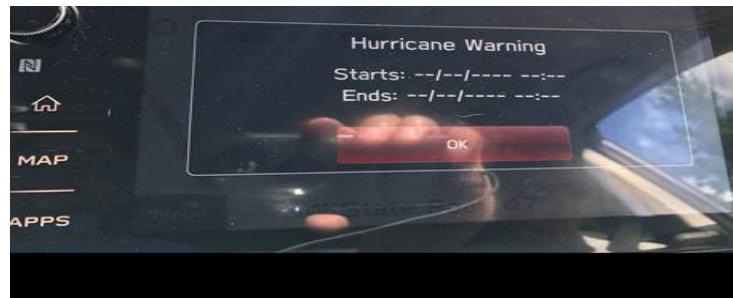
CONDITION# 10: Hurricane or Severe Weather warning message is displayed.

CAUSE: The head unit receives information from SXM and displays the message whenever there is a signal from SXM. If there is no date information from SXM, the details (dates) will not show.

RECOMMENDATION: The display matches data supplied by SXM. **NOTE:** If the concern is the frequency the message is displayed, the frequency was reduced effective with Version 3 software update release.

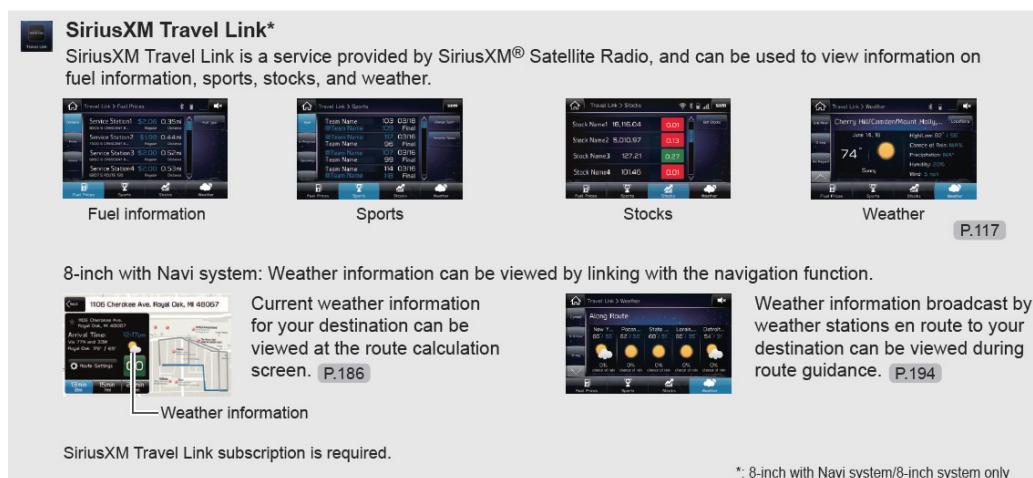
CONDITION# 12: Weather, Fuel Information, Sports, Stocks information do not display in the Multi-Function Display (MFD).

CAUSE: Weather forecasts, forecast temperature or highest / lowest temperature, and chances of precipitation, etc. can be displayed in weather information. A SiriusXM (SXM) services subscription is required.

RECOMMENDATIONS: Verify an active subscription for SiriusXM (SXM) services has been extended, after 1-year free trial period. Content using the SiriusXM® Satellite Radio Service is reset when personal information is initialized by selecting **Factory Data Reset** (Factory Data Reset) on the "GENERAL SETTINGS SCREEN".

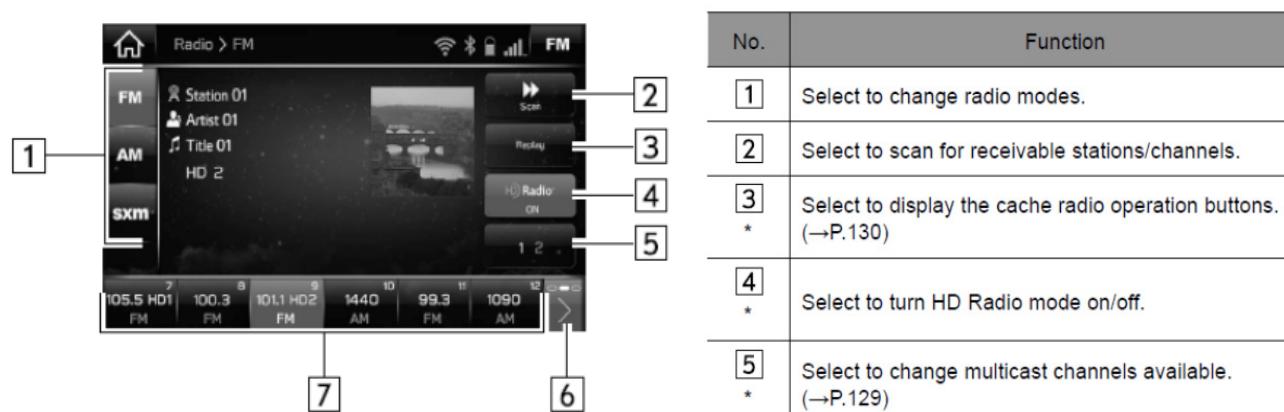
CONDITION# 14: Volume fades up and down (FM/AM HD radio).

CAUSE: Assuming the audio unit is in HD Radio mode, the vehicle is likely traveling outside of HD Radio coverage area causing the head unit to switch between HD and Analog mode.

RECOMMENDATION: Turn HD off as shown in the images below.

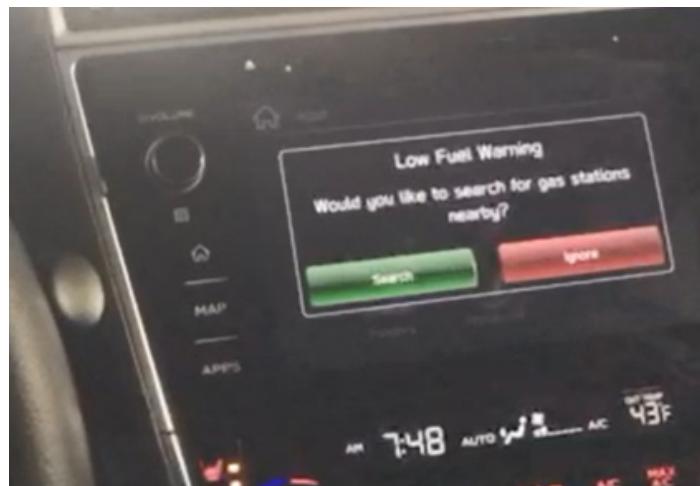
CONDITION# 15: Low Fuel Warning advisory message appears on display.

CAUSE: The head unit only displays fuel level information sent to it from the combination meter.

RECOMMENDATIONS: Confirm combination meter and sender functions are operating properly. Confirm the trip meter is reset following refueling. Confirm ignition key is not being left in the ON / RUN positions during refueling.

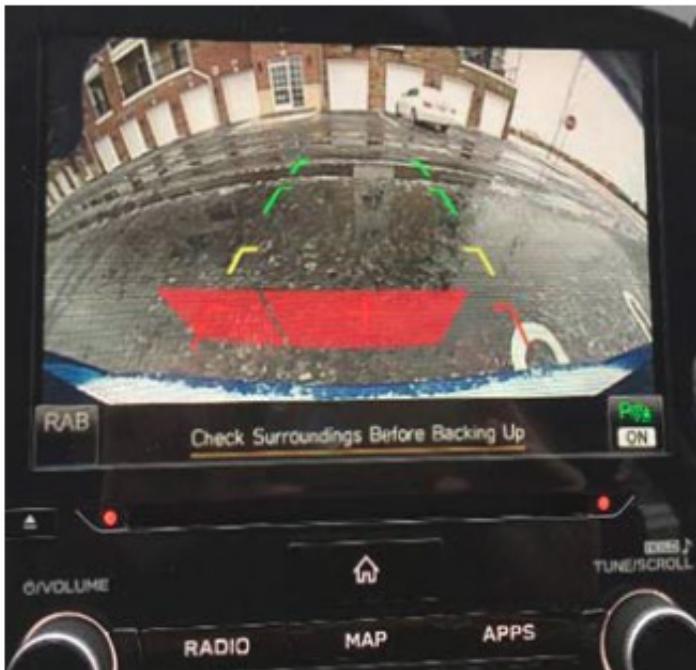
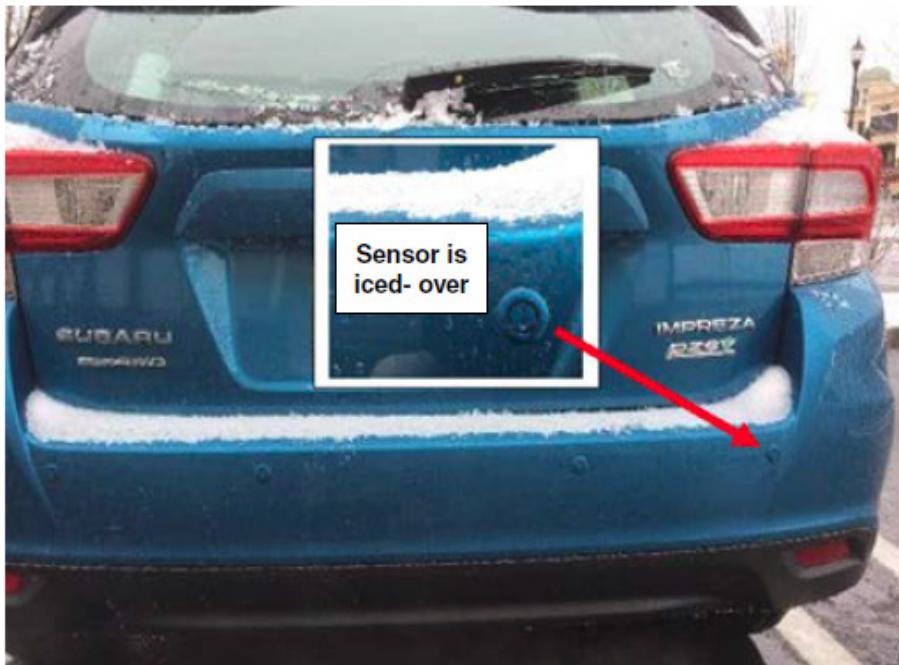
CONDITION# 19: On vehicles equipped with reverse automatic braking (RAB), a red area appears in backup camera display.

CAUSE: If a customer states they see a red box or area in their backup camera display, the system is most likely operating as designed. Always perform a visual check of the sensors on the rear bumper first. If any of the sensors are covered over or obstructed by ice and / or snow, the RAB system may not function properly and the red area shown in the example photo below will most likely appear.

RECOMMENDATIONS: When this condition occurs, the RAB system is unable to properly differentiate between what really is an obstacle and what is not. In the image below, the sensor is iced over and the red area is displayed with no obstacle present. The Owner's Manual provides a list of other potential causes for this condition to occur.

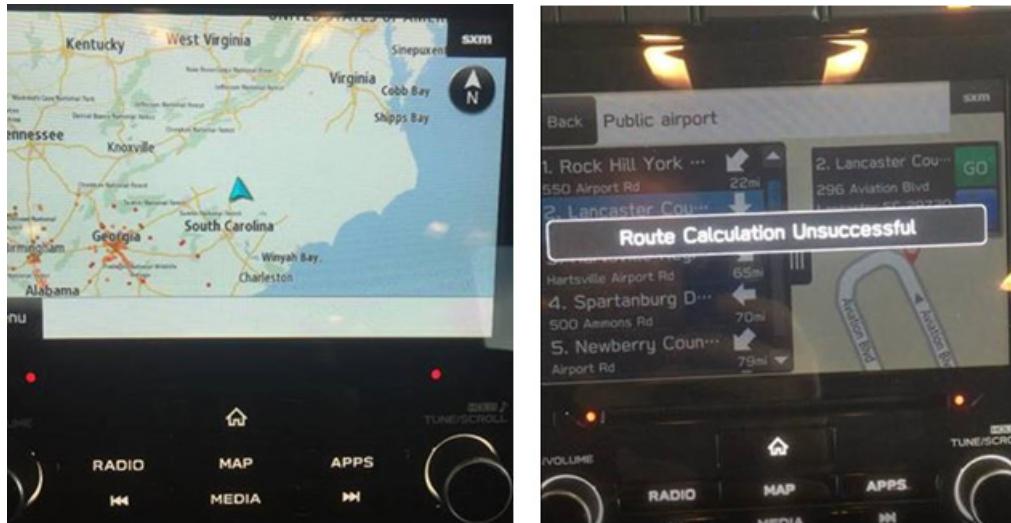
CONDITION 25: Map Display “Whiteout”. Map display is either white (blank) or, an incomplete screen (no roads) is displayed. “Route Calculation Unsuccessful” message is displayed when trying to calculate a route.

CAUSE: If a MOTA (Map Over The Air update) was performed or attempted previously, the state map data may have become corrupted. This can occur due to weak a WIFI signal during MOTA causing the state to disappear (appear white).

RECOMMENDATION: Update the map (again) successfully using a strong WIFI signal or via USB.

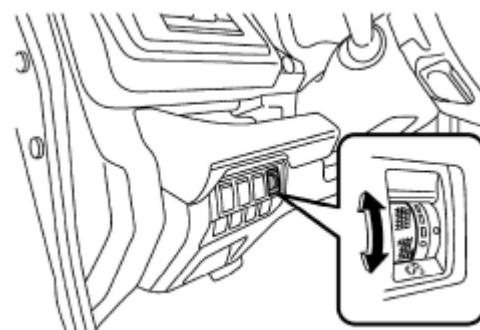
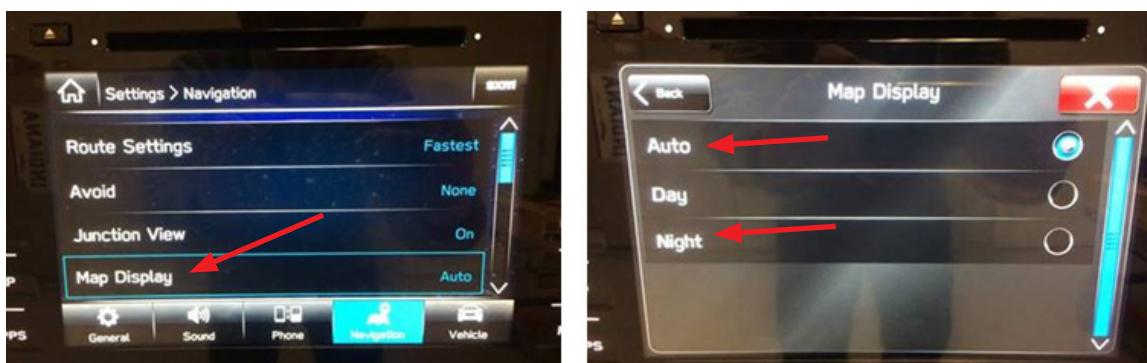
CONDITION 26: Map display not going into “Night” mode in low light (night time / dark) conditions

POSSIBLE CAUSES: Map display setting may be set to “Day” instead of “Night” or “Auto” as shown below. If the instrument panel illumination control knob is set to MAX brightness (all the way up), the map display will not change regardless if “Auto” or “Night” mode is selected in the Settings menu.

RECOMMENDATIONS: From the Settings menu, select Map Display and either “Auto” or “Night”. If there is no change, check and lower (if necessary) the illumination control knob as shown in the illustration to the right and “Auto” or “Night” mode operation will be restored.
