## SERVICE INFORMATION BULLETIN

**APPLICABILITY:** All Models with TR 580 and TH58A CVT  
Transmissions

**NUMBER:** 16-109-17R

**SUBJECT:** Fluid Service Plug Design Change

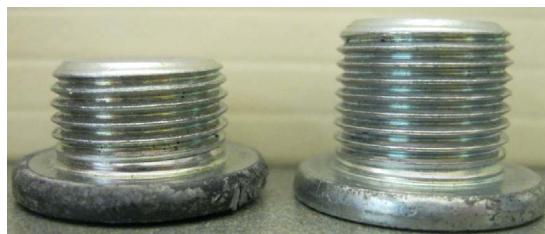
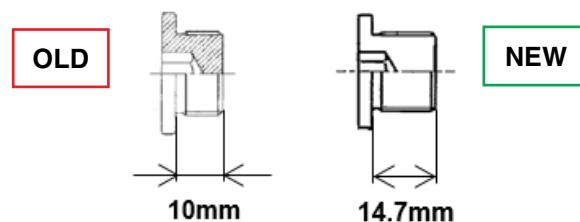
This Service Information bulletin announces a design change to the service plugs used in some places on TR580 (and TH58A used in hybrid vehicles only) CVT transmissions. A new plug with a longer (14.7mm vs. 10mm on the old style) threaded portion is now available which further distributes the forces applied to the threads and decreases the possibility of damage to the transmission case and converter housing.

The part number for the new, longer service plug is **807018070**.

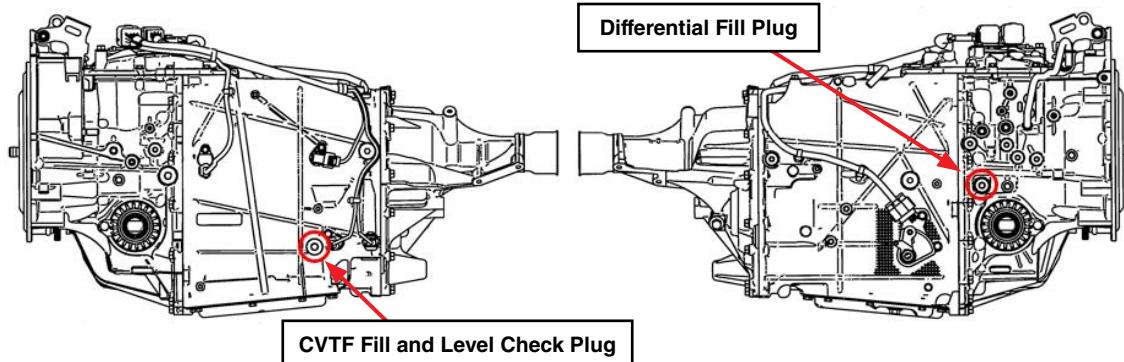
The illustrations below show the affected service plug locations circled in red.

**VERY IMPORTANT:** Whenever any of these plugs are removed, if found to be the old style, 10mm thread length type, they MUST be replaced with the new-style 14.7mm thread length part.

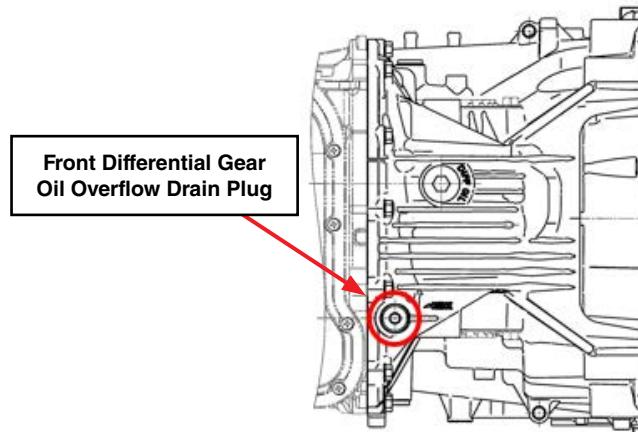
Illustration below shows an underside view of converter housing.
