**M/T - 6 Speed MTM Difficulty Selecting Gears**  
**TRANSMISSION & [CLUTCH](#)**  
 TC002-01

Title:  
 6-SPEED MTM

Models:  
 '00 - '01 Celica GTS

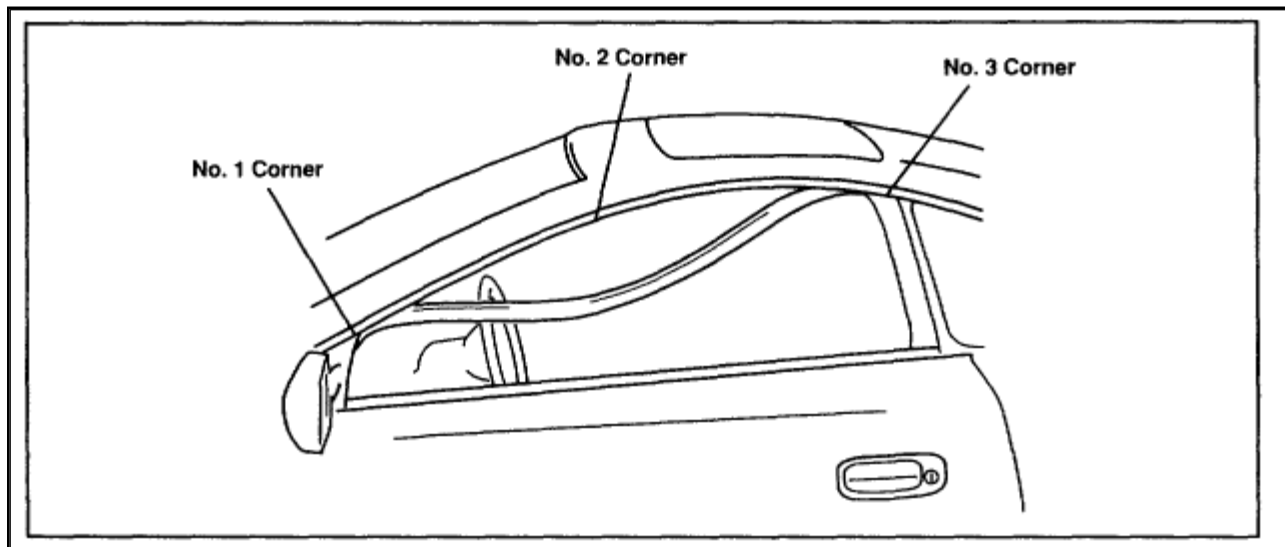
The installation method of the roof side rail weatherstrip has been modified to improve retention between the No. 1 and No. 3 corners on 2000 model year Celica vehicles. The part has not been changed. Use the following installation instructions to reinstall the roof side rail weatherstrip on vehicles with the above concern.

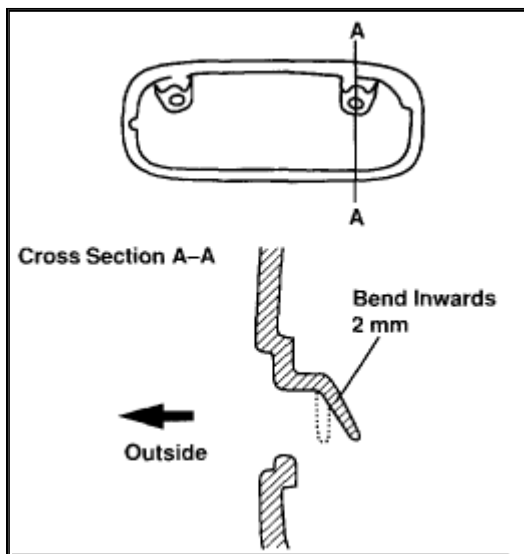
The outer [door handle](#) on some 2000 model year Celica vehicles may appear to be loose due to a gap between the door handle and door panel. A production countermeasure has been implemented. Use the following procedures to reduce outer door handle movement concerns.

7. Adjust both mounting tabs inwards 2 mm as shown in illustration.
8. If the outer [door handle](#) is still loose after adjusting the mounting tabs, install EPT sealer as indicated below:

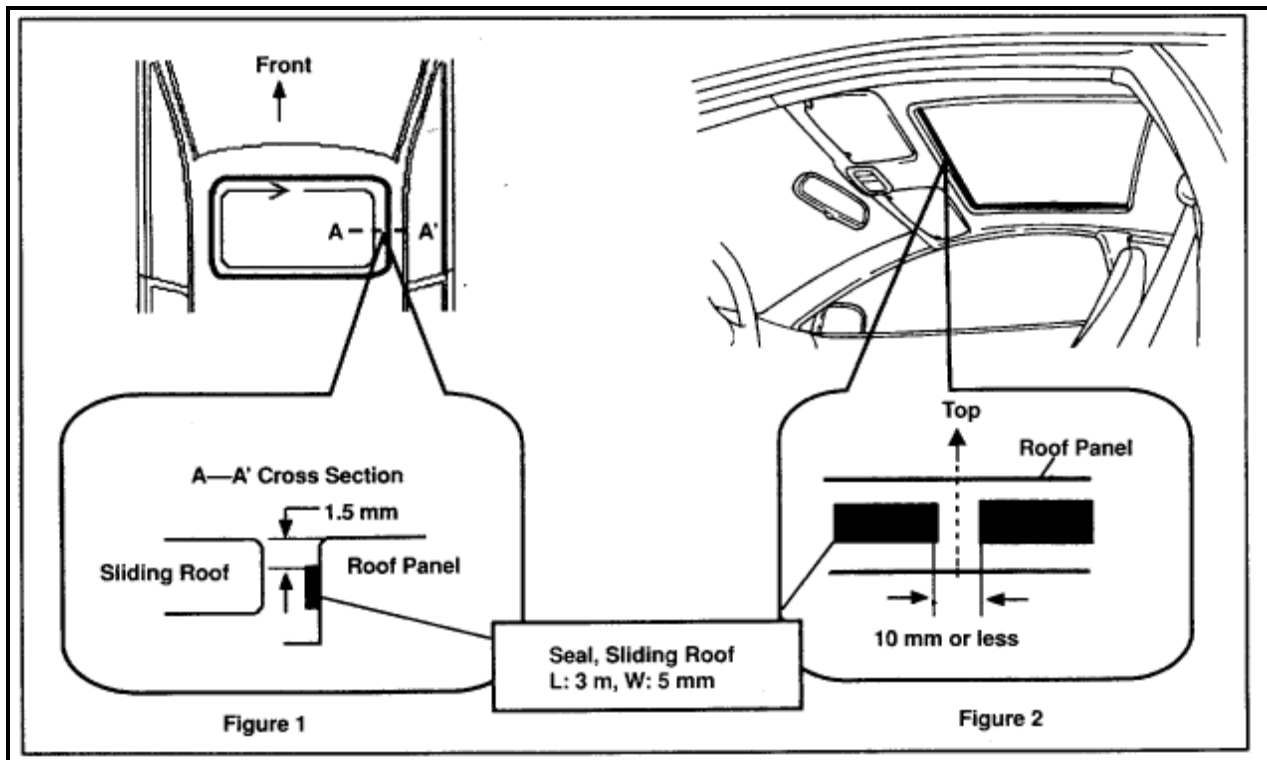
The following procedure is required to correct moon roof creak noise. This condition is caused by dirt or dust between the moon roof seal and the moon roof opening in the roof causing friction.

1. Use alcohol to clean the inside surface of the roof [body](#) flange where the [Sliding Roof](#) Seal is to be applied.
2. Apply [Sliding Roof](#) Seal to the inside surface of the roof panel as follows:

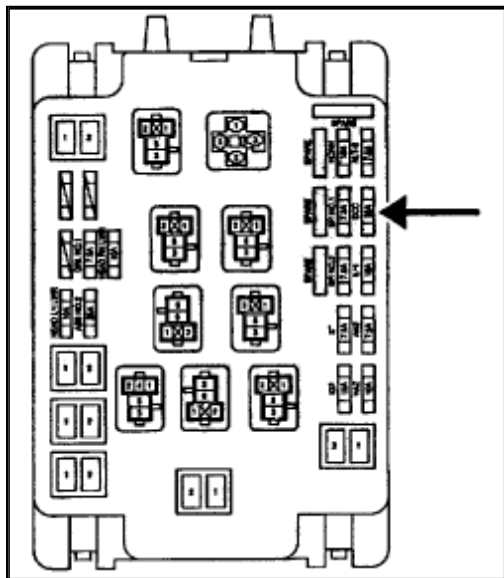
On the 2000 model year Celica the [tachometer](#) and speedometer needles will fluctuate when the ignition switch is turned on with the DCC 25 Amp fuse removed. Initial installation of this fuse should occur during PDS (Pre-Delivery Service). Tachometer/speedometer needle movement is a normal condition for this model with the DCC 25 Amp fuse removed.

If a vehicle exhibits this condition, check that the DCC 25 amp fuse is in the Junction Block as shown.

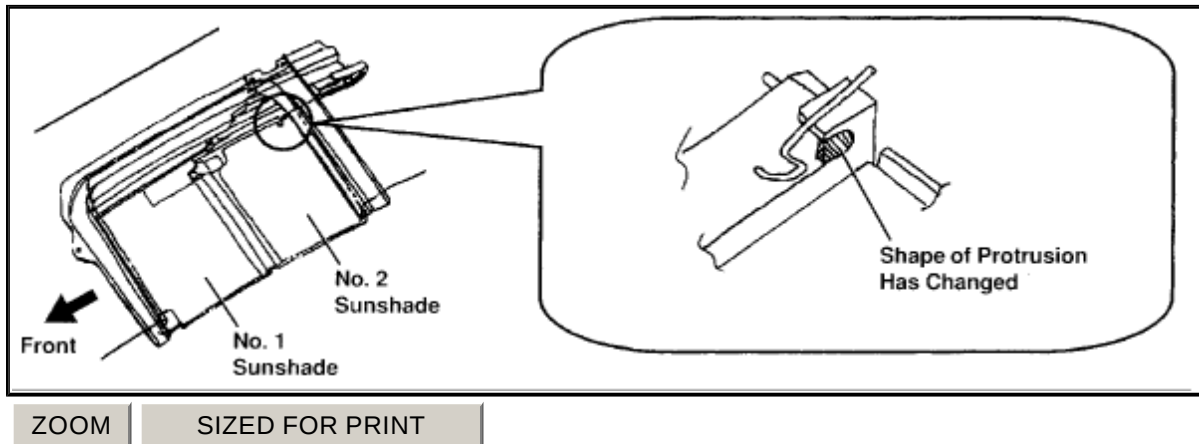
### 1. Rattle Noise With Sunshade in Closed Position

A change was made to the shape of the protrusions located at the left and right rear corners of the No.2 sunshade, as shown in the illustration above.

- Remove the headliner (please refer to the 2000 Celica Repair Manual, pages BO-88 through BO-90).
- Remove the [sliding roof](#) assembly (please refer the the 2000 Celica Repair Manual, page BO-71).
- Remove the rear sunshade stoppers.
- Replace the No. 2 sunshade.
- Replace the rear sunshade stoppers.
- Reassemble in the reverse order of disassembly.
