GROUP 54

CHASSIS ELECTRICAL

OUTLINE OF CHANGES

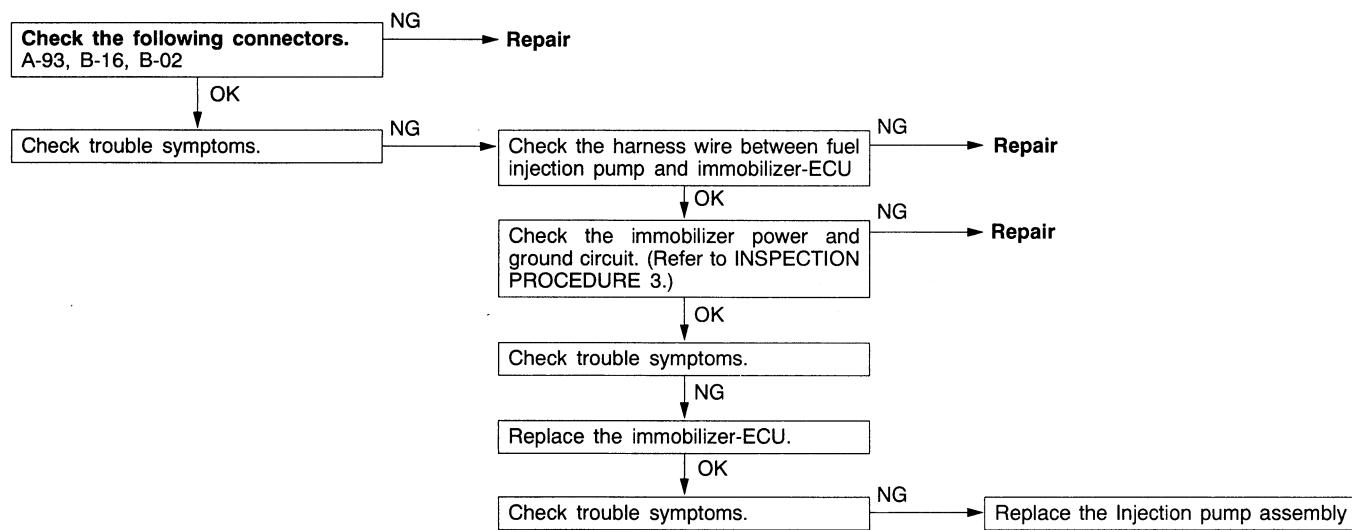
Code No.21 Communication system between immobilizer-ECU and fuel injection pump

Probable cause

After the ignition switch is turned to the ON position, the confirmation code is not received from the fuel injection pump within the allowable time, or an abnormal code is received.

- Malfunction of harness or connector
- Malfunction of the fuel injection pump
- Malfunction of the immobilizer-ECU

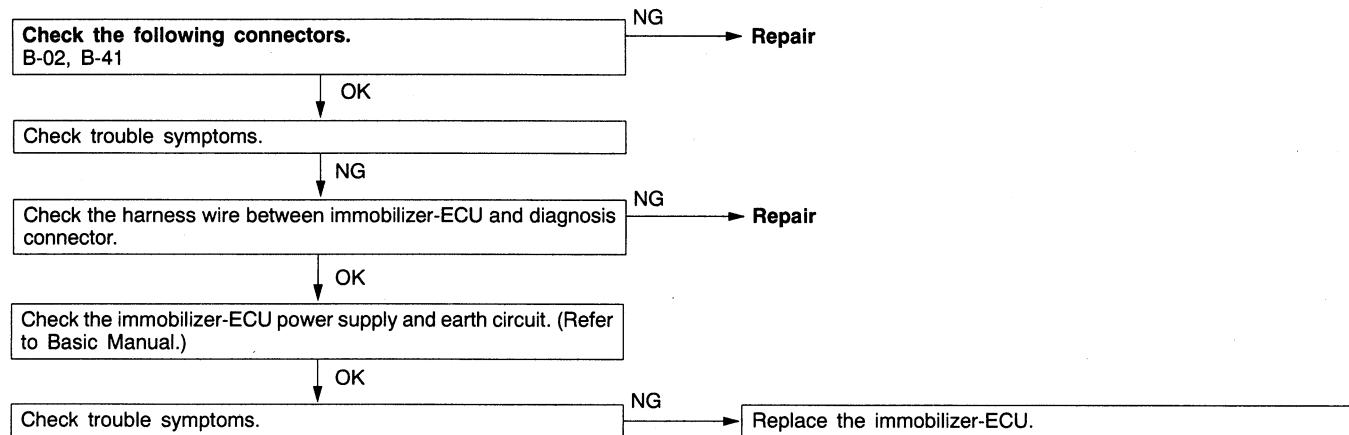
Inspection Procedure 1

Communication with MUT-II is impossible.	Probable cause
The cause is probably that a malfunction of the diagnosis line or the immobilizer-ECU is not functioning.	<ul style="list-style-type: none"> Malfunction of the diagnosis line Malfunction of harness or connector Malfunction of the immobilizer-ECU

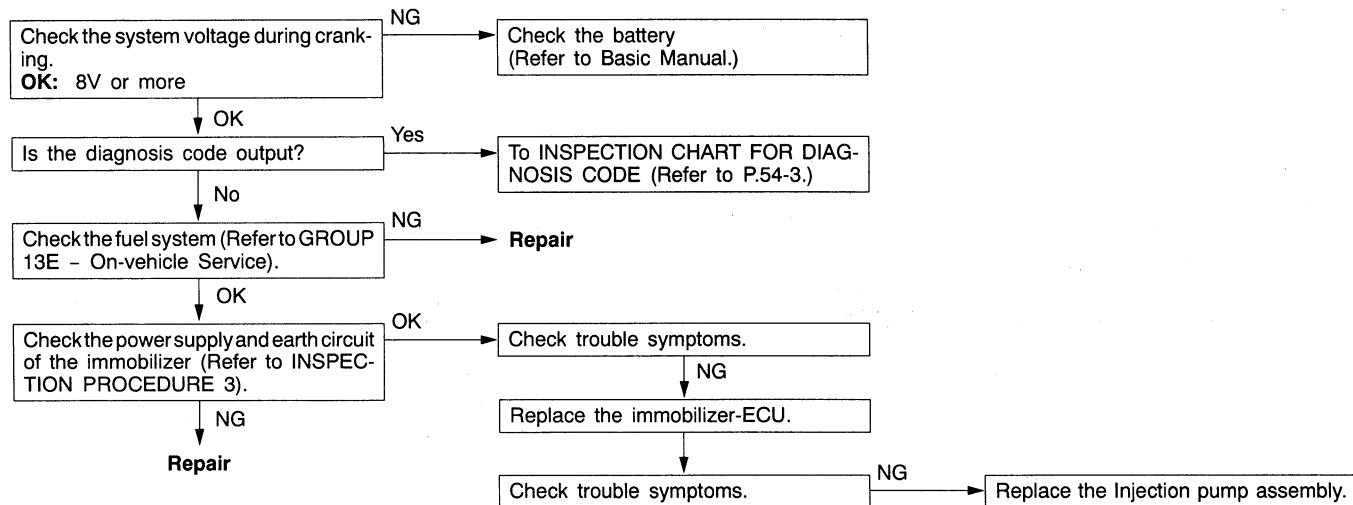
Inspection Procedure 2**Engine does not start (cranking but no initial combustion). Probable cause**

If the fuel injectors are not operating, there might be a problem with the fuel system in addition to a malfunction of the immobilizer system.
It is normal for this to occur if an attempt is made to start the engine using a key that has not been properly registered.

- Malfunction of the fuel system
- Malfunction of the immobilizer system
