Shift Indicator Panel

Adjustment

ACCORD AERO DECK

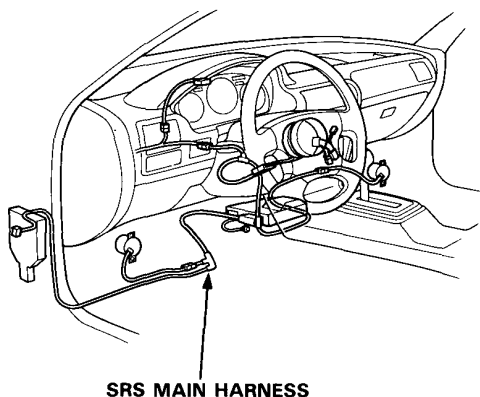
SRS wire harness is routed near the gearshift selector.

NOTE: LHD is shown; RHD is similar.

- All SRS electrical wiring harnesses are covered with yellow outer insulation.
- Replace the entire affected SRS harness assembly if it has an open circuit or damaged wiring.

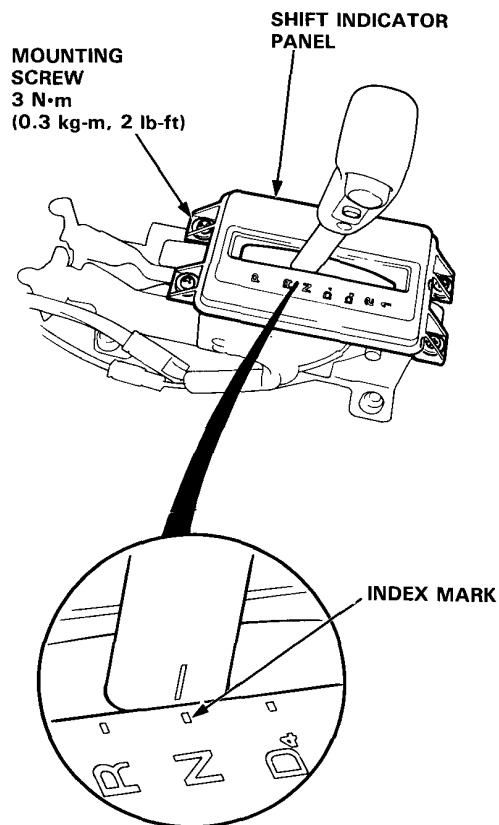
1. Check that the index mark of the indicator aligns with the **N** mark of the shift indicator panel with the transmission in NEUTRAL.
2. If not aligned, remove the center console. (see Section 14).
3. Remove the shift indicator panel mounting screws and adjust by moving the panel.

NOTE: Whenever the shift indicator panel is removed, reinstall the panel as described above.
