**Technical Service
Information Bulletin**
April 3, 1998

**R-12 AIR CONDITIONER SYSTEM
RETROFIT**

'90-'93 ES 250/300, SC 400/300, LS 400

AC001-98

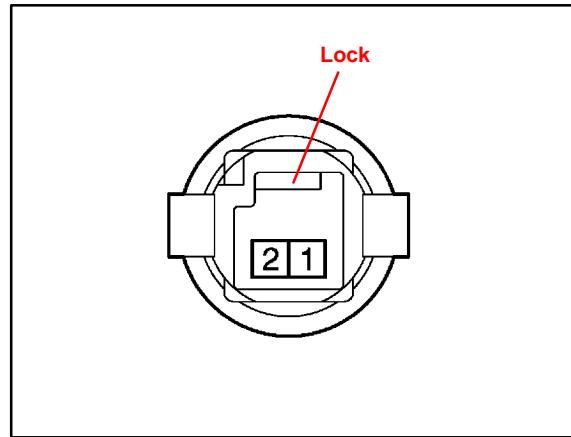
- Disconnect the solar sensor connector.
- Measure the resistance between terminals 1 and 2 of the solar sensor under the following conditions:
 - Cover the sensor with a cloth to avoid direct light.
 - Expose the sensor to light from a distance of 300 mm (11.81 in.) or less with an inspection light.

CONDITION	SPECIFICATION
When the sensor is covered with a cloth (to avoid direct light)	Infinite ohms
When the sensor is exposed to light	Less than infinite resistance

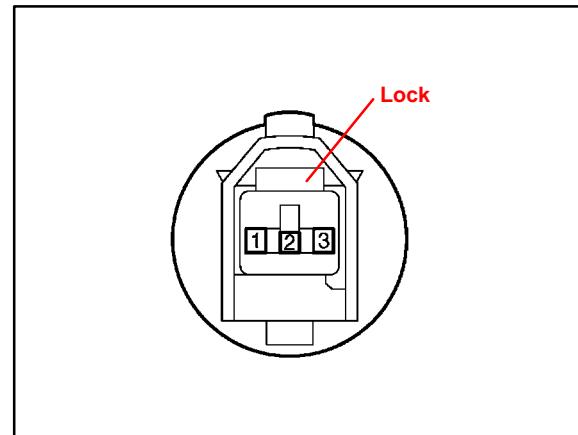
- a. Disconnect the solar sensor connector.
- b. Measure the resistance between terminals 2 and 3 of the solar sensor under the following conditions:
 - Cover the sensor with a cloth to avoid direct light.
 - Expose the sensor to light from a distance of 300 mm (11.81 in.) or less with an inspection light.

CONDITION	SPECIFICATION
When the sensor is covered with a cloth (to avoid direct light)	Infinite ohms
When the sensor is exposed to light	Less than infinite resistance

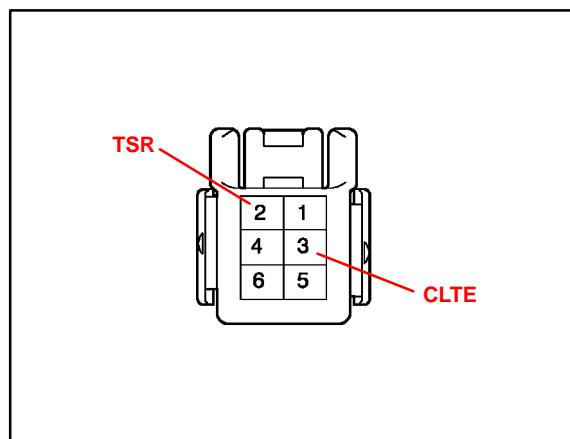
- a. Turn the ignition switch ON.
- b. Measure the voltage between terminals TSR (+) and CLTE (–) of the connector under the following conditions:
 - Cover the sensor with a cloth to avoid direct light.
 - Expose the sensor to light from a distance of 300 mm (11.81 in.) or less with an inspection light.

CONDITION	SPECIFICATION
When the sensor is covered with a cloth (to avoid direct light)	Below 0.8 V
When the sensor is exposed to light	4.3 +/– 0.3 V

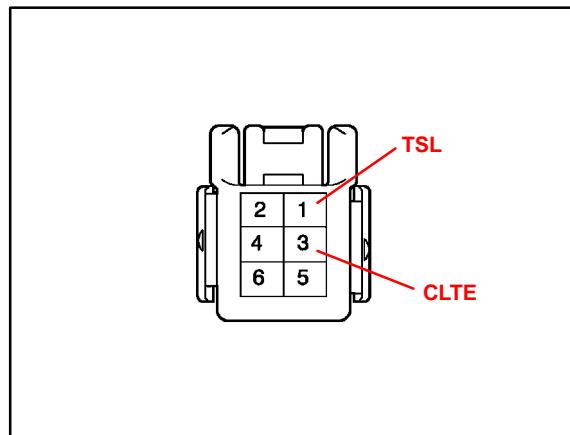
- c. Measure the voltage between terminals TSL (+) and CLTE (–) of the connector under the following conditions:
 - Cover the sensor with a cloth to avoid direct light.
 - Expose the sensor to light from a distance of 300 mm (11.81 in.) or less with an inspection light.

CONDITION	SPECIFICATION
When the sensor is covered with a cloth (to avoid direct light)	Below 0.8 V
When the sensor is exposed to light	4.3 +/– 0.3 V

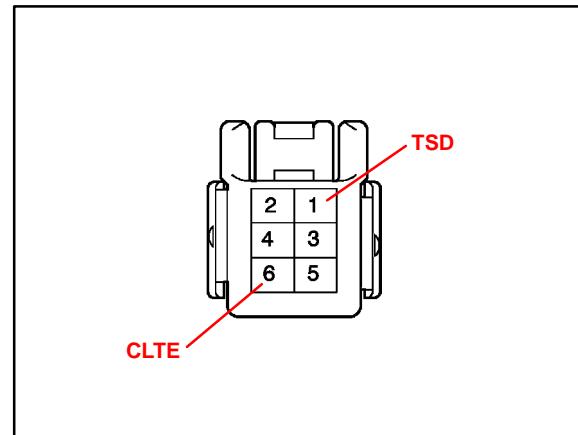
- a. Turn the ignition switch ON.
- b. Using the tester, measure the voltage between terminals TSD (+) and CLTE (–) of the connector under the following conditions:
 - Cover the sensor with a cloth to avoid direct light.
 - Expose the sensor to light from a distance of 300 mm (11.81 in.) or less with an inspection light.

CONDITION	SPECIFICATION
When the sensor is covered with a cloth (to avoid direct light)	Below 0.8 V
When the sensor is exposed to light	4.3 +/– 0.3 V

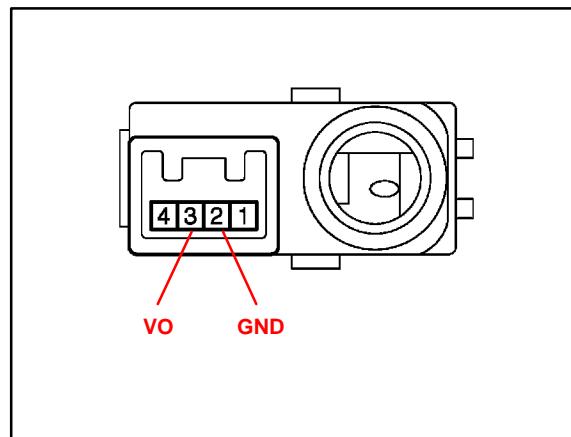
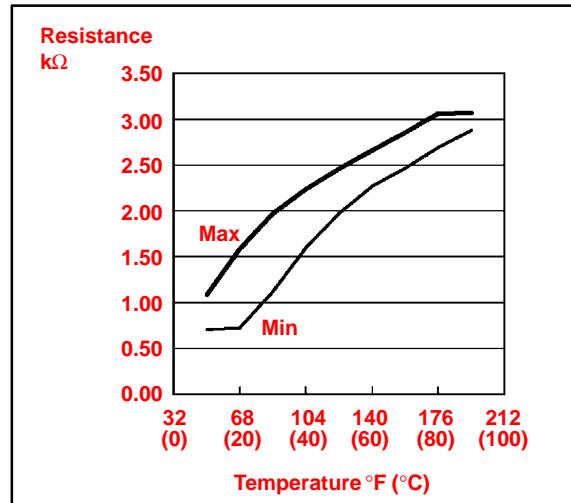
- A. Turn the ignition switch to the ON position.
- B. Measure the voltage between terminal VO (3) and GND (2) of the room humidity sensor.
- C. Measure the humidity and voltage when the room temperature (humidity sensor position) is 77°F (25°C). According to the result, determine whether the sensor is normal or not.

HUMIDITY (% RH)	OUTPUT VOLTAGE AT 77°F (25°C)
10	0.70 to 1.08 V
20	0.72 to 1.57 V
30	1.13 to 1.95 V
40	1.61 to 2.24 V
50	1.99 to 2.46 V
60	2.26 to 2.66 V
70	2.48 to 2.85 V
80	2.68 to 3.04 V
90	2.87 to 3.05 V

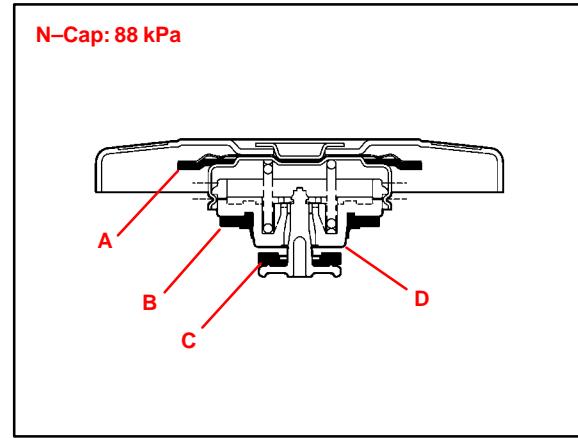
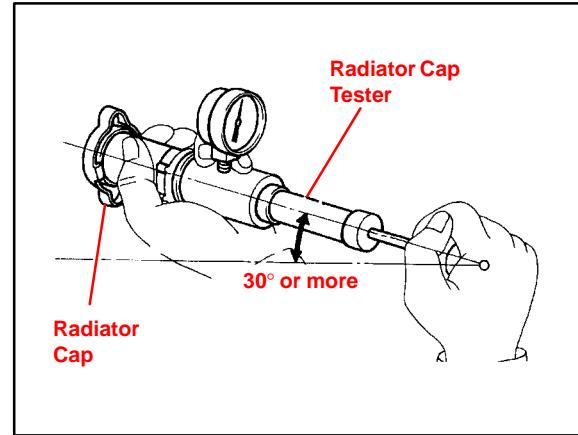
Stop pumping when the valve opens and read the gauge. The gauge must be within the standard values listed below when the pressure valve opens. The cap is considered OK when the pressure holds steady or falls very slowly, but holds within the standard values listed below for one minute.

If the maximum pressure is less than the minimum standard value, replace the radiator cap sub-assembly.

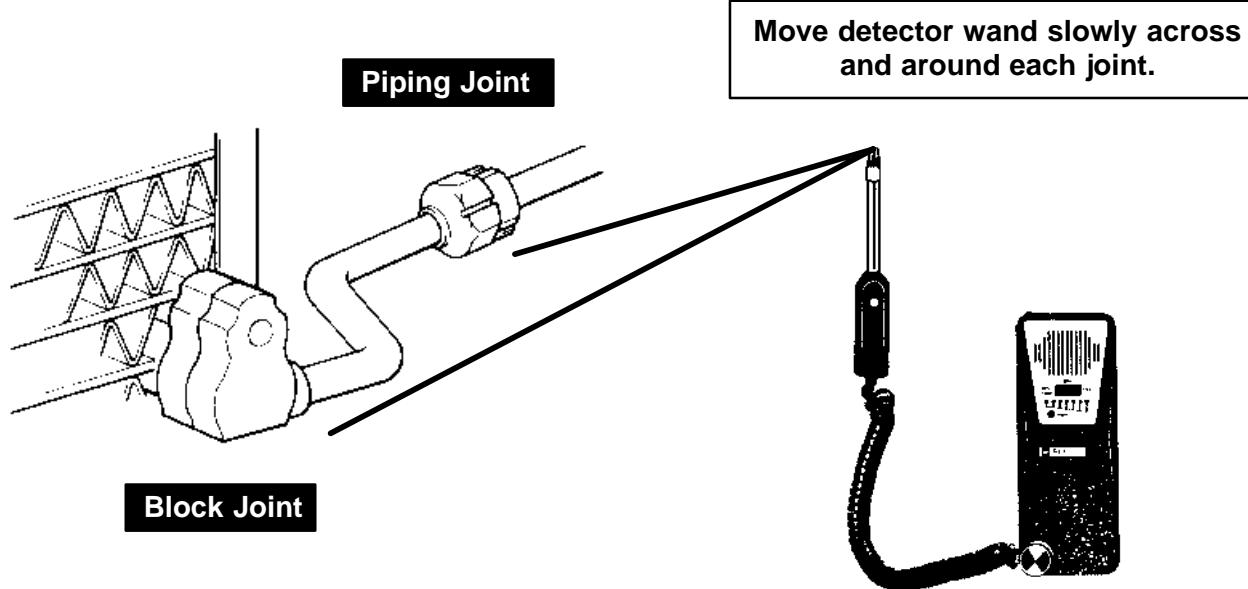
1. **Visual Inspection:** Do a quick visual inspection under the hood for signs of refrigerant leakage. Check for areas of heavy oil leakage at block and piping joints. Many times these areas have accumulated road dust and dirt.
2. **Inspection with leak detector:** **NOTE:** Make sure the system is fully charged. Operate the system to increase refrigerant pressure. Shut the system off before inspecting with leak detector.
 - A. **Checking for leakage at a joint:** Wipe the oil/dirt accumulation off the joint with a clean rag. Do not use solvents to clean the joint. Refrigerant is heavier than air so start checking for leaks with the detector wand about 1/4 in. below the joint. Move the wand slowly across and around each joint (see illustration below).

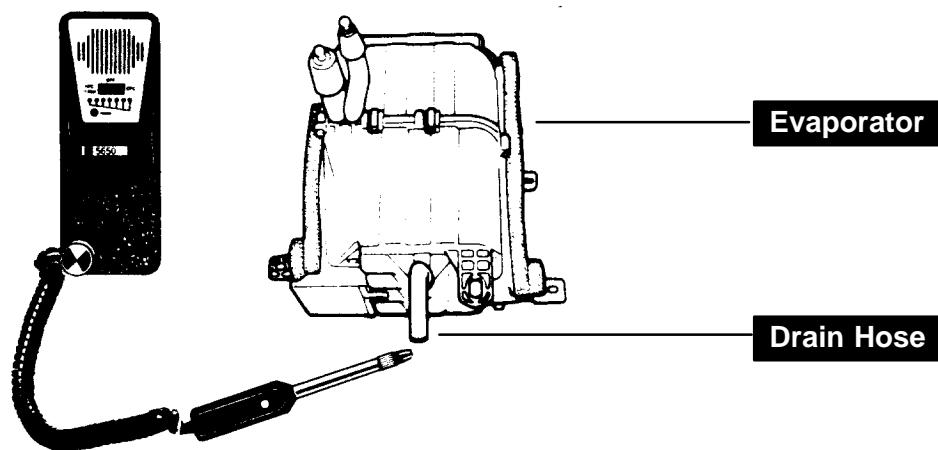
B. Checking for leakage at the evaporator: The evaporator drain hose provides an excellent access point to check for refrigerant leakage from the evaporator. Be sure to raise the vehicle on a lift so that the evaporator is as far as possible from any petrochemical source that may be on the shop floor. When leak checking in this area, turn the system off, pinch off the evaporator drain hose, and wait 10 to 15 minutes to allow the refrigerant to accumulate in the evaporator case. When the system is ready to check, release the drain hose and hold the leak detector wand about 1/4 inch below the drain opening (see diagram).

NOTE: Do not allow the leak detector tip to come in contact with water from the evaporator.

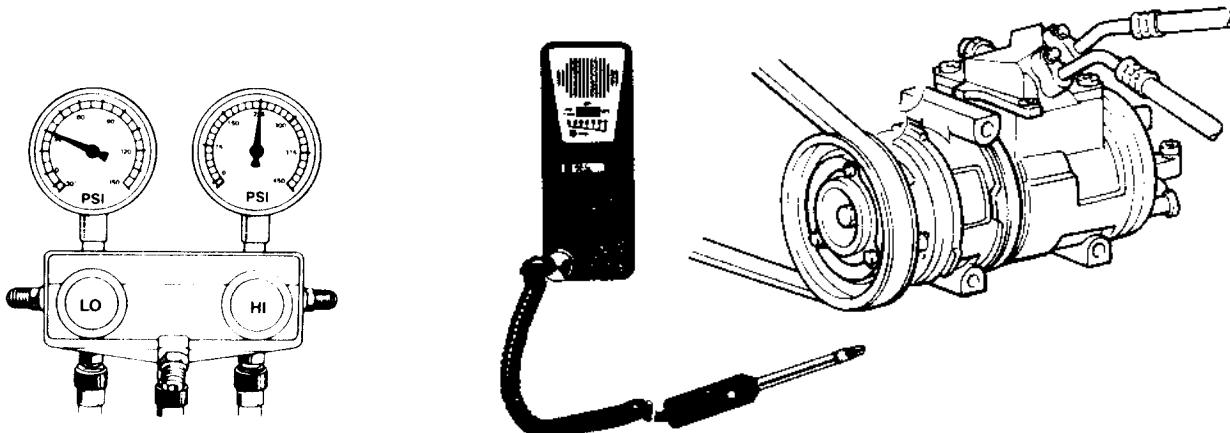
C. Checking for leakage at front compressor seal: Front compressor seal leaks are probably the most difficult leaks to detect accurately. Special diagnostic procedures must be followed for the best success. Make sure the system is fully charged. Operate the system with a pressure gauge installed and assure that the system has correct system pressures. **Shut off the engine.** Begin the leak check by placing the detector probe along the bottom half of the compressor clutch. Move the wand slowly across the bottom of the compressor clutch. Be careful not to expose the detector wand tip to any oil residue as this may cause a false leakage reading.

Move detector wand slowly across the bottom half of the compressor clutch.

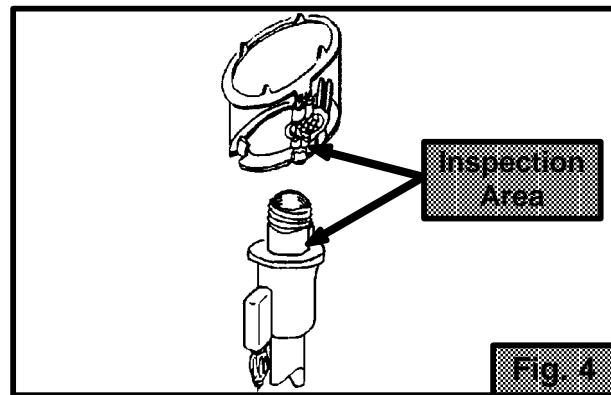
4. Remove the antenna spacer grommet at the top of the antenna assembly and inspect for corrosion. Clean with 1500 grit sandpaper (Fig. 4).

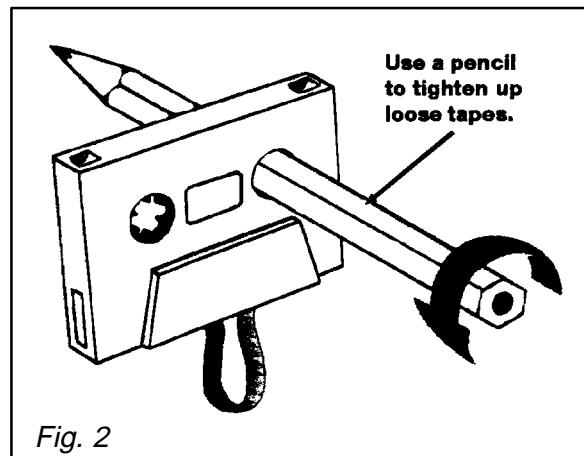
Fig. 2

1. Remove the cassette from the player when the cassette is not in use.
2. Store the cassette in its case.
3. Store the cassette in a cool, dry area away from direct sunlight and magnetic components such as speakers.
4. Avoid touching the tape itself. This could result in poor sound quality or sound drop out.
5. Keep the tape tightly wound as shown in figure 2. Tape speed can be affected by loosely wound tape.

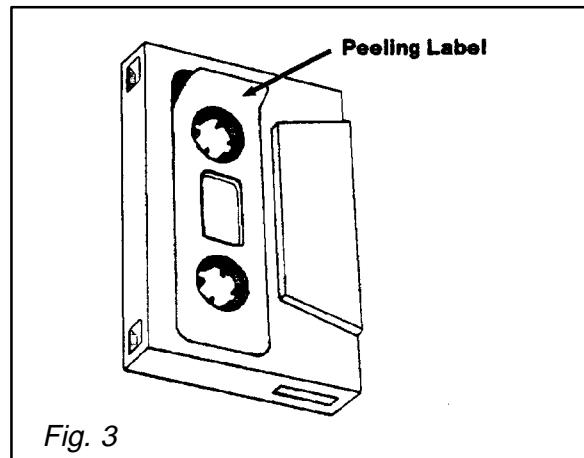
Fig. 3

6. Avoid inserting a cassette into the player if the cassette label is loose or peeling as shown in figure 3. This can cause a cassette to become stuck in the player.

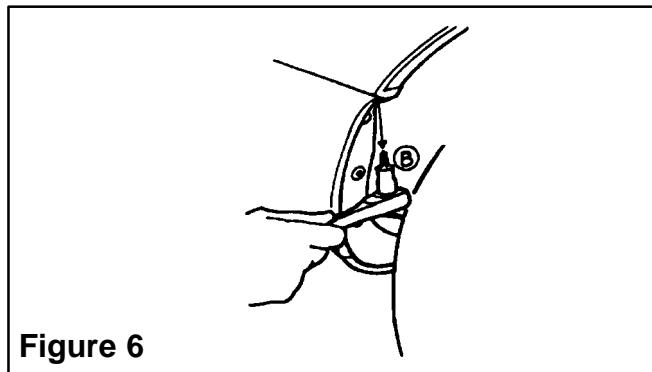
Figure 6

1. Remove bolt B, found at lower body panel, to fender well attachment intersection (See Figure 6).

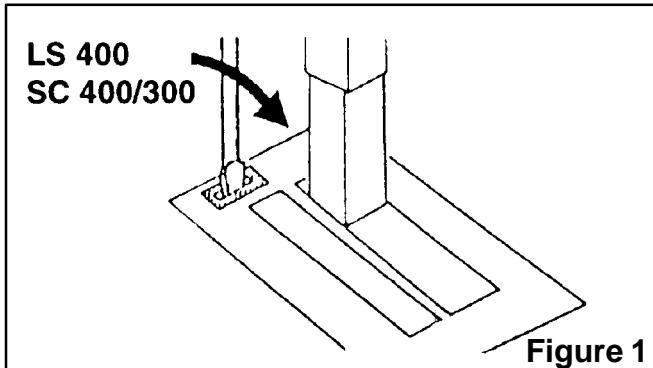
1. Apply the parking brake and turn the ignition key to the "OFF" position.
2. For LS 400, SC 400/300, insert a flat bladed screwdriver or equivalent into the index on top of the ORB cover and pry towards the shift handle (see Figure 1).

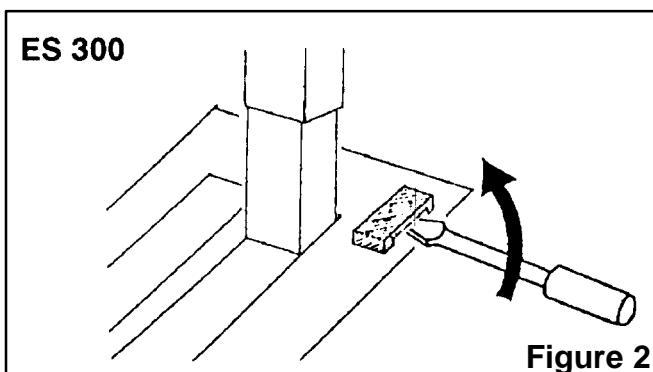
3. For ES 300, insert a flat-bladed screwdriver or equivalent into the index on the side of the ORB cover and pry it up (see Figure 2).

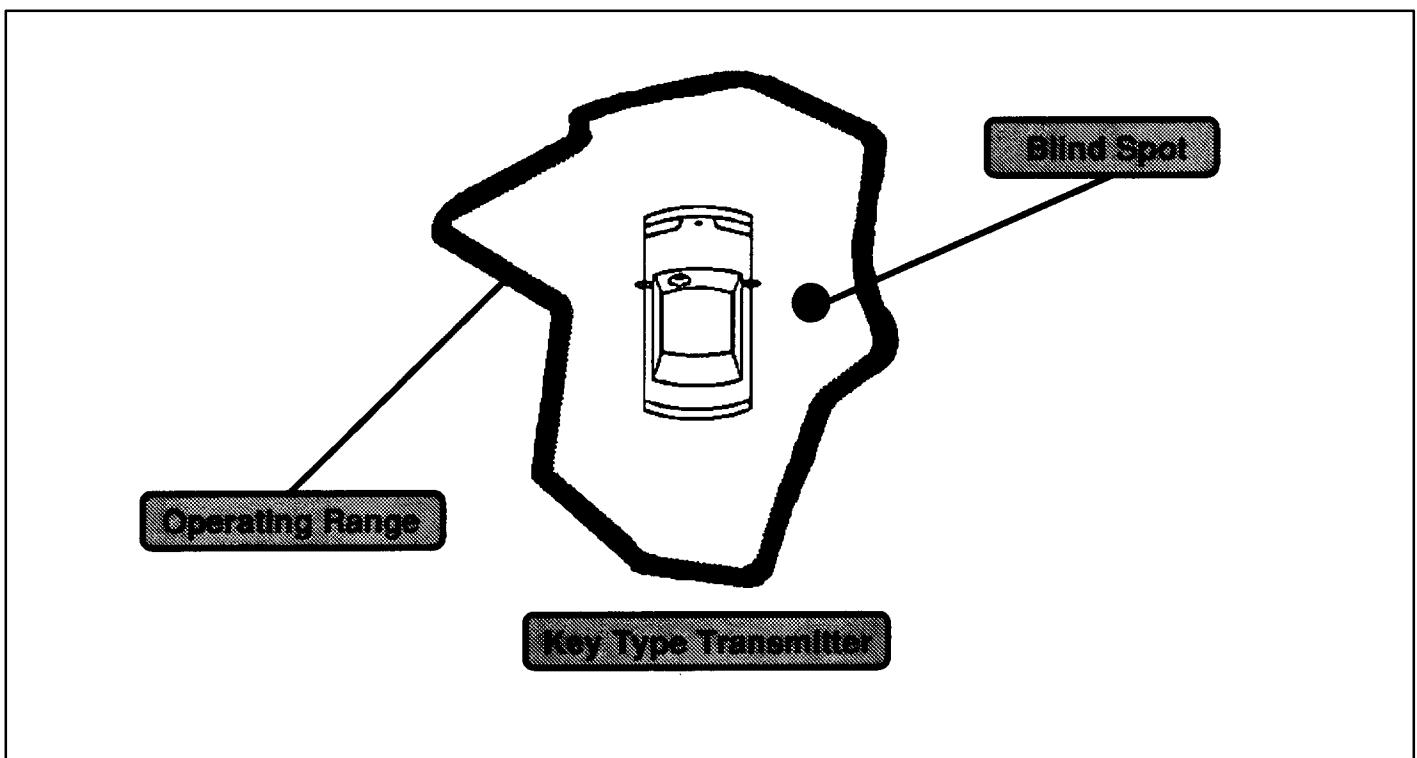
NOTE: Diagram represents only a generalized view which may vary depending on the model and operating conditions. Fob type transmitters accommodate a larger transmitter and battery which typically provide increased operating range.

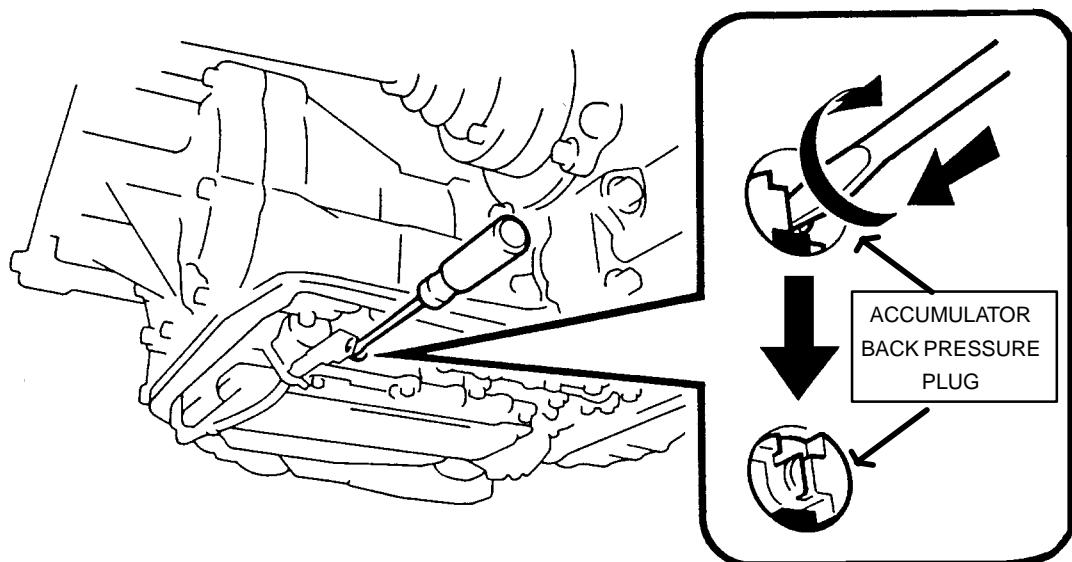
NOTE: Depress the accumulator back-pressure plug slightly inward with a screwdriver and turn the plug to the full right position. The plug will then be set to the most protruded position (refer to illustration).
