**Technical Service
Information Bulletin**
December 16, 2004

SENSOR INSPECTION FOR AIR CONDITIONING SYSTEM

TSIB
AC005-04

Introduction This service bulletin contains inspection procedures to more precisely confirm proper operation of the following temperature sensors of the air conditioning system. Follow the procedures in this service bulletin when inspecting these sensors. These contents will be reflected in future repair manuals.

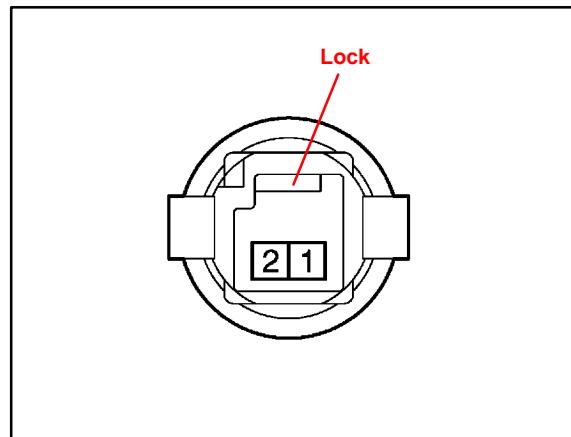
- Disconnect the solar sensor connector.
- Measure the resistance between terminals 1 and 2 of the solar sensor under the following conditions:
 - Cover the sensor with a cloth to avoid direct light.
 - Expose the sensor to light from a distance of 300 mm (11.81 in.) or less with an inspection light.

CONDITION	SPECIFICATION
When the sensor is covered with a cloth (to avoid direct light)	Infinite ohms
When the sensor is exposed to light	Less than infinite resistance

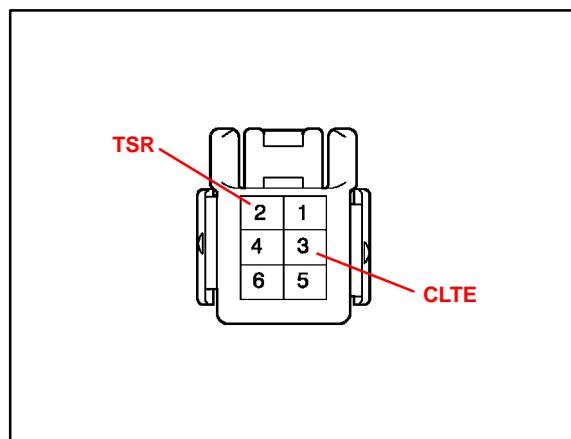
- a. Turn the ignition switch ON.
- b. Measure the voltage between terminals TSR (+) and CLTE (–) of the connector under the following conditions:
 - Cover the sensor with a cloth to avoid direct light.
 - Expose the sensor to light from a distance of 300 mm (11.81 in.) or less with an inspection light.

CONDITION	SPECIFICATION
When the sensor is covered with a cloth (to avoid direct light)	Below 0.8 V
When the sensor is exposed to light	4.3 +/– 0.3 V

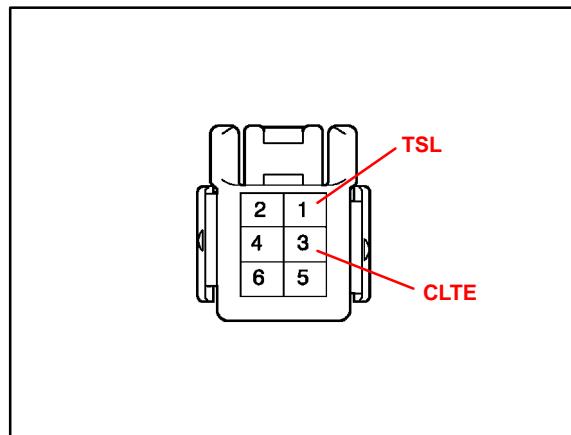
- c. Measure the voltage between terminals TSL (+) and CLTE (–) of the connector under the following conditions:
 - Cover the sensor with a cloth to avoid direct light.
 - Expose the sensor to light from a distance of 300 mm (11.81 in.) or less with an inspection light.

CONDITION	SPECIFICATION
When the sensor is covered with a cloth (to avoid direct light)	Below 0.8 V
When the sensor is exposed to light	4.3 +/– 0.3 V

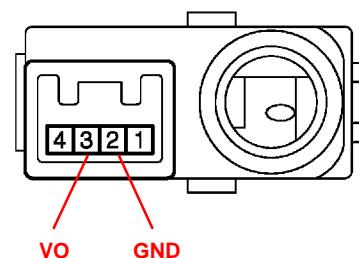
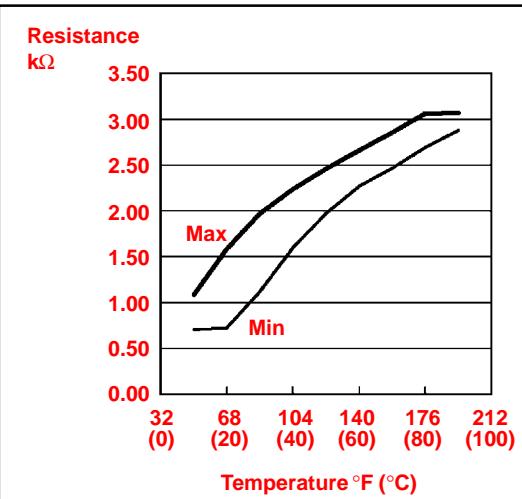
- A. Turn the ignition switch to the ON position.
- B. Measure the voltage between terminal VO (3) and GND (2) of the room humidity sensor.
- C. Measure the humidity and voltage when the room temperature (humidity sensor position) is 77°F (25°C). According to the result, determine whether the sensor is normal or not.

HUMIDITY (% RH)	OUTPUT VOLTAGE AT 77°F (25°C)
10	0.70 to 1.08 V
20	0.72 to 1.57 V
30	1.13 to 1.95 V
40	1.61 to 2.24 V
50	1.99 to 2.46 V
60	2.26 to 2.66 V
70	2.48 to 2.85 V
80	2.68 to 3.04 V
90	2.87 to 3.05 V

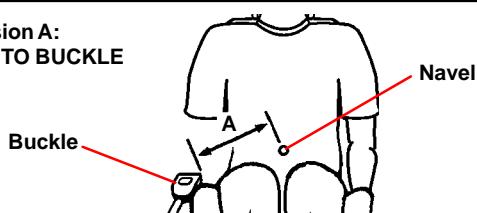
Dimension A:
NAVEL TO BUCKLE

Dimension B:
LATCH TO BUCKLE

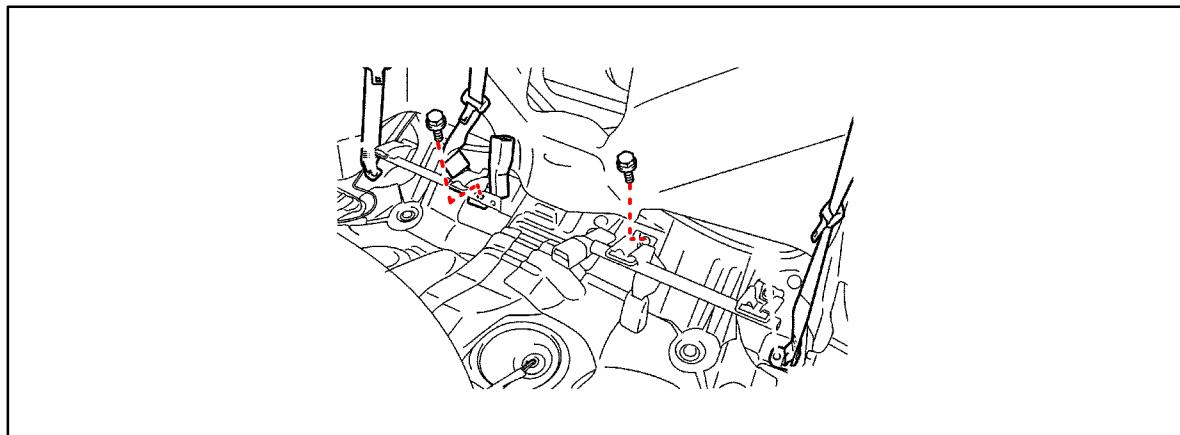
A. Remove the 2 bolts and release the floor anchors of the seat belts.

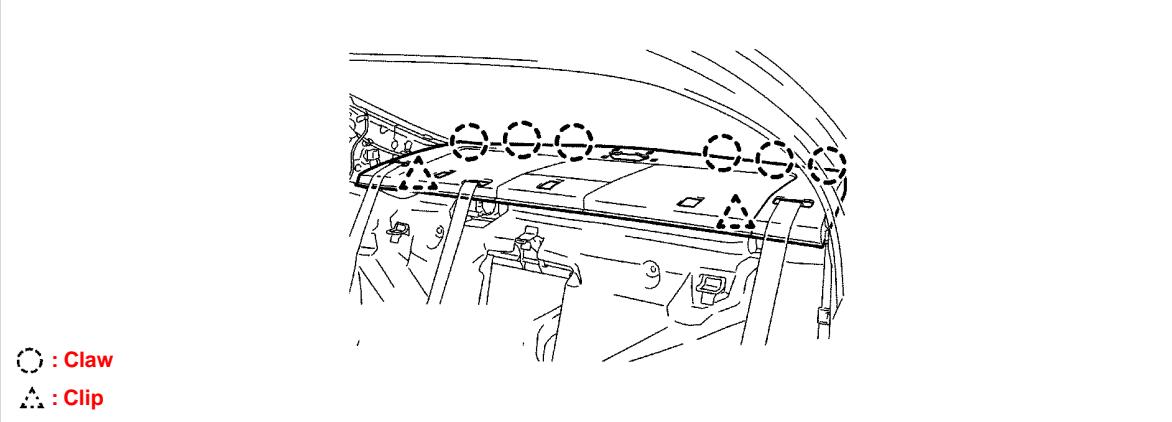
Engage the 6 claws and 2 clips to install the package tray trim panel assembly.

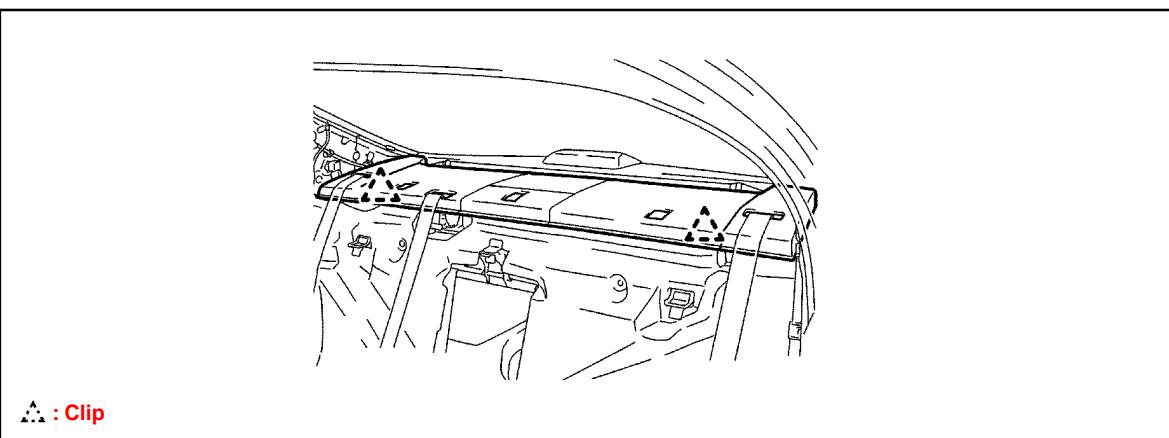
Engage the 2 clips to install the package tray trim panel assembly.

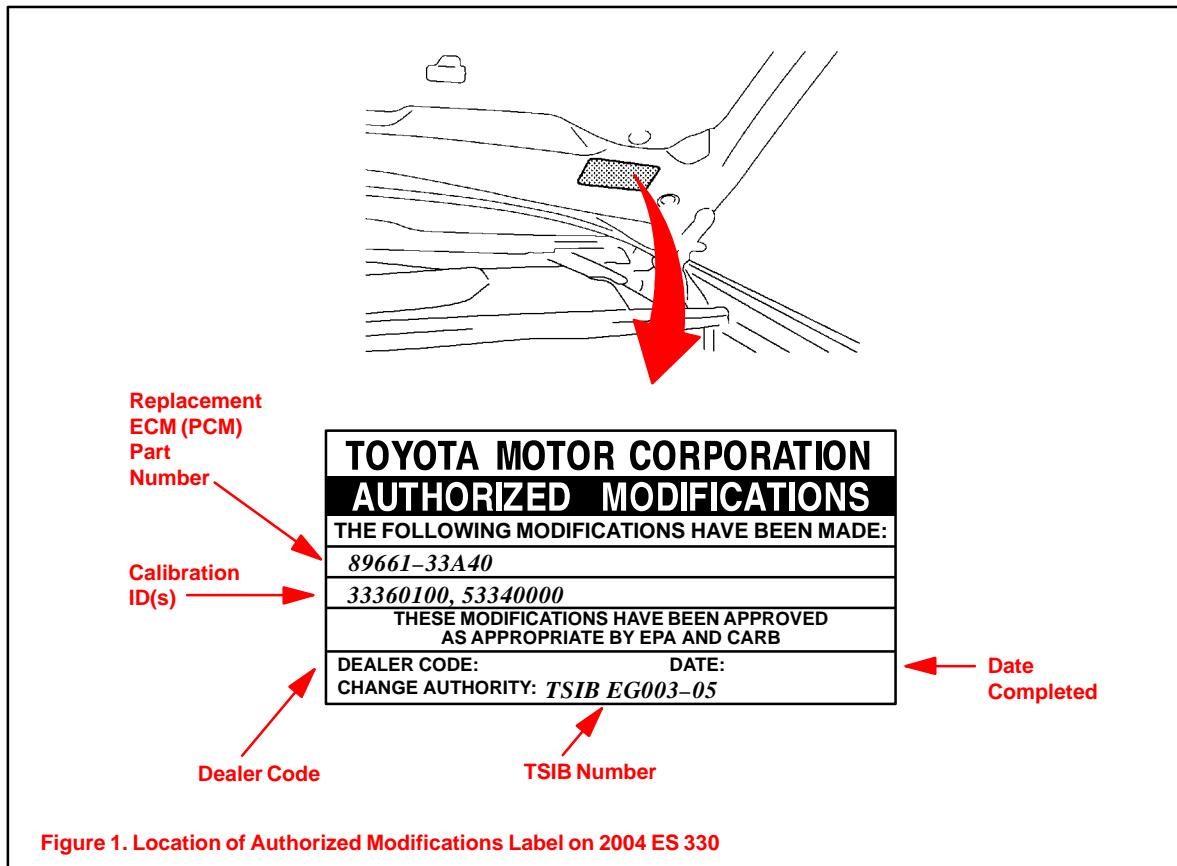
Figure 1. Location of Authorized Modifications Label on 2004 ES 330

1. Replace both Bank 1, Sensor 1 and Bank 2, Sensor 1 air fuel ratio sensors.
2. Check for the Authorized Modifications Label affixed to the vehicle in the location shown in Figure 1. Confirm if ECM (PCM) calibration has been updated. If not the latest ECM (PCM) calibration — go to step 3.

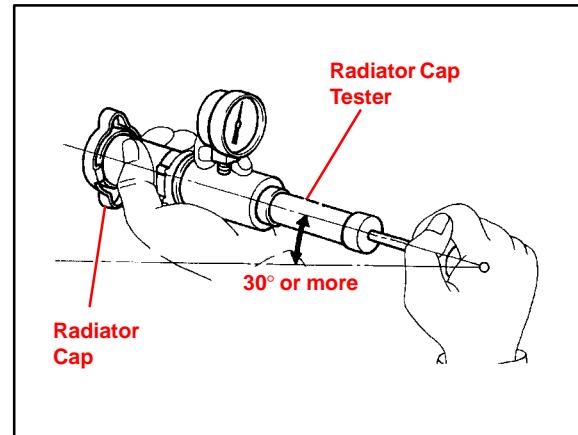
Stop pumping when the valve opens and read the gauge. The gauge must be within the standard values listed below when the pressure valve opens. The cap is considered OK when the pressure holds steady or falls very slowly, but holds within the standard values listed below for one minute.

If the maximum pressure is less than the minimum standard value, replace the radiator cap sub-assembly.

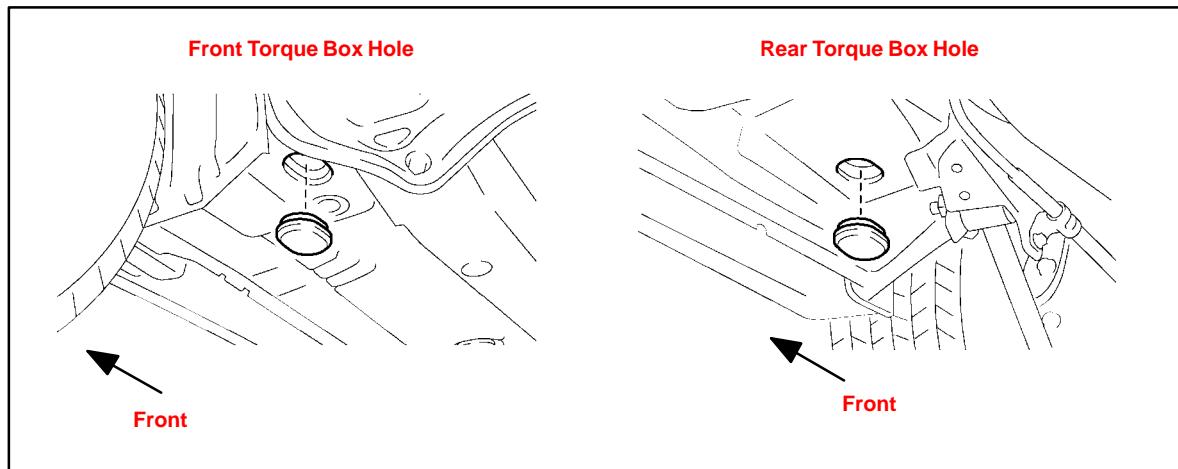
If the rubber body plugs are not securely installed, road (tire) noise will transfer to the vehicle interior through the torque box holes and rust could occur inside the torque boxes by water entry.

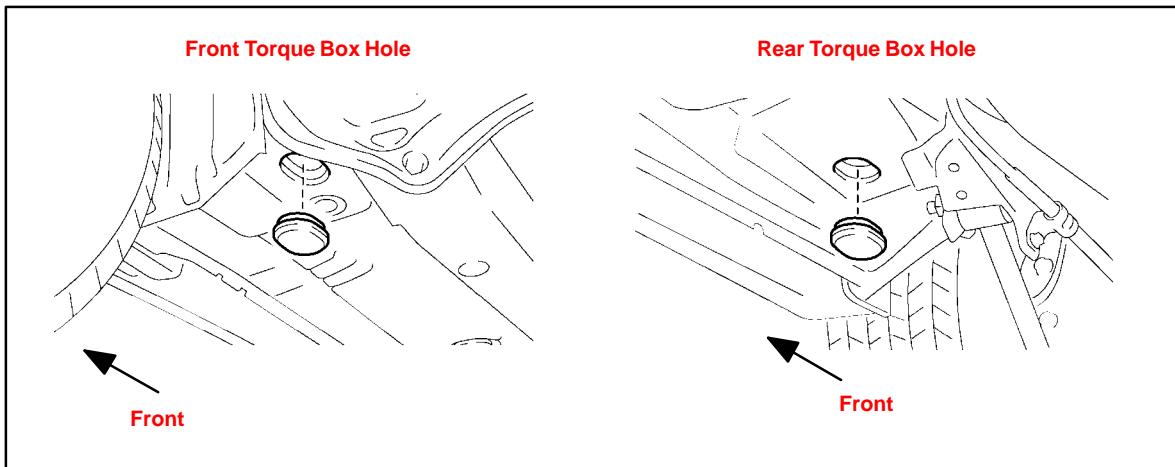
If the rubber body plugs are NOT securely installed, road (tire) noise will transfer to the vehicle interior through the torque box holes and rust could occur inside the torque boxes by water entry.

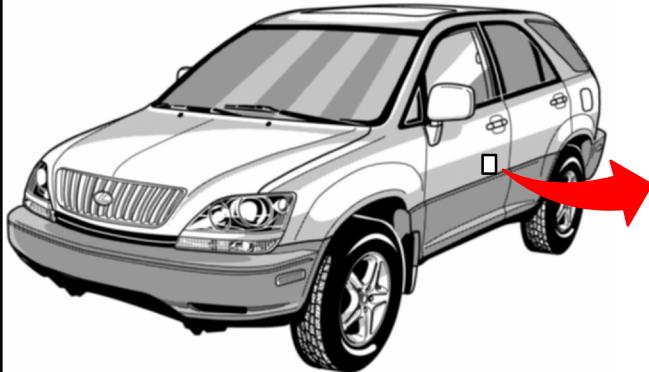
Certification Label Location

MFD.BY:TOYOTA MOTOR CORPORATION DATE 10/01
GVWR: 2247KG (3040LB)
GAWR: FRT 1379KG (3040LB) WITH P225/70R16 TIRES
16X6 1/2JJ RIMS AT 210 KPA (30PSI) COLD
RR 1153KG (2540LB) WITH P225/70R16 TIRES.
16X6 1/2JJ RIMS AT 210 KPA (30PSI) COLD
THIS VEHICLE CONFORMS TO ALL APPLICABLE
FEDERAL MOTOR VEHICLE SAFETY, BUMPER, AND
THEFT PREVENTION STANDARDS IN EFFECT ON
THE DATE OF MANUFACTURE SHOWN ABOVE.
JTOXX00X0X0000000 MPV MCU10L-AWPGKA
C/TR 8P4/LB00
A/AM-01A/
U140E
MADE IN JAPAN
NO. 736

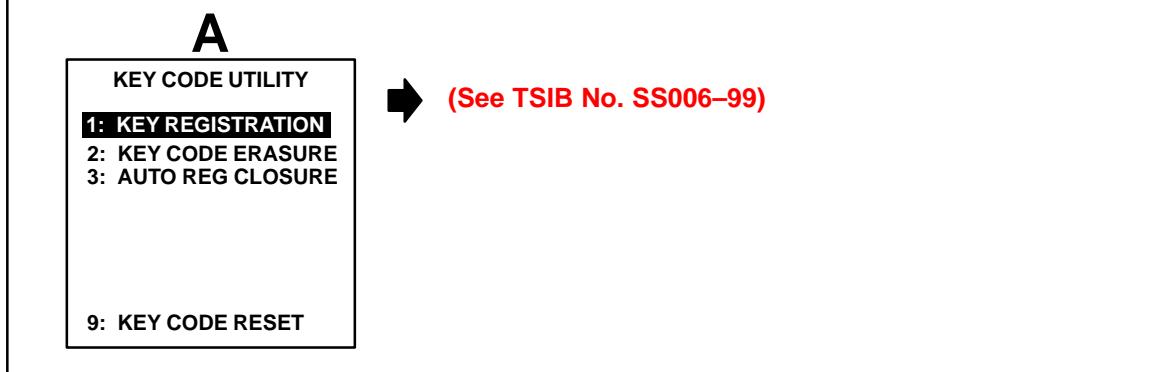
FIGURE 8. KEY REGISTRATION

5. All previously registered key codes have been erased except the Master Key used during “Key Code Reset.”
Register any additional customer keys by using “Key Registration.”
Each key will start the engine if registered correctly.
 - Please refer to TSIB No. SS006–99, “Scantool Immobilizer Key Code Utility,” for additional detail on this procedure.

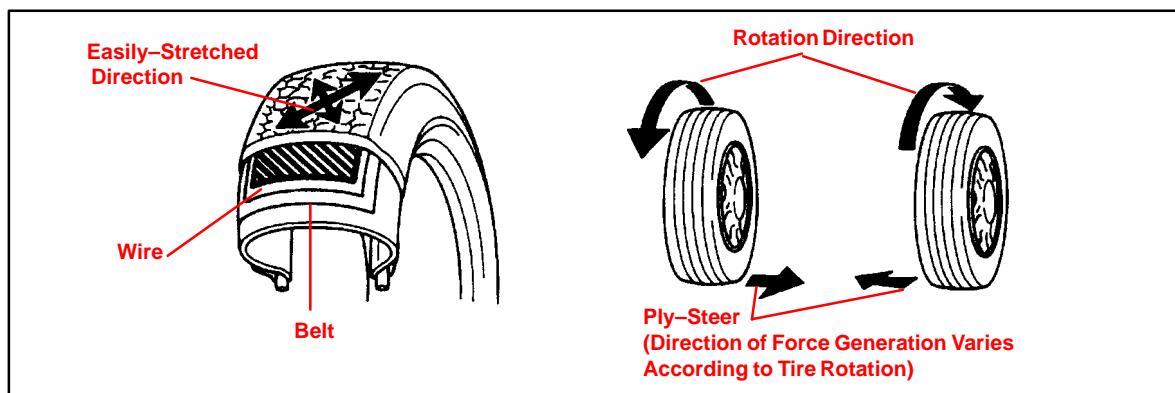
Lateral force due to ply-steer is produced by the construction of the belts inside the tire tread. With radial tires, the wire of the belt is slanted as shown in the illustration below. Thus, it is in the lateral direction that tire tread easily changes shape (stretches), and lateral force is generated between the tire and the road surface in the lateral direction.

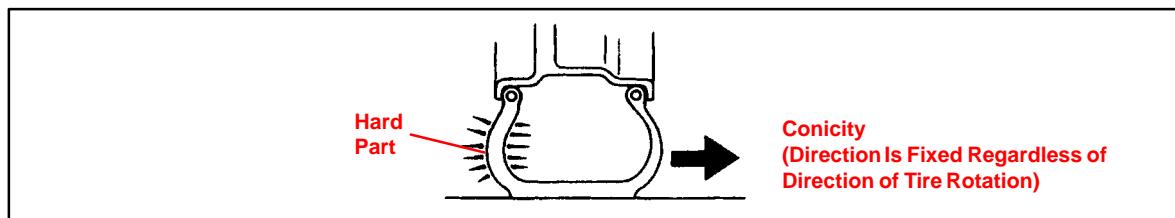
Conicity is lateral force resulting from uneven formation of the left and right sides of the tire. The direction the lateral force is exerted depends on the hardness of the side walls and the difference in height between the left/right sides of the tire.

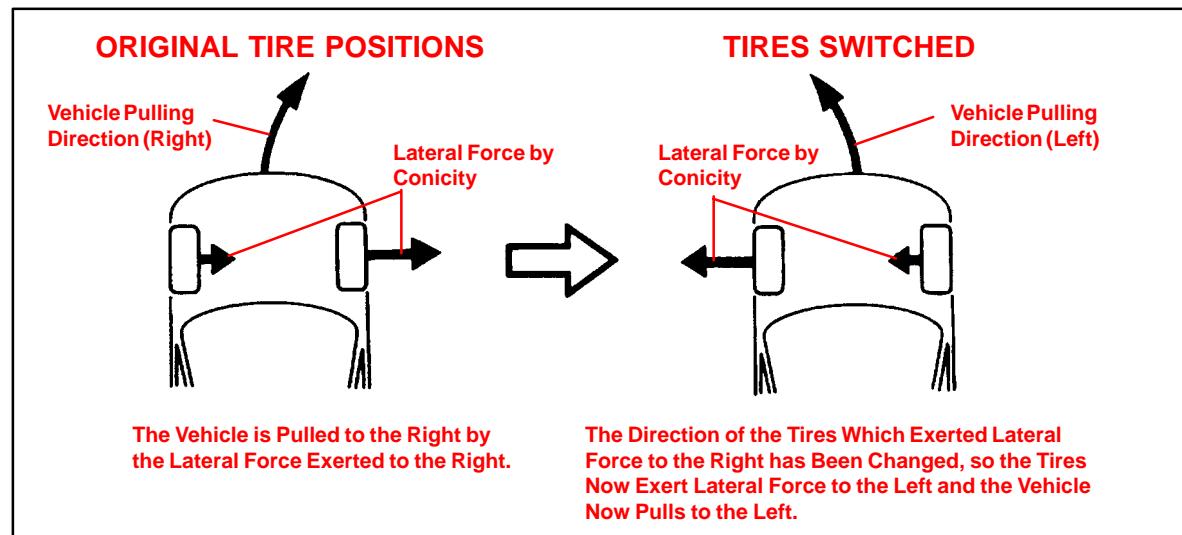
- The direction of lateral force from tire conicity becomes reversed when the left and right tires are switched. Therefore, if the pulling direction changes when the tires are switched, it can be concluded that vehicle pulling is caused by tire conicity.

- If the pulling direction does not change after the front tires are switched, the cause of vehicle pulling is not tire conicity. In this case, the likely cause is a front wheel alignment condition.
