| <b>DTC</b> | <b>B2233</b> | <b>FRONT LEFT CENTER SENSOR<br/>MALFUNCTION</b> |

## CIRCUIT DESCRIPTION

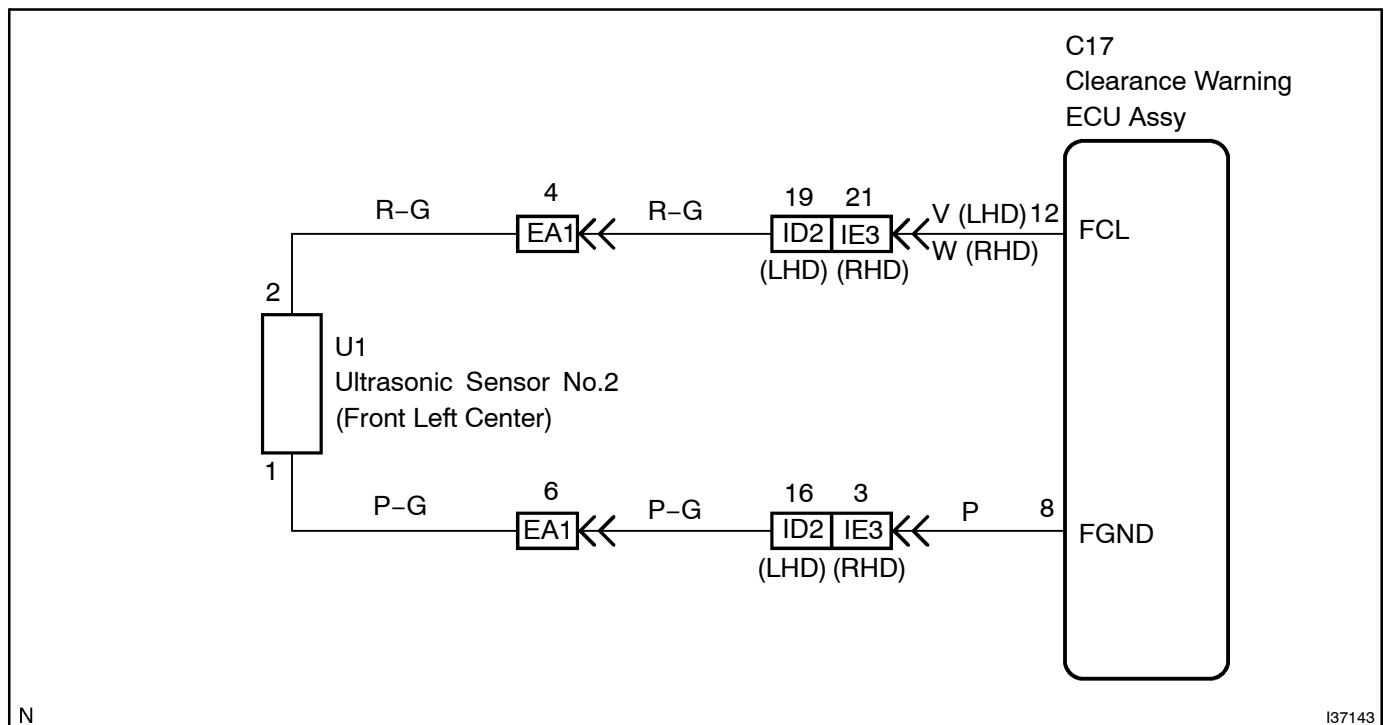
## WIRING DIAGRAM

Ultrasonic sensor consists of a sensor portion that transmits and receives ultrasonic waves and a pre-amplifier that amplifies them. The ultrasonic sensor outputs the ultrasonic transmission and reception signals to the clearance warning ECU Assy.

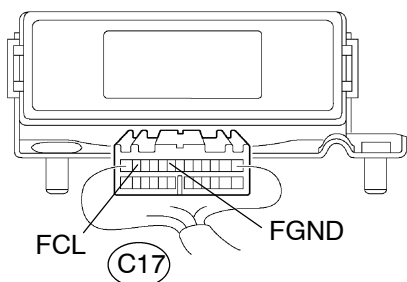
I37163

Clearance Warning ECU Assy:

- (a) Disconnect the C17 connector from the clearance warning ECU assy.  
 (b) Disconnect the U1 connector from ultrasonic sensor No.2.  
 (c) Measure the resistance according to the value(s) in the table below.

| Tester connection (Symbols) | Condition | Specified value |
| C17-12 (FCL) - U1-2 | Always | Below $1 \Omega$ |
| C17-8 (FGND) - U1-1 | Always | Below $1 \Omega$ |
| C17-12 (FCL) - Body ground | Always | $10 \text{ k}\Omega$ or higher |
| C17-8 (FGND) - Body ground | Always | $10 \text{ k}\Omega$ or higher |

**REPAIR OR REPLACE HARNESS OR CONNECTOR**

**REPLACE CLEARANCE WARNING ECU ASSY (SEE PAGE 67-30)**
