| <b>DTC</b> | <b>B0135/73</b> | <b>Short in P/T Squib (LH) Circuit</b> |

## CIRCUIT DESCRIPTION

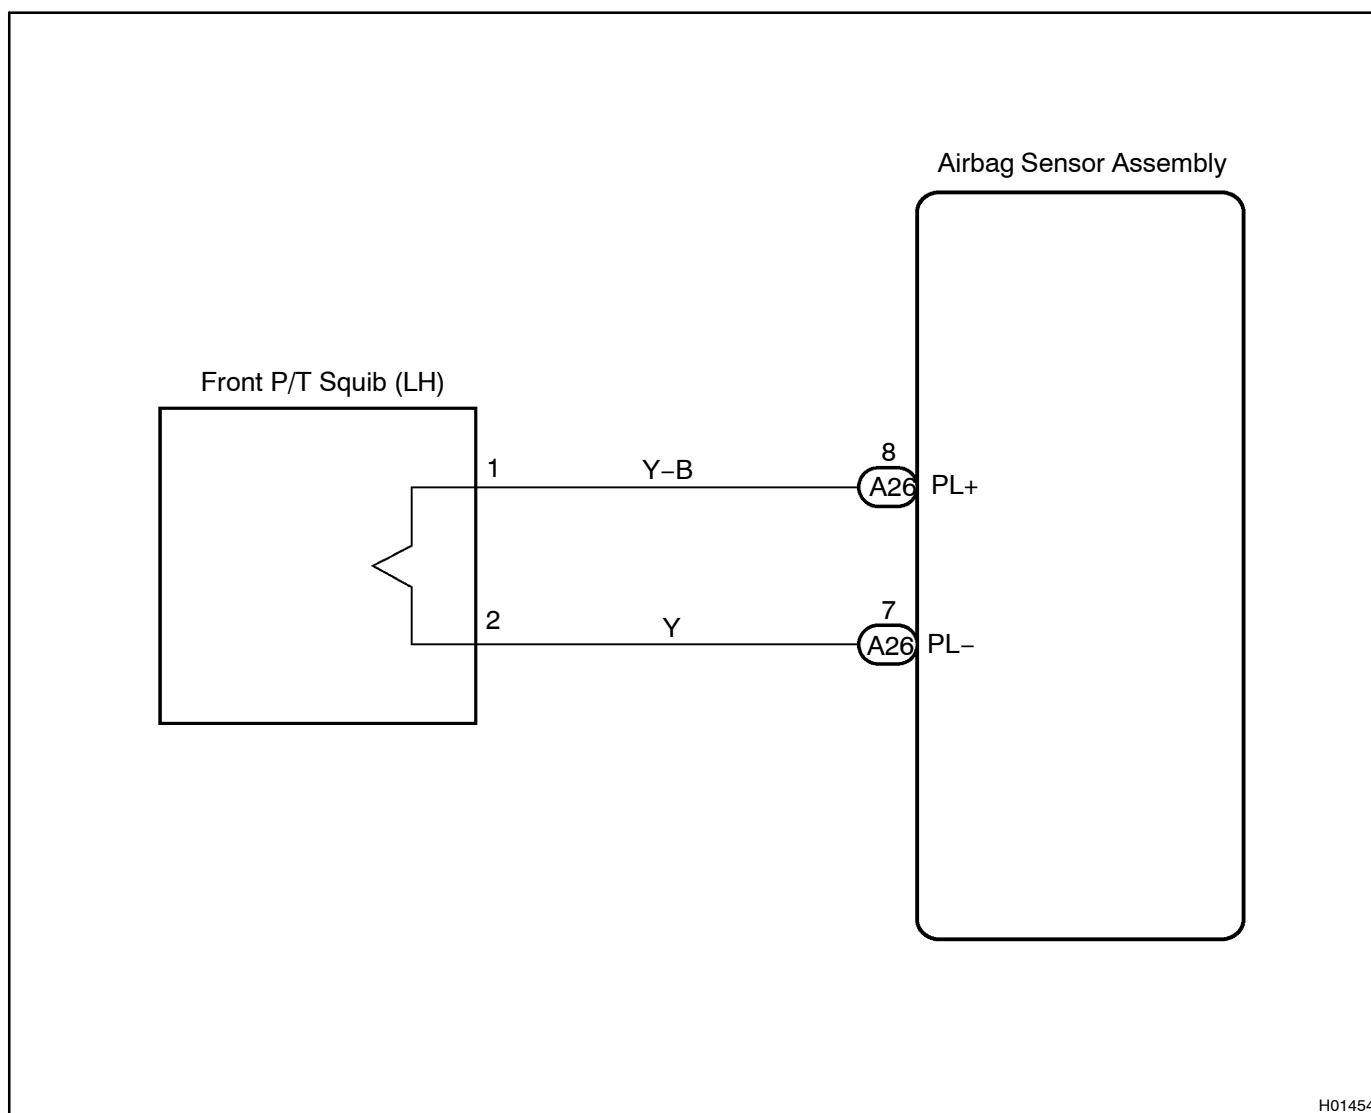
H01454

The front P/T squib (LH) circuit consists of the airbag sensor assembly and front seat belt pretensioner (LH). It causes the SRS to deploy when the SRS deployment conditions are satisfied.

## WIRING DIAGRAM

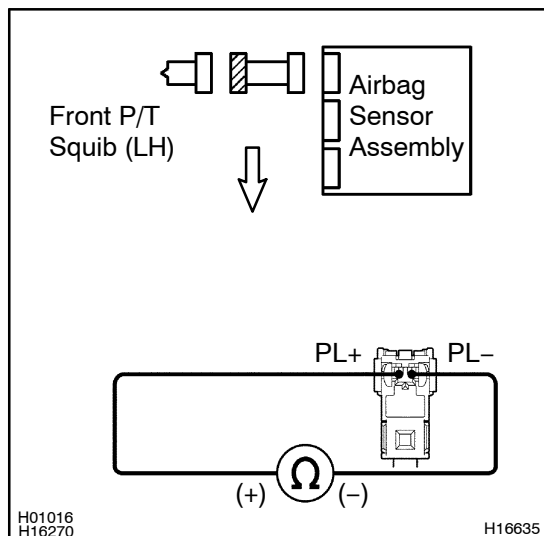
- 2 Check front P/T squib (LH) circuit.

Release the airbag activation prevention mechanism of the connector (on the airbag sensor assembly side) between the airbag sensor assembly and the front seat belt pretensioner (LH) ([See page DI-484](#)).

For the connector (on the front seat belt pretensioner side) between the front seat belt pretensioner (LH) and the airbag sensor assembly, measure the resistance between PL+ and PL-.

**Resistance: 1 MΩ or Higher**

**Repair or replace harness or connector between front seat belt pretensioner (LH) and airbag sensor assembly.**

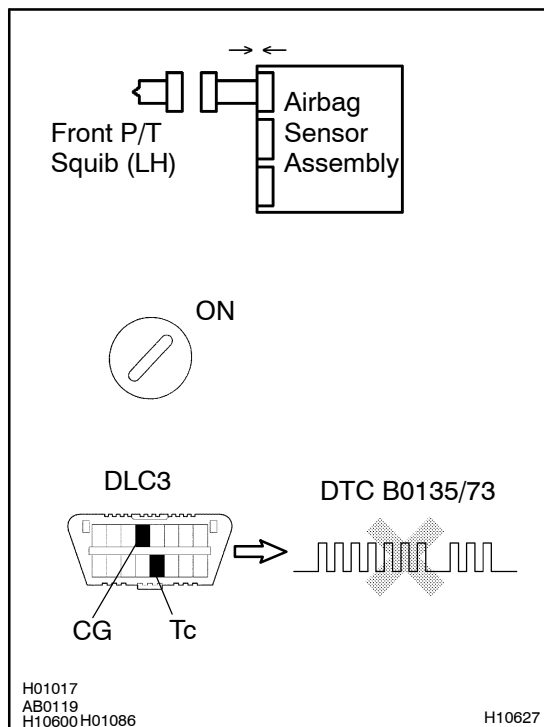
### 3 Check airbag sensor assembly.

- Connect the connector to the airbag sensor assembly.
- Connect negative (-) terminal cable to the battery, and wait at least for 2 seconds.

- Turn the ignition switch to ON and wait at least for 20 seconds.
- Clear the DTC stored in memory ([See page DI-484](#)).
- Turn the ignition switch to LOCK, and wait at least for 20 seconds.
- Turn the ignition switch to ON, and wait at least for 20 seconds.
- Check the DTC ([See page DI-484](#)).

**DTC B0135/73 is not output.**

**Replace airbag sensor assembly.**

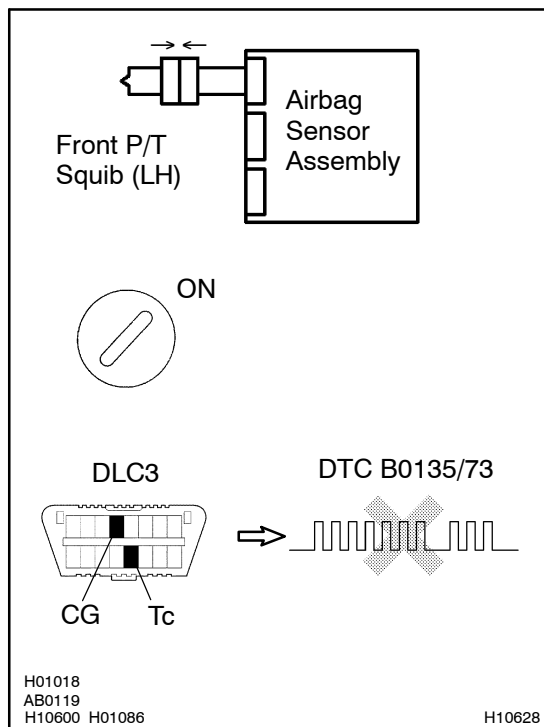
#### 4 Check front P/T squib (LH).

- Turn the ignition switch to LOCK.
- Disconnect negative (-) terminal cable from the battery, and wait at least for 90 seconds.
- Connect the front seat belt pretensioner (LH) connector.
- Connect negative (-) terminal cable to the battery, and wait at least for 2 seconds.

- Turn the ignition switch to LOCK, and wait at least for 20 second.
- Turn the ignition switch to ON, and wait at least for 20 seconds.
- Clear the DTC stored in memory ([See page DI-484](#)).
- Turn the ignition switch to LOCK, and wait at least for 20 seconds.
- Turn the ignition switch to ON, and wait at least for 20 seconds.
- Check the DTC ([See page DI-484](#)).

**DTC B0135/73 is not output.**

**Replace front seat belt pretensioner (LH).**
