| <b>DTC</b> | <b>B0138/72</b> | <b>Short in P/T Squib (LH) Circuit (to B+)</b> |

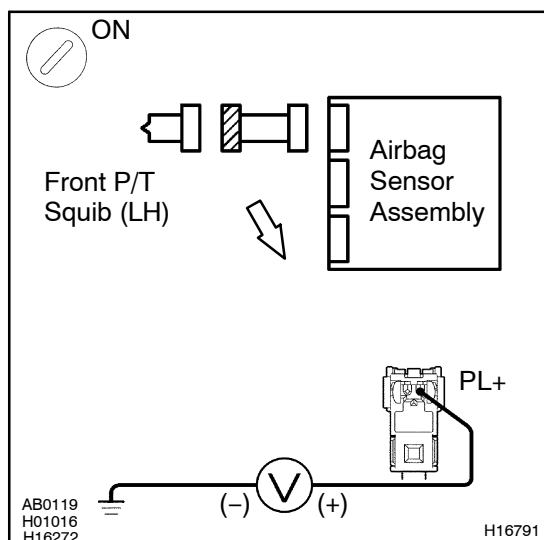
| <b>2</b> | <b>Check front P/T squib (LH) circuit.</b> |

- Turn the ignition switch to ON.
- For the connector (on the front seat belt pretensioner side) between the front seat belt pretensioner (LH) and the airbag sensor assembly, measure the voltage between PL+ and body ground.

**Voltage: 0 V**

**Repair or replace harness or connector between front seat belt pretensioner (LH) and airbag sensor assembly.**

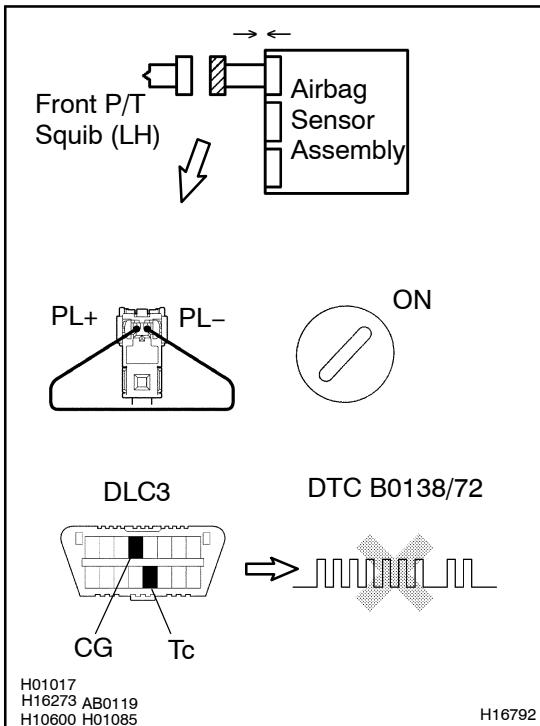
### 3 Check airbag sensor assembly.

- Connect the connector to the airbag sensor assembly.
- Using a service wire, connect PL+ and PL- of the connector (on the front seat belt pretensioner side) between the front seat belt pretensioner (LH) and the airbag sensor assembly.
- Connect negative (-) terminal cable to the battery, and wait at least for 2 seconds.

- Turn the ignition switch to ON and wait at least for 20 seconds.
- Clear the DTC stored in memory (See step 5 on [page DI-484](#)).
- Turn the ignition switch to LOCK, and wait at least for 20 seconds.
- Turn the ignition switch to ON, and wait at least for 20 seconds.
- Check the DTC ([See page DI-484](#)).

**DTC B0138/72 is not output.**

**Replace airbag sensor assembly.**

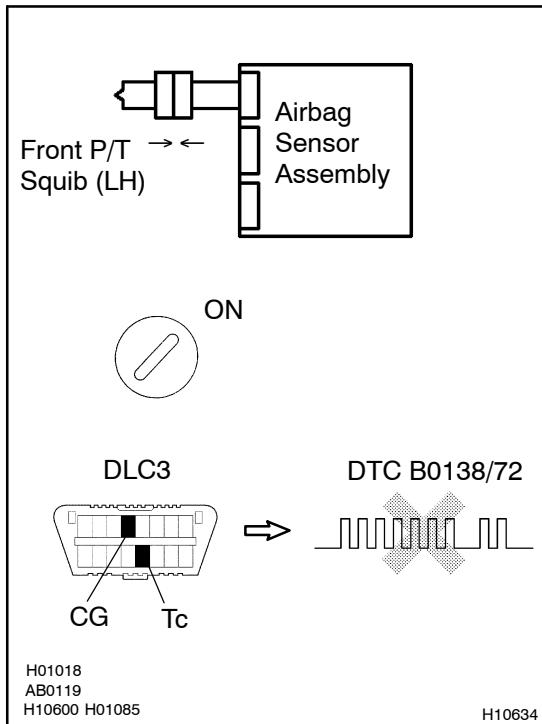
#### 4 Check front P/T squib (LH).

- Turn the ignition switch to LOCK.
- Disconnect negative (-) terminal cable from the battery, and wait at least for 90 seconds.
- Connect the front seat belt pretensioner (LH) connector.
- Connect negative (-) terminal cable to the battery, and wait at least for 2 seconds.

- Turn the ignition switch to ON, and wait at least for 20 seconds.
- Clear the DTC stored in memory (See step 5 on [page DI-484](#)).
- Turn the ignition switch to LOCK, and wait at least for 20 seconds.
- Turn the ignition switch to ON, and wait at least for 20 seconds.
- Check the DTC (See [page DI-484](#)).

**DTC B0138/72 is not output.**

**Replace front seat belt pretensioner (LH).**
