| <b>DTC</b> | <b>B1193/66</b> | <b>Short in Rear P/T Squib (RH) Circuit (to B+)</b> |

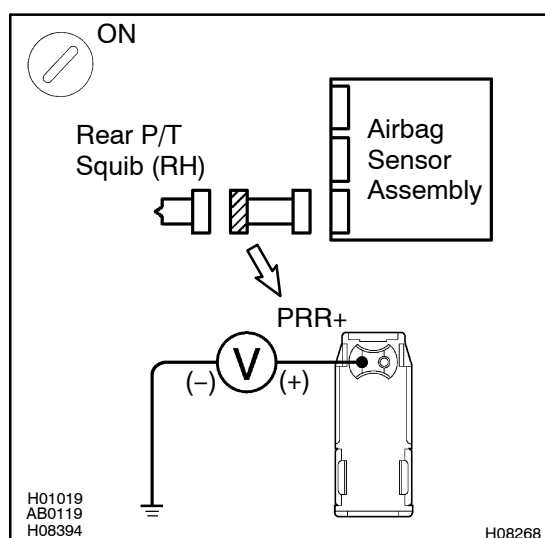
| <b>2</b> | <b>Check rear P/T squib (RH) circuit.</b> |

- Turn the ignition switch to ON.
- For the connector (on the rear seat belt pretensioner side) between the rear seat belt pretensioner (RH) and the airbag sensor assembly, measure the voltage between PRR+ and body ground.

**Voltage: 0 V**

**Repair or replace harness or connector between rear seat belt pretensioner (RH) and airbag sensor assembly.**

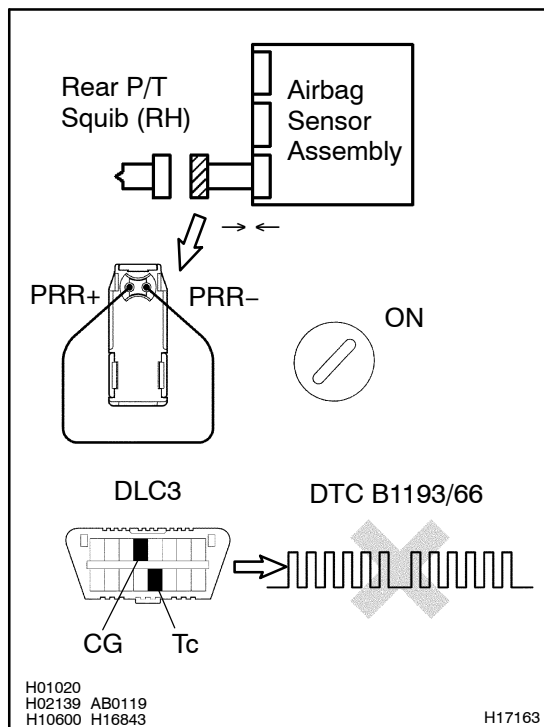
### 3 Check airbag sensor assembly.

- Connect the connector to the airbag sensor assembly.
- Using a service wire, connect PRR+ and PRR- of the connector (on the rear seat belt pretensioner side) between the rear seat belt pretensioner (RH) and the airbag sensor assembly.
- Connect negative (-) terminal cable to the battery, and wait at least for 2 seconds.

- Turn the ignition switch to ON and wait at least for 20 seconds.
- Clear the DTC stored in memory (See step 5 on [page DI-484](#)).
- Turn the ignition switch to LOCK, and wait at least for 20 seconds.
- Turn the ignition switch to ON, and wait at least for 20 seconds.
- Check the DTC ([See page DI-484](#)).

**DTC B1193/66 is not output.**

**Replace airbag sensor assembly.**

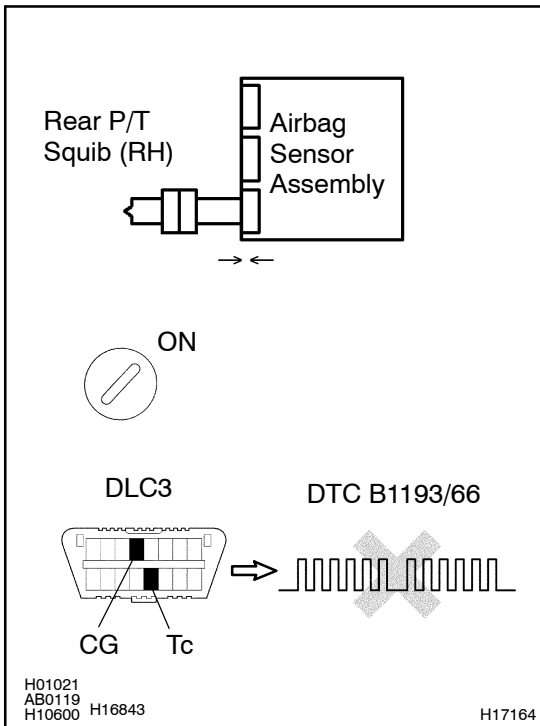
#### 4 Check rear P/T squib (RH).

- Turn ignition switch to LOCK.
- Disconnect negative (-) terminal cable from the battery, and wait at least for 90 seconds.
- Connect the rear seat belt pretensioner (RH) connector.
- Connect negative (-) terminal cable to the battery, and wait at least for 2 seconds.

- Turn the ignition switch to ON, and wait at least for 20 seconds.
- Clear the DTC stored in memory (See step 5 on [page DI-484](#)).
- Turn the ignition switch to LOCK, and wait at least for 20 seconds.
- Turn the ignition switch to ON, and wait at least for 20 seconds.
- Check the DTC (See [page DI-484](#)).

**DTC B1193/66 is not output.**

**Replace rear seat belt pretensioner (RH).**
