## Rear IG Power Source Circuit

### CIRCUIT DESCRIPTION

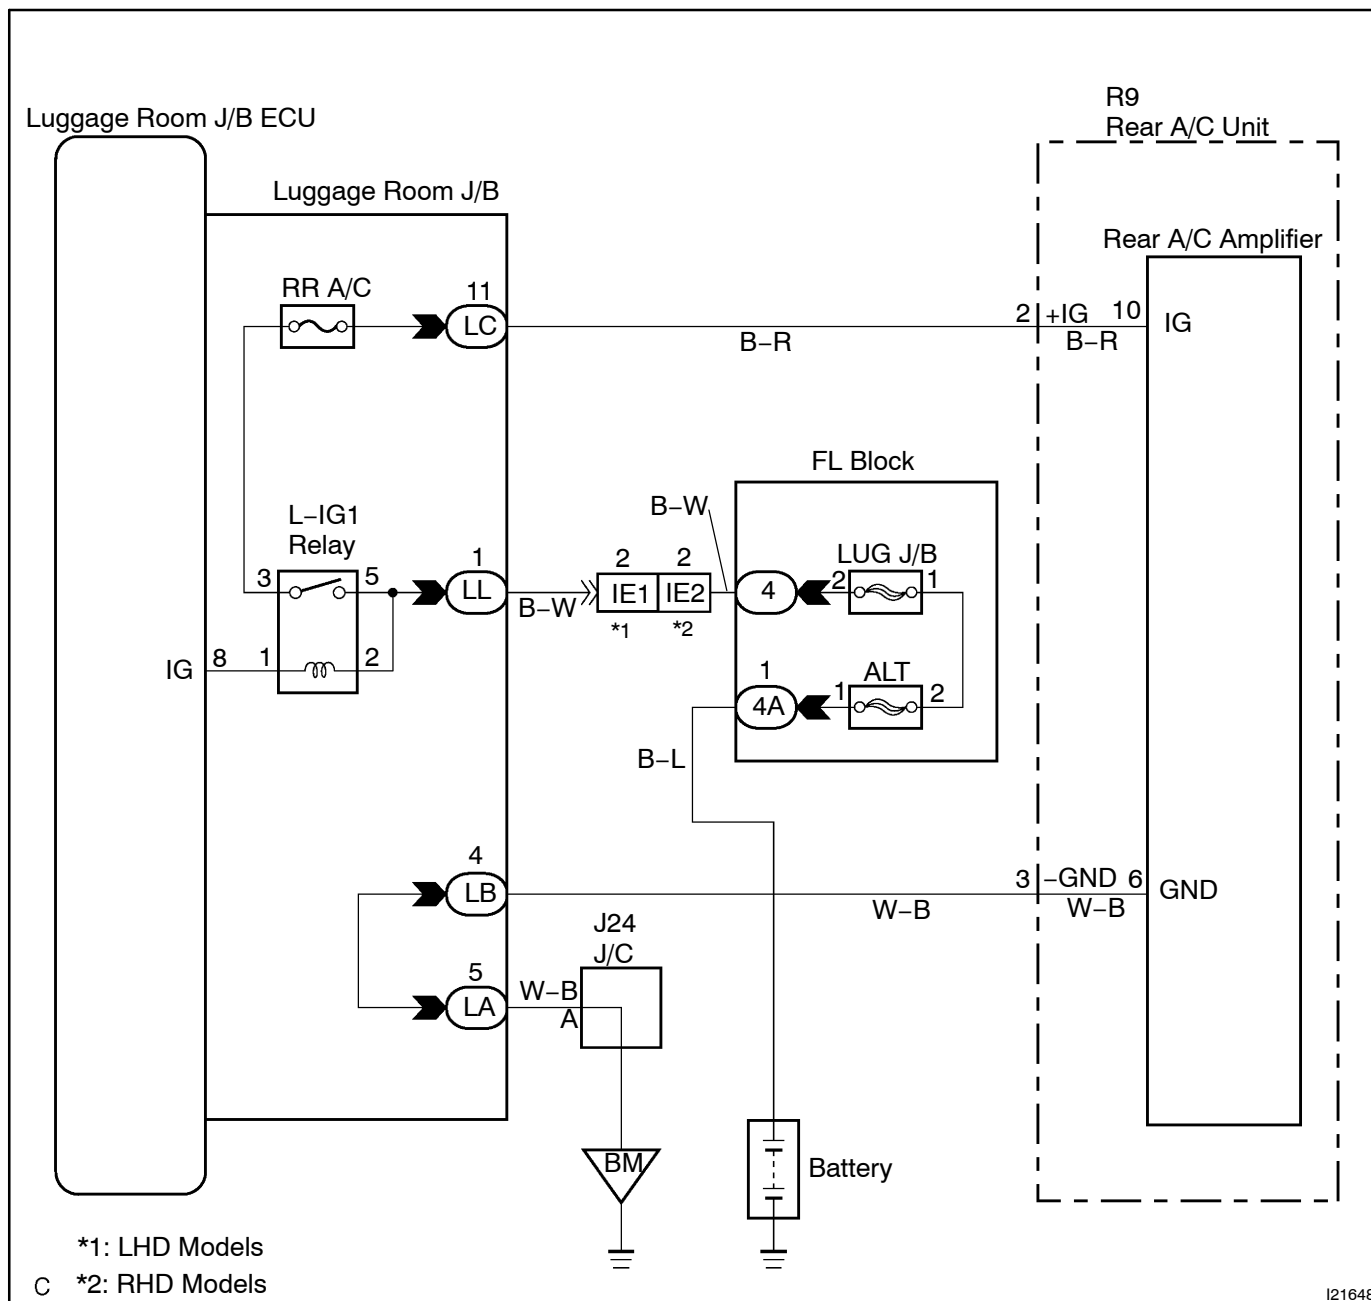
### WIRING DIAGRAM

This is the power source for the A/C amplifier and servomotors, etc.

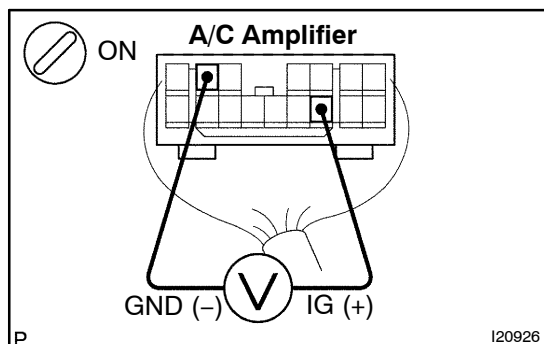
**INSPECTION PROCEDURE****1 Check voltage between terminal IG and GND of A/C amplifier connector.**

Remove the A/C amplifier with connectors still connected.

- (a) Turn ignition switch to ON.
- (b) Measure voltage between terminals IG and GND of A/C amplifier.

**Voltage: Battery voltage**

Proceed to next circuit inspection shown on problem symptoms table ([See page DI-1772](#)).

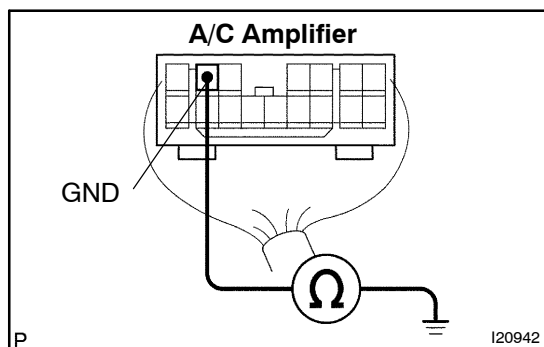
**NG****2 Check continuity between terminal GND of A/C amplifier and body ground.**

Measure resistance between terminal GND of A/C amplifier and body ground.

**Resistance: 0 Ω (continuity)**

**Repair or replace harness or connector.**

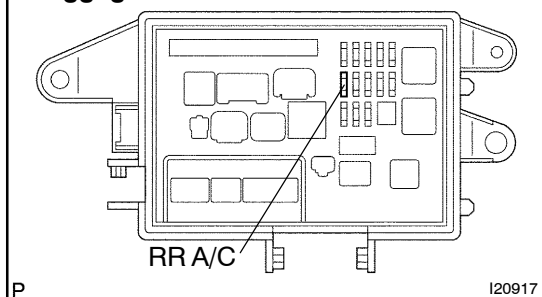
**3 Check RR A/C fuse.****Luggage Room J/B**

Remove RR A/C fuse from luggage room J/B.

Check continuity of RR A/C fuse.

**Continuity exists**

**Check for short in all the harness and components connected to the RR A/C fuse.**

**Check and repair harness and connector between A/C amplifier and battery.**
