SERVICE BULLETIN

SERVICE BULLETIN		NO.: ESB-96E37-002	
		DATE: 1996-07-30	<MODEL> CARISMA <M/Y> 96-10
SUBJECT: CHANGE OF POWER STEERING RETURN HOSE AND BOLT TIGHTENING TORQUES			
GROUP: STEERING			
INFORMATION:

POWER STEERING HOSES

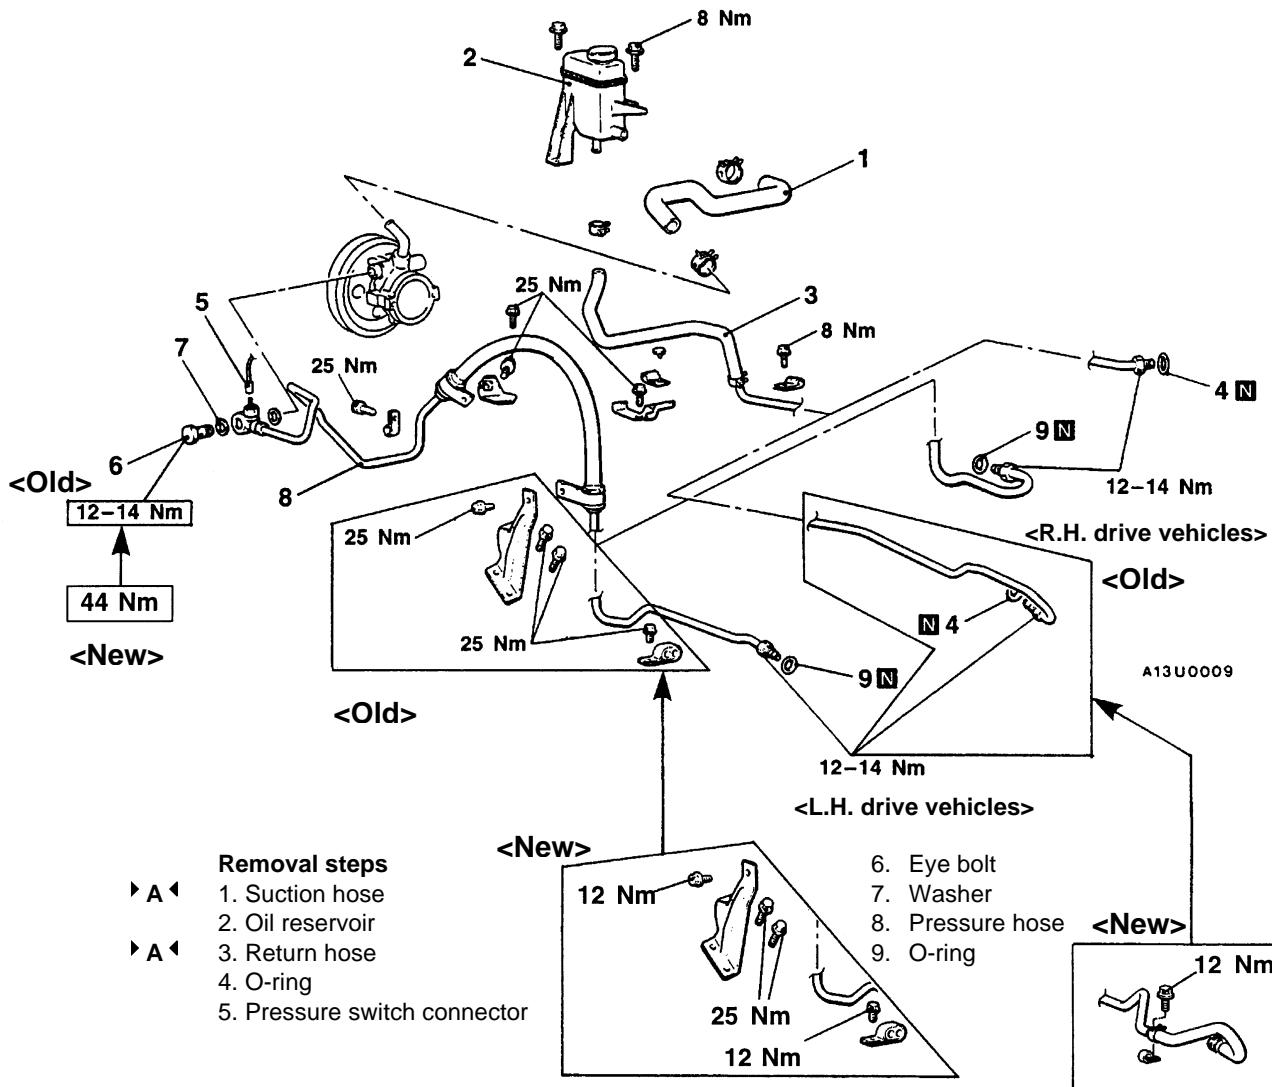
► A1 Removal steps

1. Suction hose
2. Oil reservoir
3. Return hose
4. O-ring
5. Pressure switch connector

The power steering return hose has been changed on left-hand drive models. In Addition, the tightening torque specifications for pressure hose attaching bolts and Eye bolts have been changed.

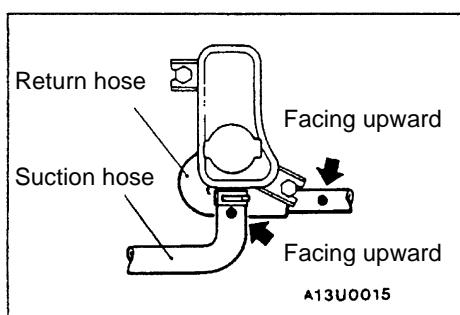
► A1 RETURN HOSE/SUCTION HOSE INSTALLATION

Connect the hose so that the marking is facing upwards.
