GROUP 55B

AUTOMATIC AIR CONDITIONING

GENERAL DESCRIPTION

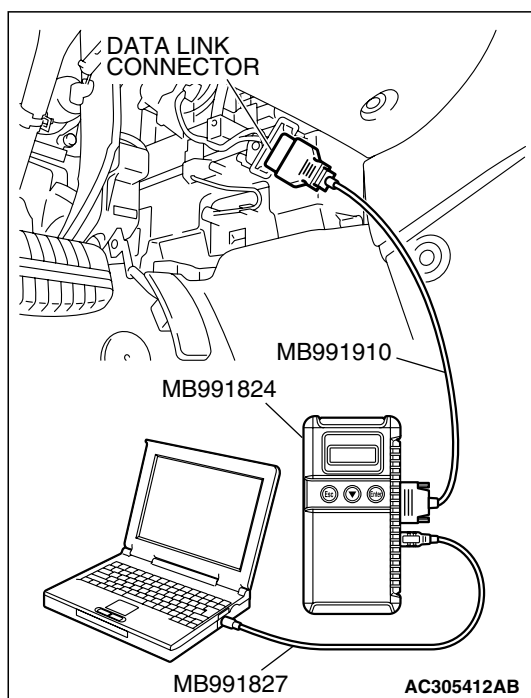
HOW TO CONNECT THE SCAN TOOL (M.U.T.-III)

1. Ensure that the ignition switch is at the "LOCK" (OFF) position.
2. Start up the personal computer.
3. Connect special tool MB991827 to special tool MB991824 and the personal computer.
4. Connect special tool MB991910 to special tool MB991824
5. Connect special tool MB991910 to the data link connector.
6. Turn the power switch of special tool MB991824 to the "ON" position.

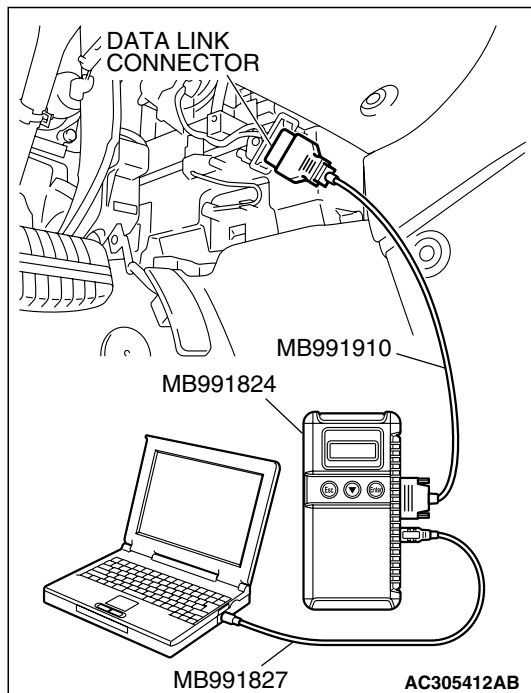
1. Connect the scan tool MB991958 to the data link connector.
2. Turn the ignition switch to the "ON" position.
3. Select "Interactive Diagnosis" from the start-up screen.
4. Select "System Select."
5. Choose "AUTO A/C" from the "BODY" tab.
6. Select "MITSUBISHI."
7. Select "Data List."
8. Choose an appropriate item and select the "OK" button.

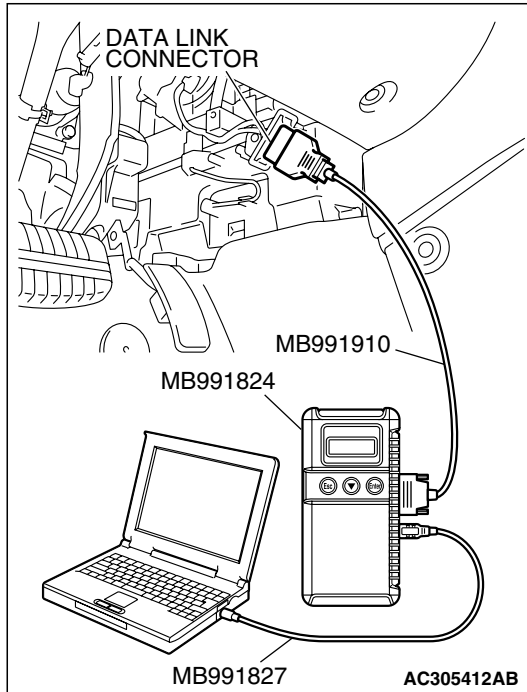
1. Connect the scan tool MB991958 to the data link connector.
2. Turn the ignition switch to the "ON" position.
3. Select "Interactive Diagnosis" from the start-up screen.
4. Select "System Select."
5. Choose "AUTO A/C" from the "BODY" tab.
6. Select "MITSUBISHI."
7. Choose "Actuator Test" from "AUTO A/C" screen.
8. Choose an appropriate item and select the "OK" button.

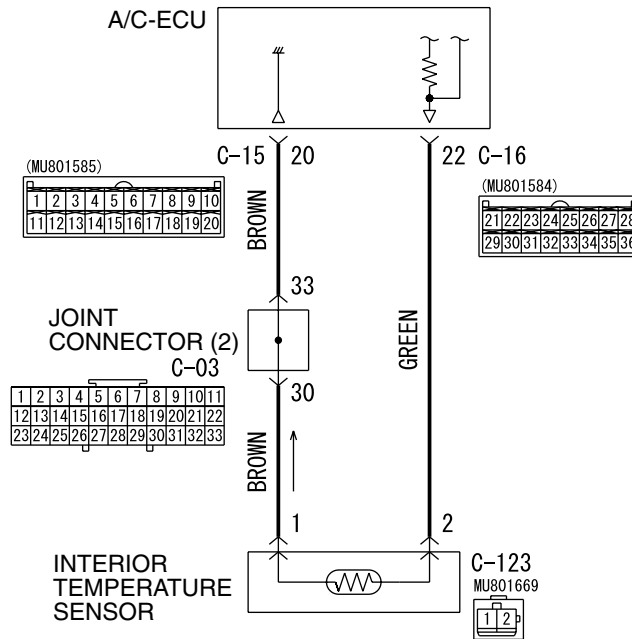
Interior Temperature Sensor Circuit

DTC SET CONDITION

- DTC B1001 is set if there is a short circuit in the interior temperature sensor input circuit.
- DTC B1002 is set if there is a defective connector connection, or if there is an open circuit in the harness.

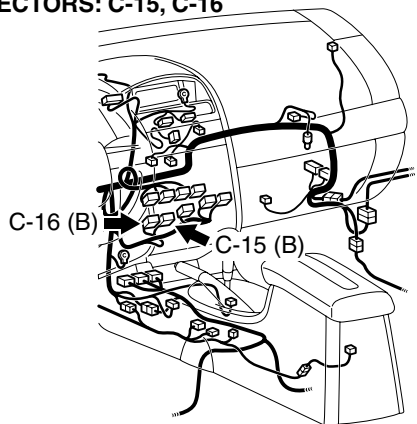
CONNECTORS: C-15, C-16

STEP 4. Check A/C-ECU connector C-15, C-16 and interior temperature sensor connector C-123 for loose, corroded or damaged terminals, or terminals pushed back in the connector.

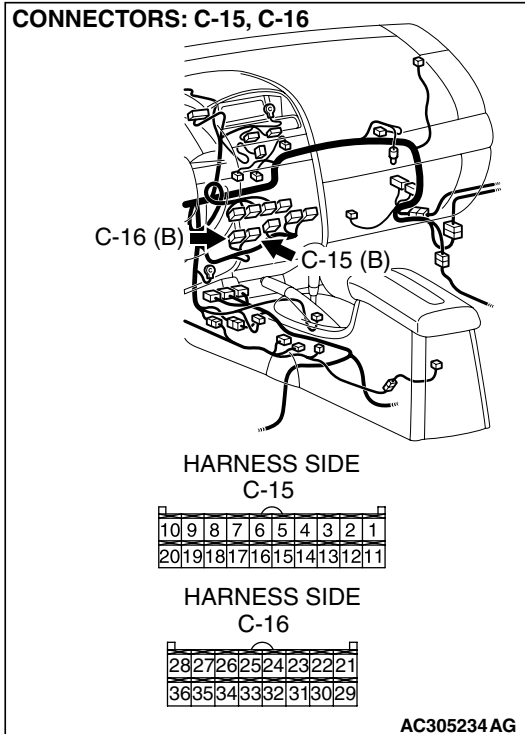
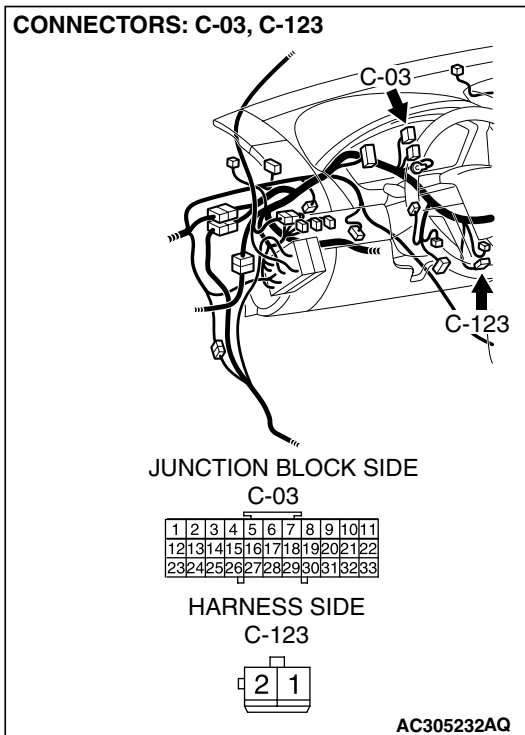
AC305231CK

STEP 5. Check the wiring harness between A/C-ECU connector C-15 (terminals 20), C-16 (terminals 22) and interior temperature sensor connector C-123 (terminals 1 and 2).

Q: Are the wiring harnesses between A/C-ECU connector C-15 (terminals 20), C-16 (terminals 22) and interior temperature sensor connector C-123 (terminals 1 and 2) in good condition?

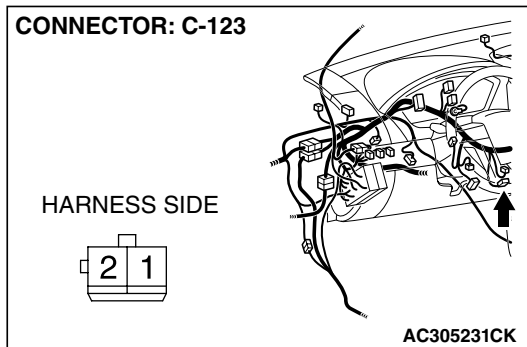
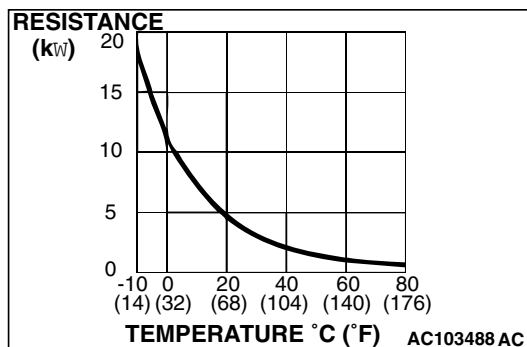
(2) When the resistance between the sensor terminals is measured under two or more temperature conditions, the resistance should approximately satisfy the illustrated values.

NOTE: The temperature conditions when checking should not exceed the range shown in the diagram.

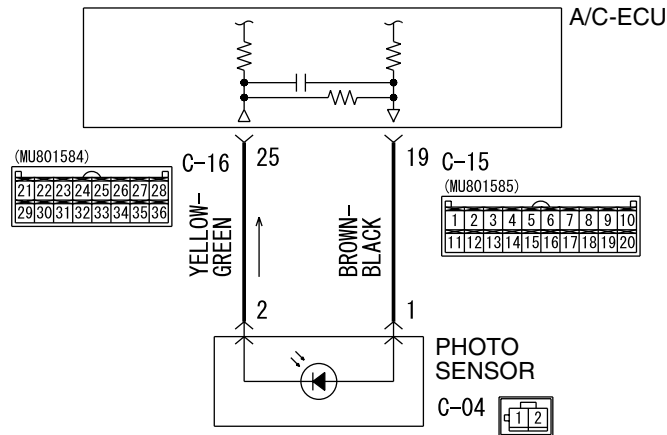
Photo Sensor Motor Circuit

CIRCUIT OPERATION

When the blower air temperature cannot be changed even if the preset temperature is changed, the sensors may be defective.

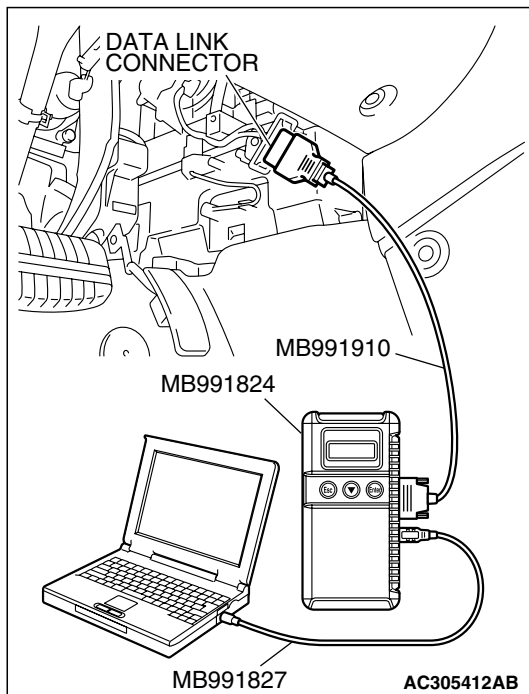
STEP 3. Using scan tool MB991958, check data list item 06: Photo sensor.

- (1) Connect scan tool MB991958 to the data link connector.
- (2) Start the engine.
- (3) Set scan tool MB991958 to the data reading mode for item 06: Photo sensor.
 - Check that the display on the scan tool changes when the photo sensor is covered with hands.
- (4) Turn the ignition switch to the "LOCK" (OFF) position.

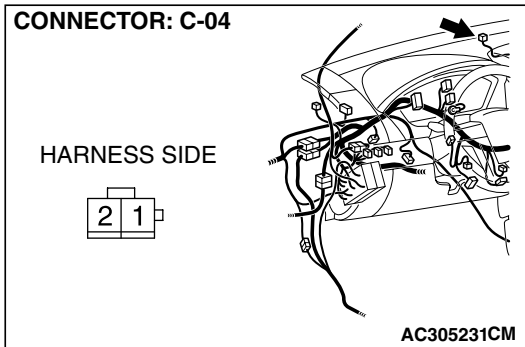
AC305234AG

STEP 5. Check the wiring harness between photo sensor connector C-04 (terminal 1, 2) and A/C-ECU connector C-15 (terminal 19), C-16 (terminal 25).

Q: Is the wiring harness between photo sensor connector C-04 (terminal 1, 2) and A/C-ECU connector C-15 (terminal 19), C-16 (terminal 25) in good condition?

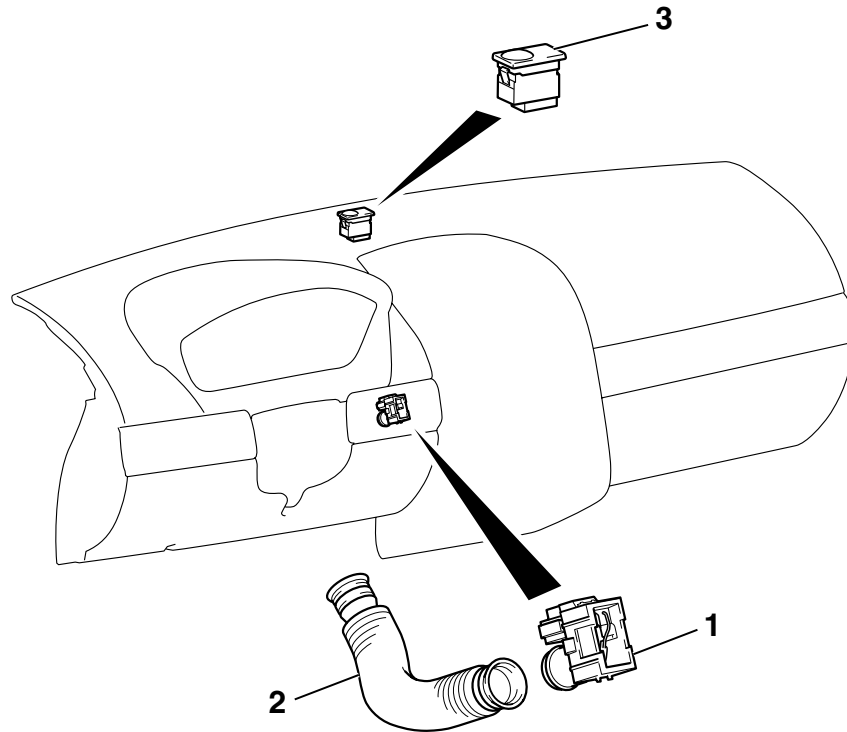
AC306634AB

INTERIOR TEMPERATURE SENSOR REMOVAL STEPS

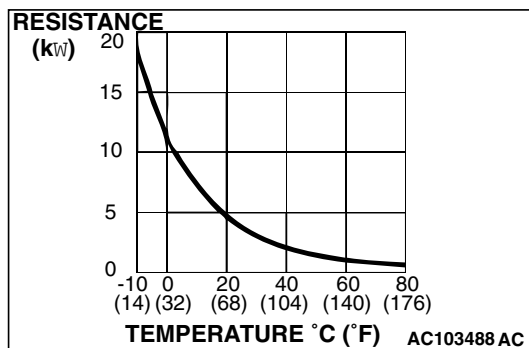
When the resistance between the sensor terminals is measured under two or more temperature conditions, the resistance should approximately satisfy the illustrated values.

NOTE: The temperature conditions when checking should not exceed the range shown in the diagram.
