POWER ASSISTED SYSTEM (POWER STEERING)

6. Pipe Assembly

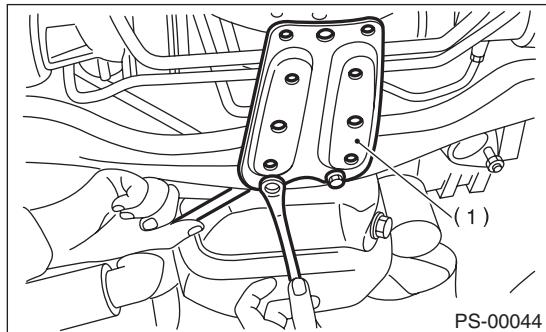
(1) Jack-up plate

- 1) Disconnect the ground cable from the battery.
- 2) Lift up the vehicle and remove the jack-up plate.

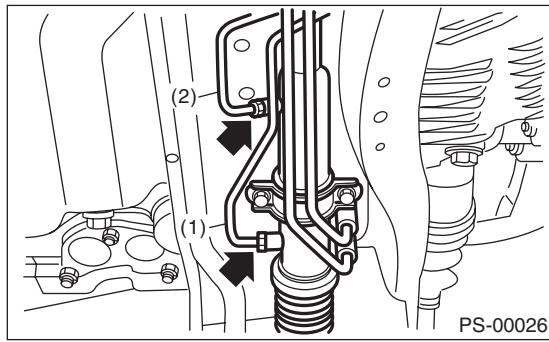
- 3) Remove the one pipe joint at the center of gearbox assembly, and connect a vinyl hose to the pipe and the joint. Discharge the fluid by turning the steering wheel fully clockwise and counterclockwise. Discharge the fluid similarly from other pipes.

(1) Pipe A
(2) Pipe B

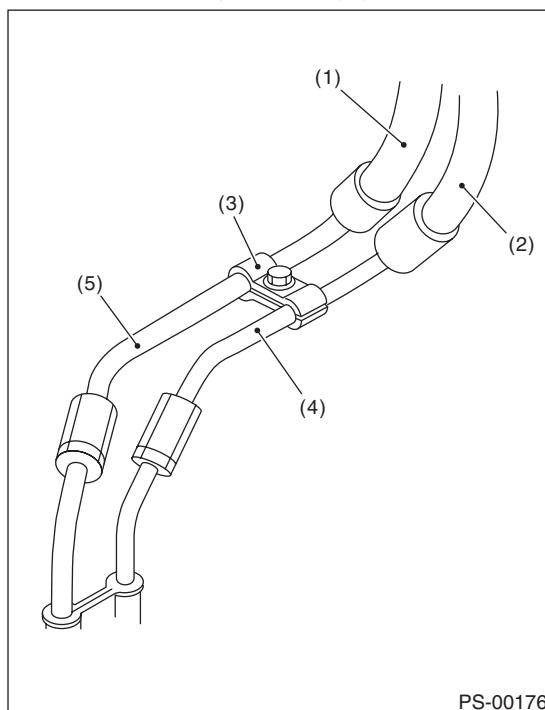
- 4) Remove the clamp E from pipe C and D.

(1) Return hose
(2) Pressure hose
(3) Clamp E
(4) Pipe C
(5) Pipe D

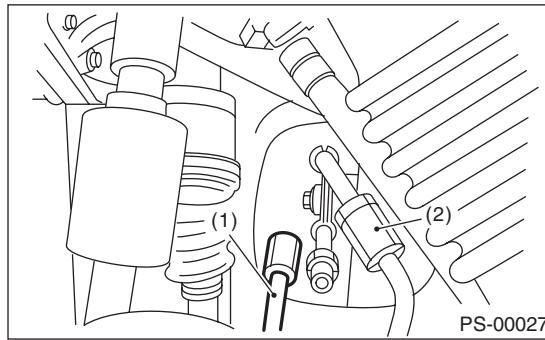
- 5) Disconnect the pipe C and D from the gearbox.

(1) Pipe C
(2) Pipe D

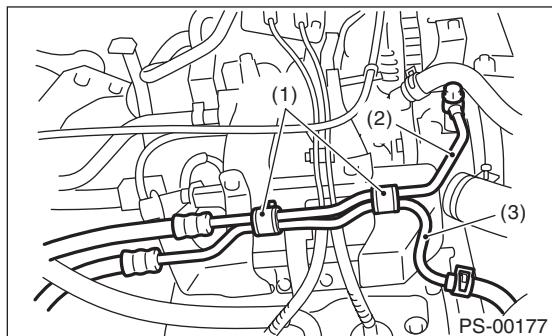
8) Disconnect the pipe C from oil pump. Disconnect the pipe D from the return hose.

- **Do not allow fluid from the hose end to come into contact with pulley belt.**
- **To prevent foreign matter from entering the hose and pipe, cover the open ends with clean cloth.**

- (1) Bolt A
- (2) Pipe C
- (3) Pipe D

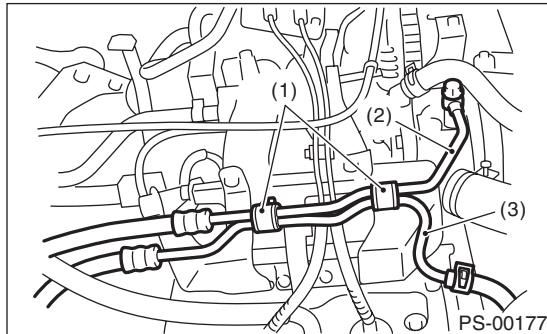
1) Temporarily tighten the two bolts (bolts A) fixing pipe C and D in place.

Visually check that the hose between tank and pipe D is not bent or twisted.

(1) Bolt A

(2) Pipe C

(3) Pipe D

(1) Connect pipe D to the reservoir tank.

(2) Install the pipe C to the oil pump using a new gasket.

39 N·m (4.0 kgf-m, 28.9 ft-lb)

(3) Tighten the two bolts (bolts A) fixing pipe C and D in place.

13 N·m (1.3 kgf-m, 9.4 ft-lb)

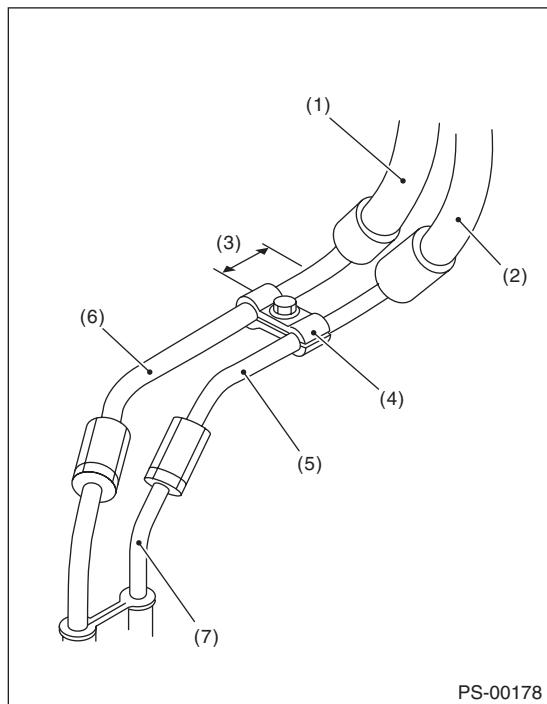
PS-00178

2) Temporarily connect the pipes C and D to the gearbox assembly.

- (1) Return hose
- (2) Pressure hose
- (3) Approx. 30 mm (1.18 in)
- (4) Clamp E
- (5) Pipe C
- (6) Pipe D
- (7) Pipe (on gearbox assembly side)

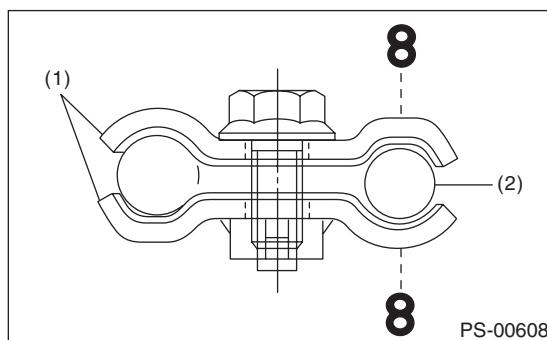
3) Temporarily install clamp E on pipes C and D.

Make sure that the character "8" on each clamp is positioned on the same side, as shown in the figure.

- (1) Clamp E
- (2) Pipe C

4) Tighten the clamp E.

7.4 N·m (0.75 kgf-m, 5.4 ft-lb)

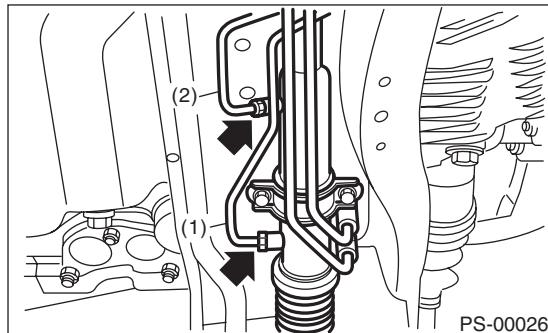
6) Connect pipe A and B to the four pipe joints of the gearbox assembly. Connect the upper pipe B first, and lower pipe A.

13 N·m (1.3 kgf-m, 9.4 ft-lb)

- (1) Pipe A
- (2) Pipe B

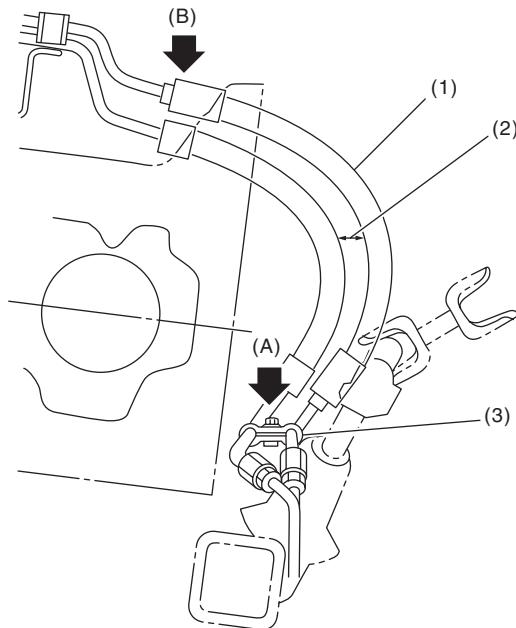
PS-00179

11) Finally, check clearance between pipes or hoses as shown in the figure.

10 mm (0.39 in) or more

If the cruise control actuator and power steering hose clearance is less than 10 mm (0.39 in), move section (A) held in place by the clamp, or bend (B) to adjust.

(1) High-pressure hose

(2) No interference is allowed between hoses.

(3) Clearance between crossmember and pipe: 3 — 8 mm (0.12 — 0.31 in)

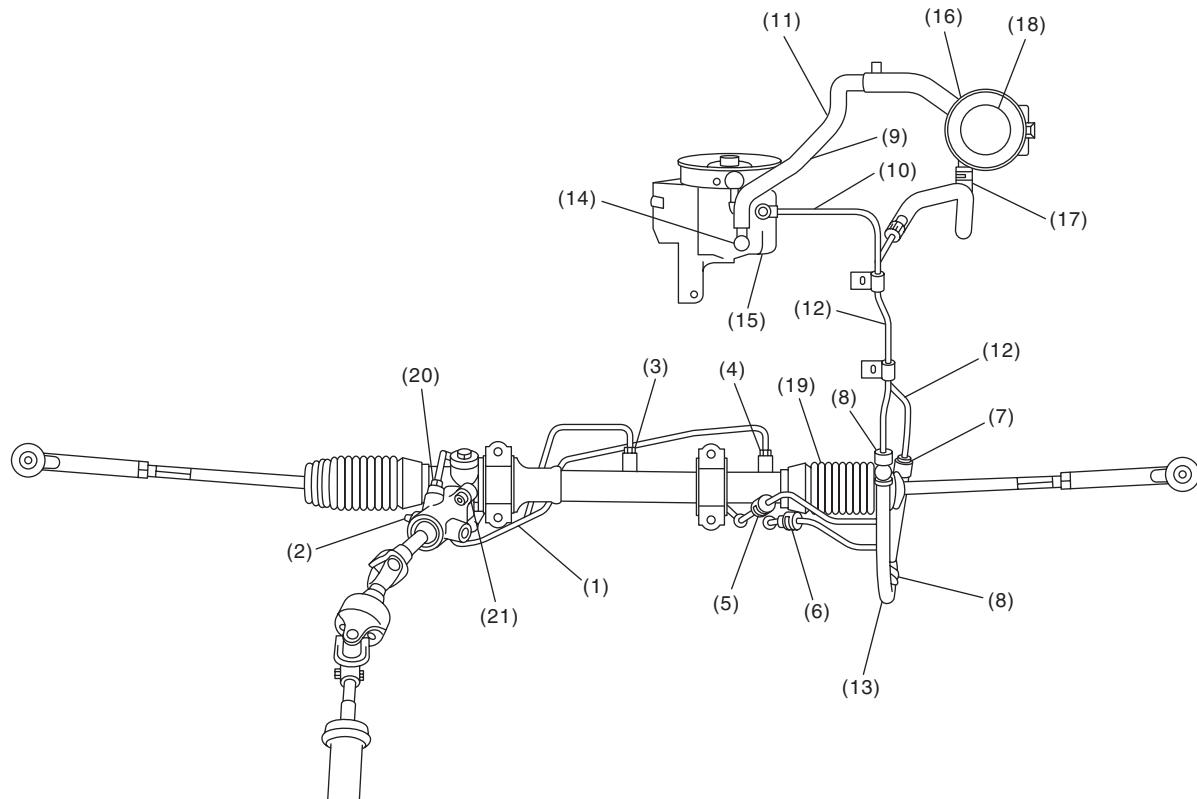
PS-00022

Fluid leaking area	Possible cause	Corrective action
Leakage from the connections of pipes and hoses, numbered with (1) through (10) in the figure	Insufficient tightening of flare nuts, dirt accumulation, damage to flare or flare nut or eye bolt	Loosen and retighten. Replace if ineffective.
	Improper installation of hoses or poor clamping	Retighten or replace the clamp.
	Damaged O-ring or gasket	Replace the O-ring, gasket pipe or hose with new parts. If there is still no improvement, replace the gearbox assembly.
Leakage from hose (11), (12) and (13) in the figure	Crack or damage in hose	Replace with a new part.
	Crack or damage in hose hardware	Replace with a new part.
Leakage from surrounding of cast iron portion of oil pump, (14) and (15) in the figure	Damaged O-ring	Replace the oil pump.
	Damaged gasket	Replace the oil pump.
Leakage from reservoir (16) and (17) in the figure	Crack in the reservoir tank	Replace the reservoir tank.

Leakage from filler neck of (18)	Damaged cap packing	Replace the cap.
	Crack in root of filler neck	Replace the reservoir tank.
	Fluid level too high	Adjust the fluid level.
Leakage from power cylinder of gearbox area (19) in the figure	Damaged oil seal	Replace the oil seal.
Leakage from (20), (21) in the figure and control valve of gearbox	Damaged packing or oil seal	Replace the problem parts.
	Damage in control valve	Replace the control valve.

There are conditions in which a fluid leak is diagnosed, but is not actually leaking. This is because the fluid spilt during the last maintenance was not completely wiped off. Be sure to wipe off spilt fluid thoroughly after maintenance.
