27. Rear Side Marker Light Bulb

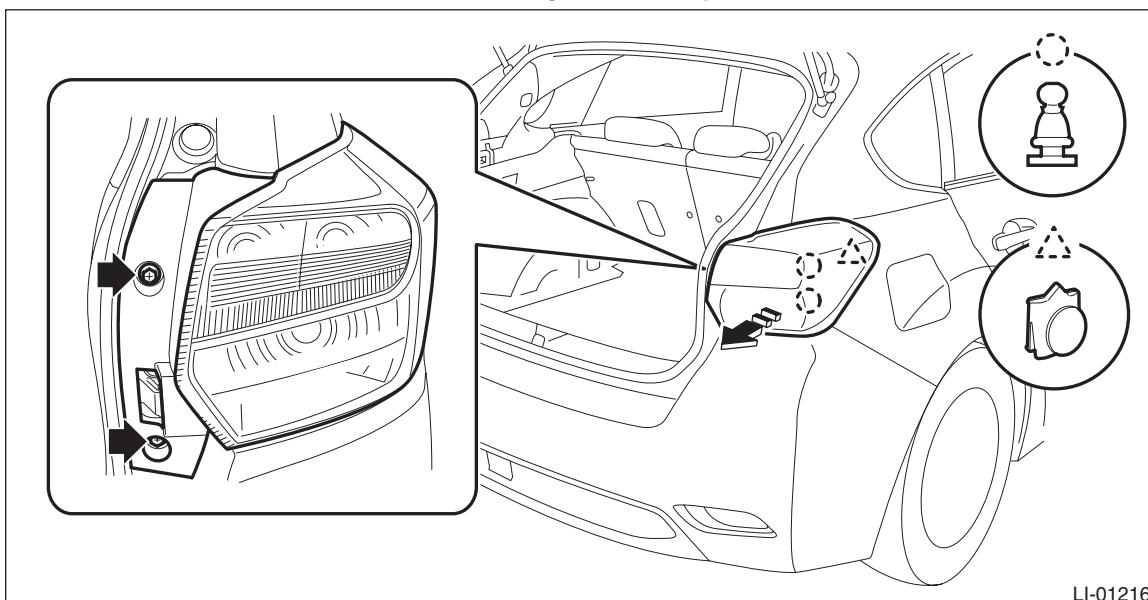
- (1) Release the bolts and clips, then pull out the light assembly - rear combination to the vehicle rear.
- (2) Disconnect the connector and remove the light assembly - rear combination.

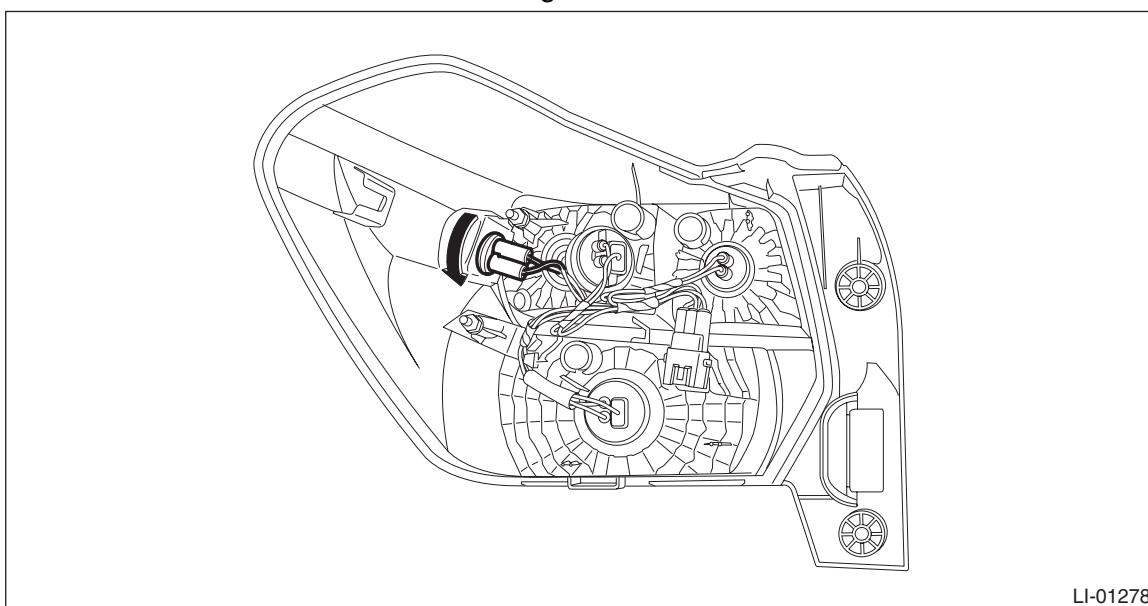
- 3) Remove the bulb socket and rear side marker light bulb.
