3. Inspection Locations after a Collision

AIRBAG SYSTEM

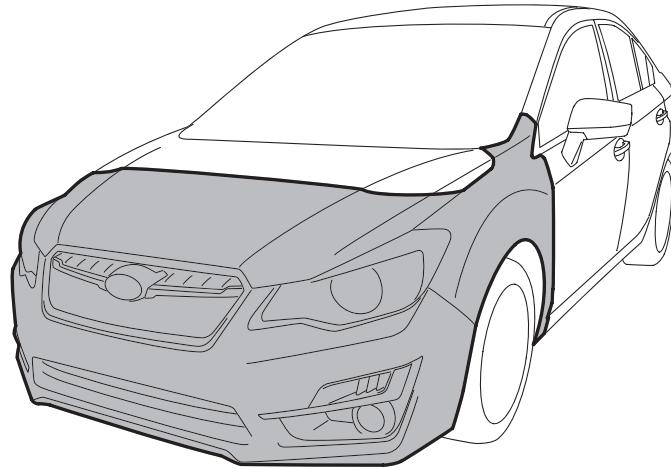
AB-03765

If the section of vehicle as shown in the figure is damaged, check the following items and replace the damaged parts with new parts.

- Front sub sensor is cracked or deformed.
- Connector is scratched, cracked or deformed.
- Driver's airbag module, knee airbag module or passenger's airbag module has been activated.

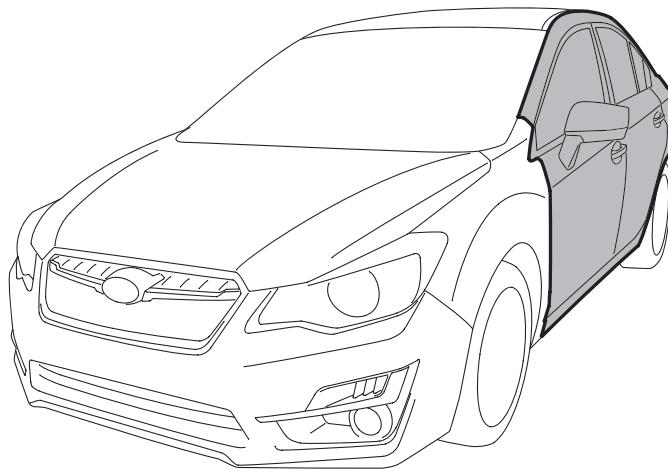
AB-03766

If the section of vehicle as shown in the figure is damaged, check the following items and replace the damaged parts with new parts.

- Front door impact sensor, satellite safing sensor, side airbag sensor and curtain airbag sensor are cracked or deformed.
- Mounting bracket is cracked or deformed.
- Connector is scratched, cracked or deformed.
- Side airbag module or curtain airbag module has been activated. (Operating side)

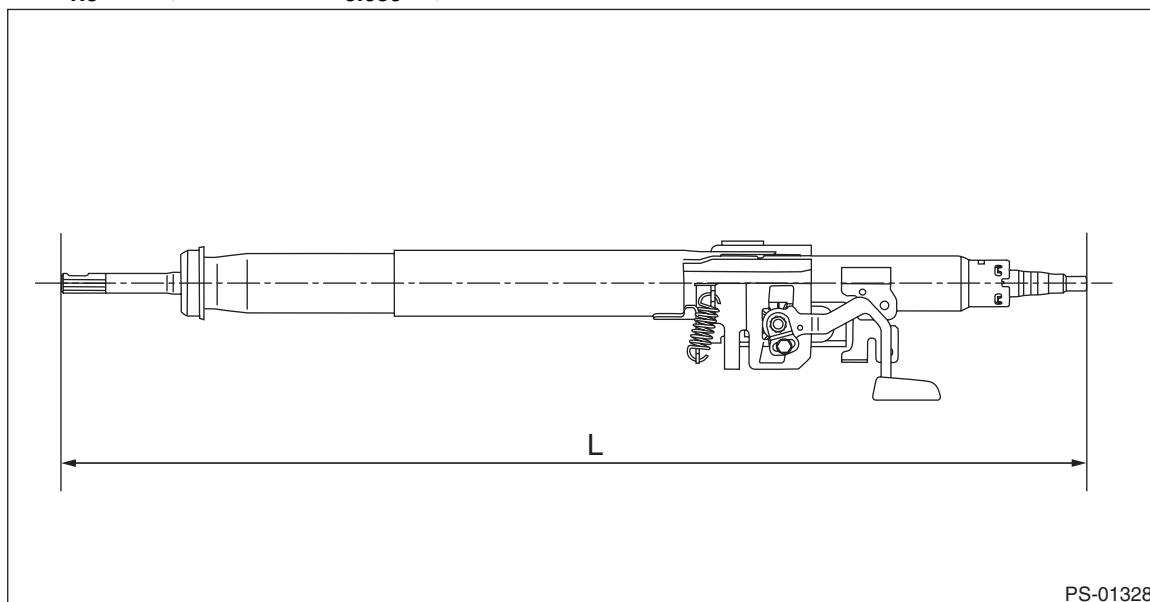
- Measure the whole length of the column assembly - steering.

Standard: Overall length L

Tilt and telescopic column (measure while minimized)

$819.7^{+1.5}_{-1.5}$ mm (32.27 $^{+0.059}_{-0.059}$ in)

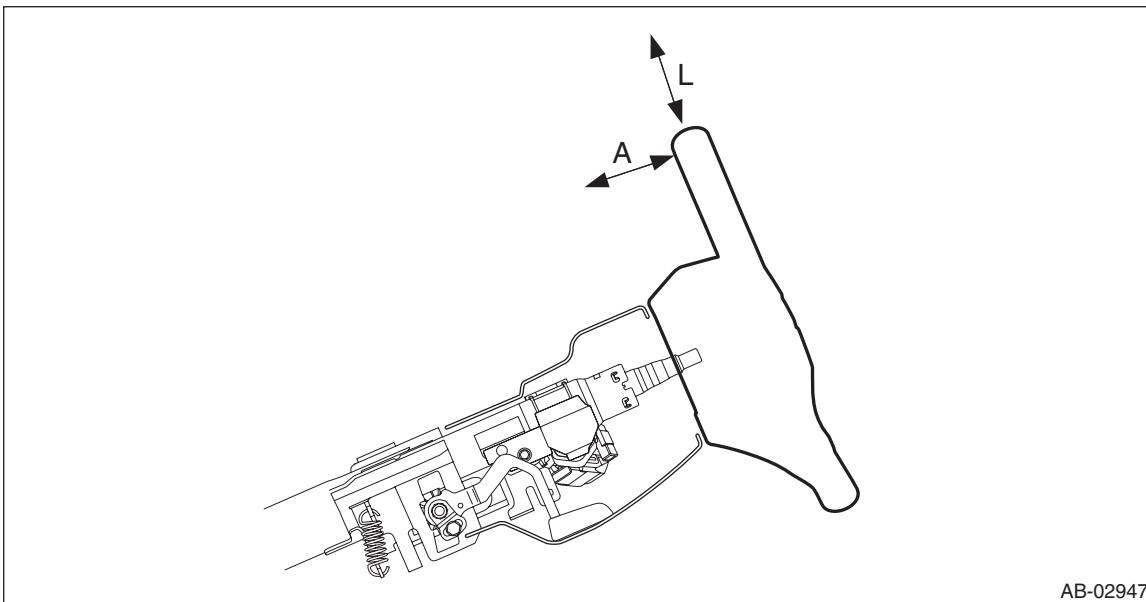
- Check the steering wheel deflection in axial and vertical directions.

Axial deflection A (deflection of steering wheel)

Less than 6 mm (0.24 in)

Vertical deflection L (runout of steering wheel)

Less than 17 mm (0.68 in)

Check the column assembly - steering for mounting conditions and deflection of front and rear, upward and downward directions, and deflection of front and rear direction with tilt lever released. (After a collision, absorbing part of the column assembly - steering may have been operated.)
