## 5. Audio

### A: REMOVAL

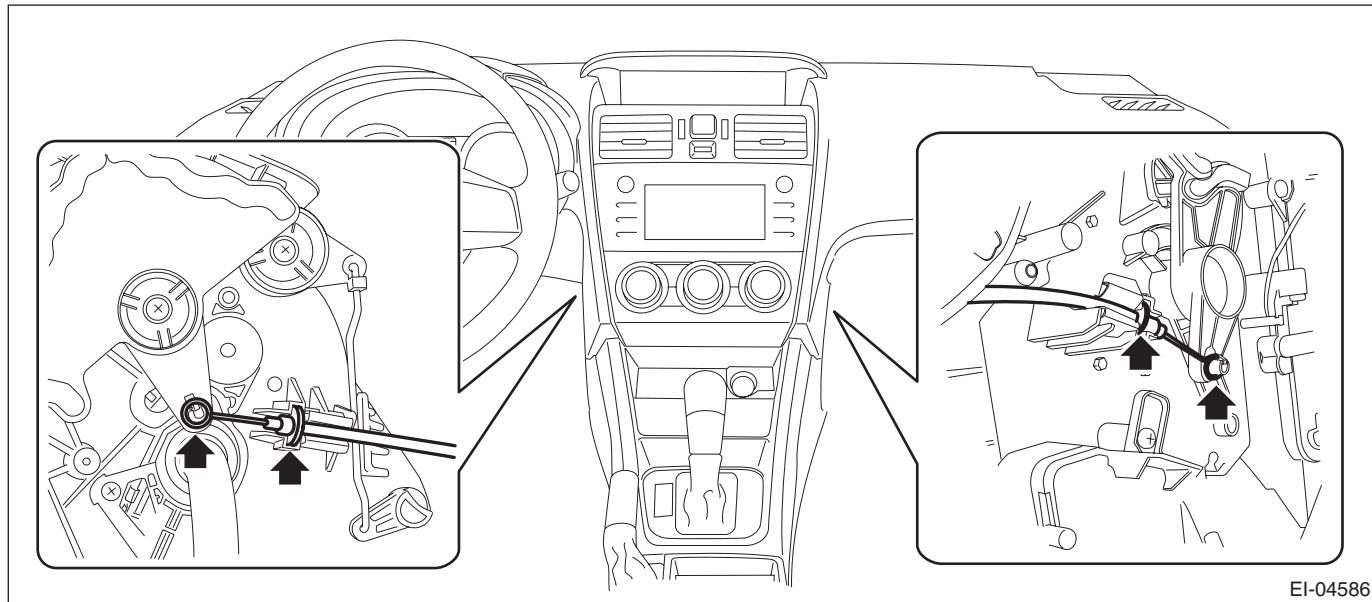
(1) On manual A/C models, disconnect the control cables from both sides of the heater & cooling unit.

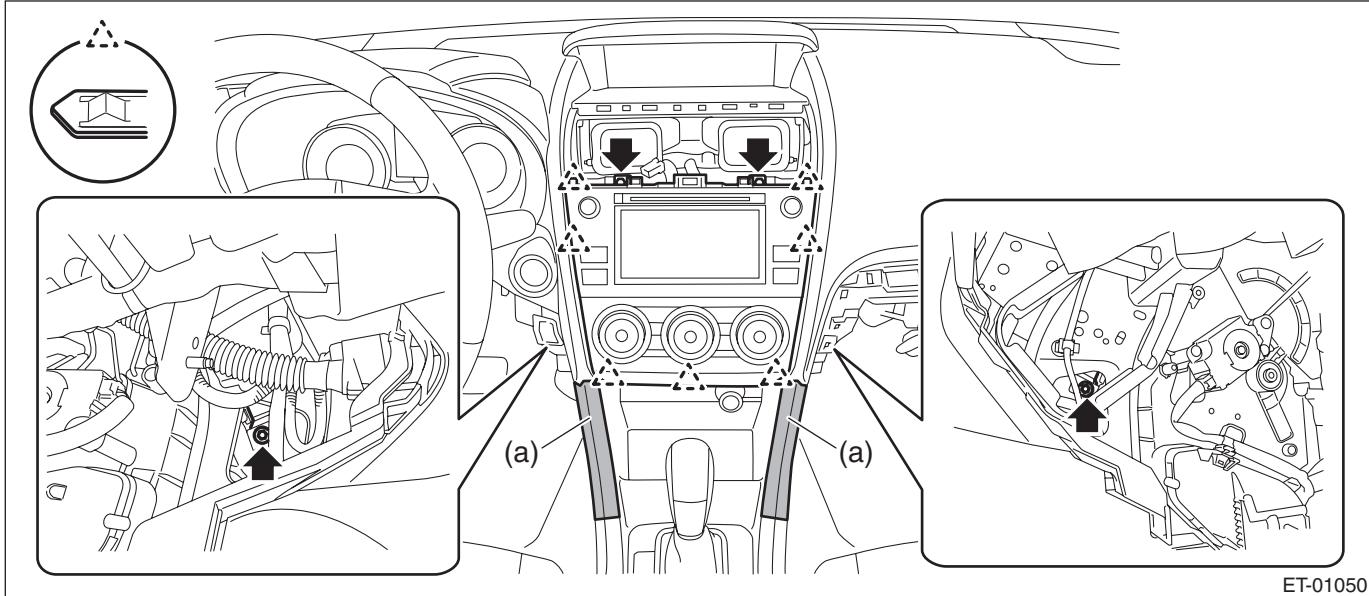
(2) Attach the protective tape (a) to the cover - shift lever.

(3) Remove the screws, bolts and claws, and partially pull out the audio assembly.

Release the claws by using a clip remover wrapped with protective tape.

(4) Disconnect the connectors, and remove the audio assembly.

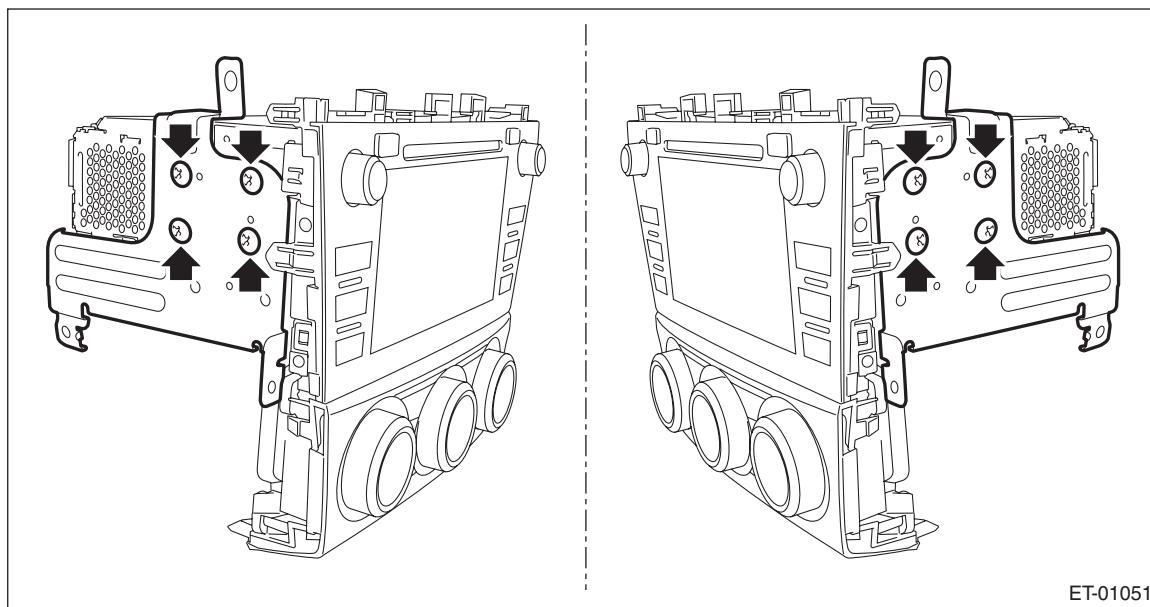
6) Remove the screws, and then remove the audio bracket.

#### *Tightening torque:*

7.5 N·m (0.76 kgf·m, 5.5 ft-lb)

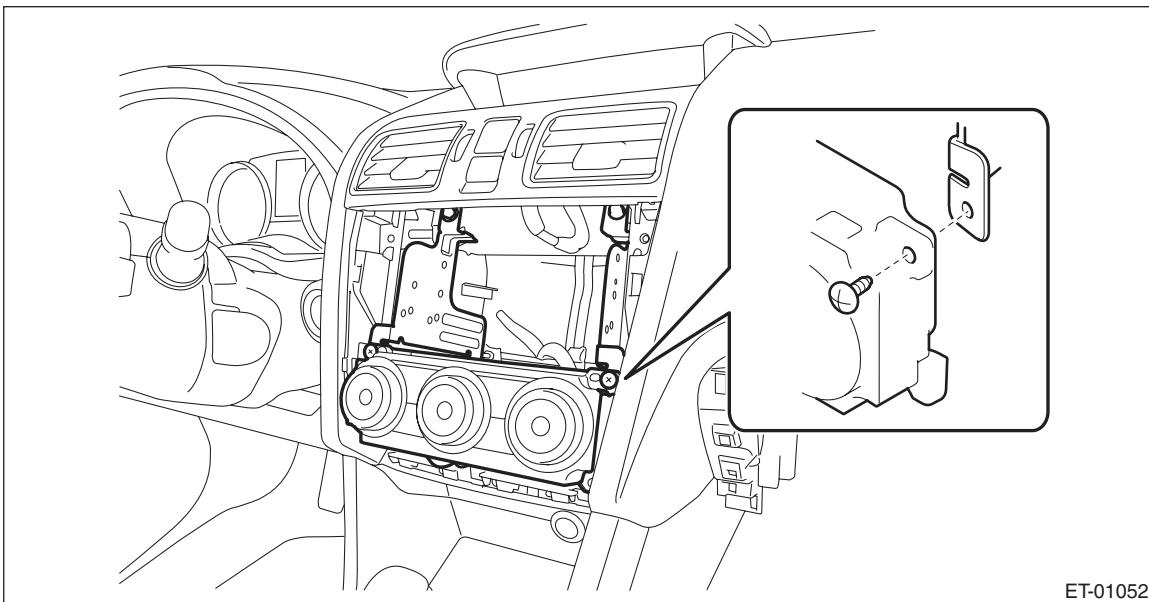
To have the audio repaired, remove the audio bracket and the heater control assembly, and install it to the vehicle as shown in the figure. <Ref. to AC-50, REMOVAL, Control Panel.>
