27.Rear Side Marker Light Bulb

LIGHTING SYSTEM

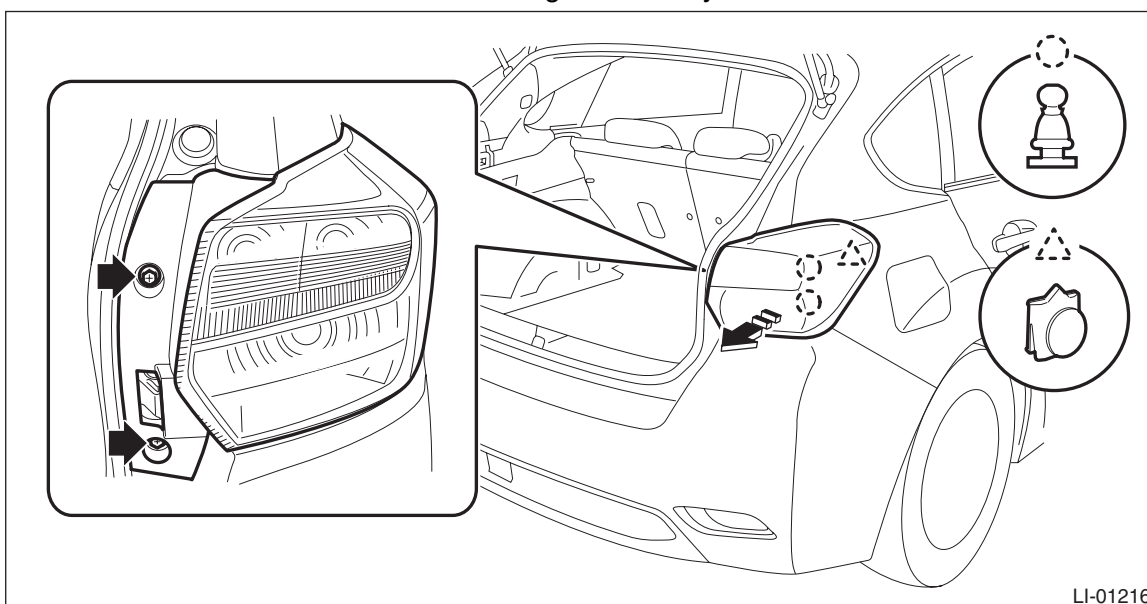
LI-01216

- (1) Release the bolts and clips, then pull out the light assembly - rear combination to the vehicle rear.
- (2) Disconnect the connector and remove the light assembly - rear combination.

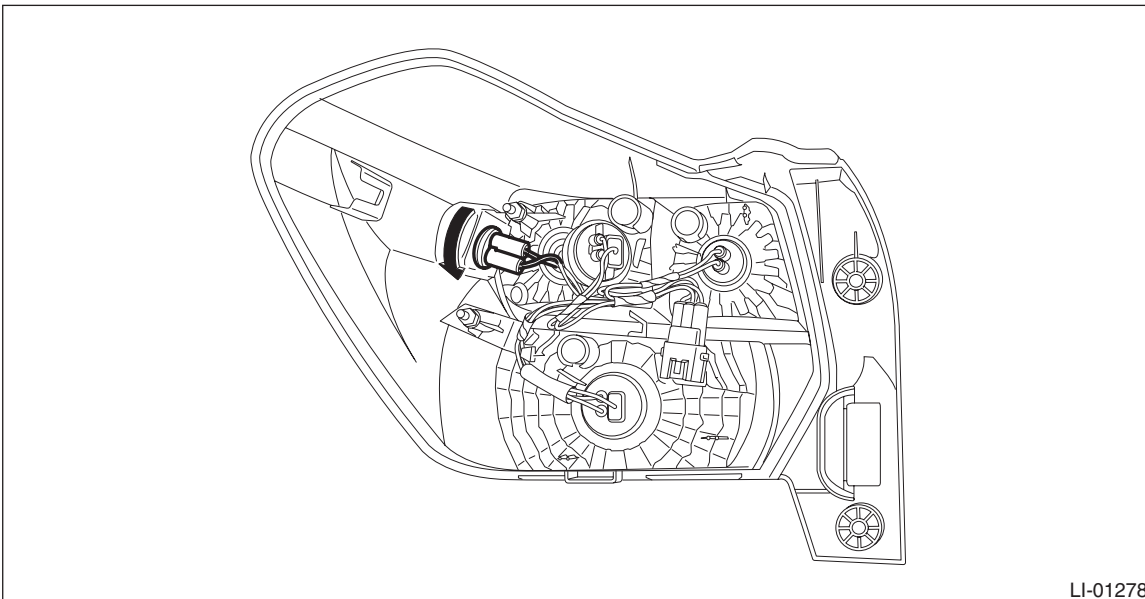
LI-01278

3) Remove the bulb socket, and remove the rear side marker light bulb.

- Gasoline engine model

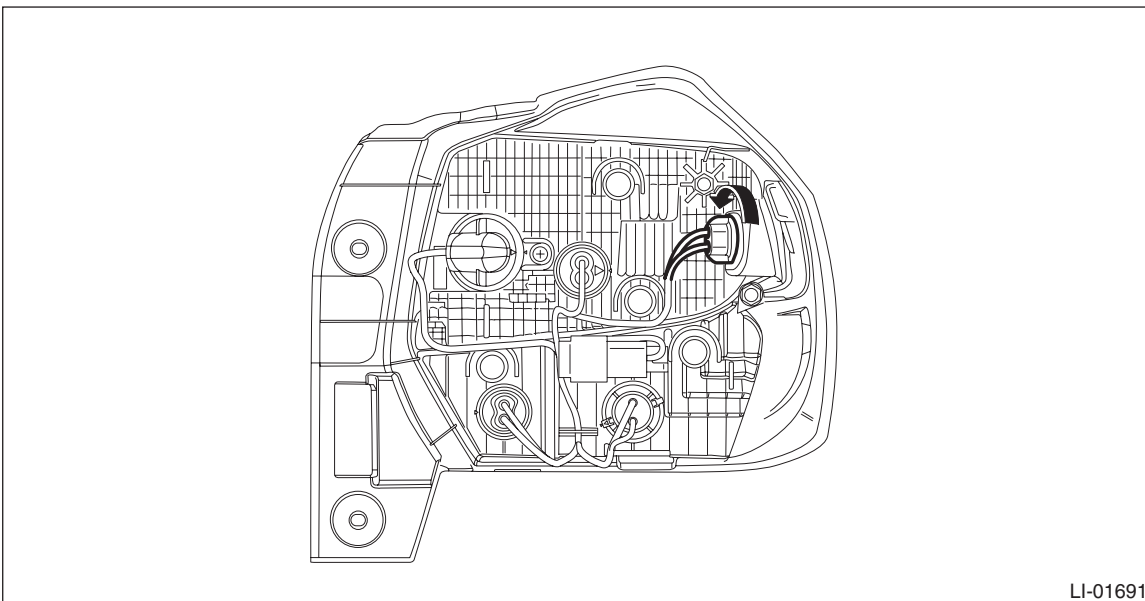
LI-01691

- HEV model
