| <b>DTC</b> | <b>B0138/72</b> | <b>Short in P/T Squib (LH) Circuit (to B+)</b> |

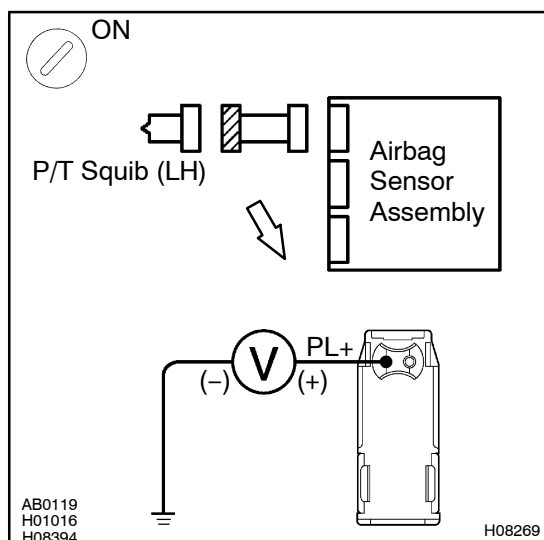
| <b>2</b> | <b>Check P/T squib (LH) circuit.</b> |

- Turn the ignition switch to ON.
- For the connector (on the seat belt pretensioner side) between the seat belt pretensioner (LH) and the airbag sensor assembly, measure the voltage between PL+ and body ground.

**Voltage: 0 V**

**Repair or replace harness or connector between seat belt pretensioner (LH) and airbag sensor assembly.**

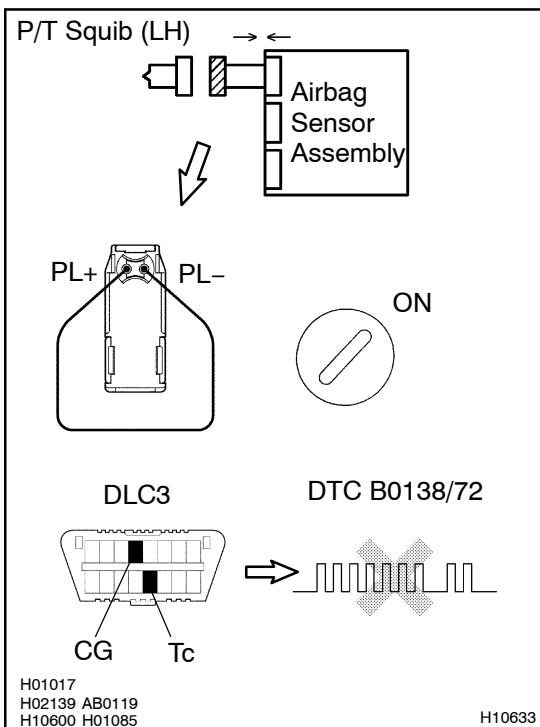
### 3 Check airbag sensor assembly.

- Connect the connector to the airbag sensor assembly.
- Using a service wire, connect PL+ and PL- of the connector (on the seat belt pretensioner side) between the seat belt pretensioner (LH) and the airbag sensor assembly.
- Connect negative (-) terminal cable to the battery, and wait at least for 2 seconds.

- Turn the ignition switch to ON and wait at least for 20 seconds.
- Clear the DTC stored in memory (See step 5 on [page DI-118](#)).
- Turn the ignition switch to LOCK, and wait at least for 20 seconds.
- Turn the ignition switch to ON, and wait at least for 20 seconds.
- Check the DTC ([See page DI-118](#)).

**DTC B0138/72 is not output.**

**Replace airbag sensor assembly.**

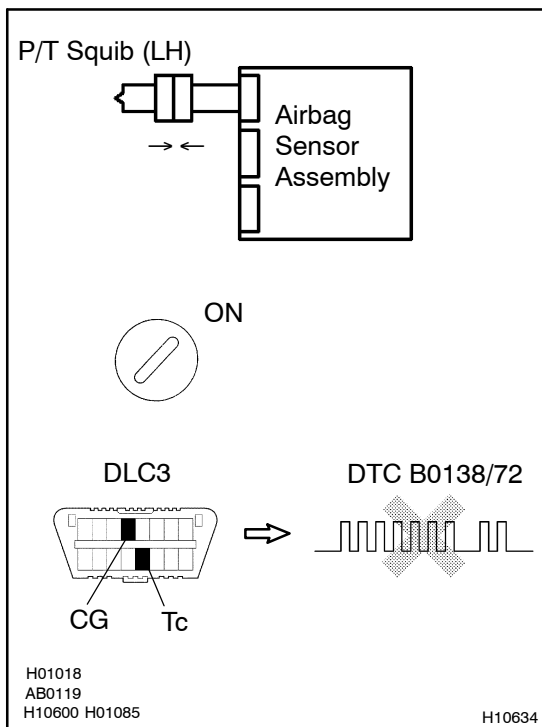
# 4 Check P/T squib (LH).

- Turn the ignition switch to LOCK.
- Disconnect negative (-) terminal cable from the battery, and wait at least for 90 seconds.
- Connect the seat belt pretensioner (LH) connector.
- Connect negative (-) terminal cable to the battery, and wait at least for 2 seconds.

- Turn the ignition switch to ON, and wait at least for 20 seconds.
- Clear the DTC stored in memory (See step 5 on [page DI-118](#)).
- Turn the ignition switch to LOCK, and wait at least for 20 seconds.
- Turn the ignition switch to ON, and wait at least for 20 seconds.
- Check the DTC (See [page DI-118](#)).

**DTC B0138/72 is not output.**

**Replace seat belt pretensioner (LH).**
