## INSPECTION

### 1. VEHICLE NOT INVOLVED IN A COLLISION

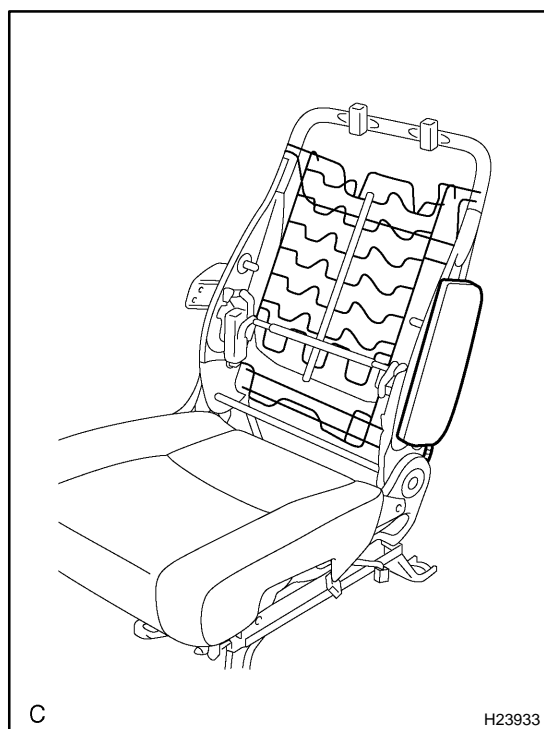
- (b) Perform a visual check which includes the following items with the seatback assembly removed from the vehicle.
  - Cuts, tears and cracks on the side airbag assembly.
  - Cuts and cracks in the wire harness, and chipping in the connectors.
