FRONT LOWER BALL JOINT ON-VEHICLE INSPECTION

SA0AW-05

INSPECT LOWER BALL JOINT EXCESSIVE PLAY ON-VEHICLE

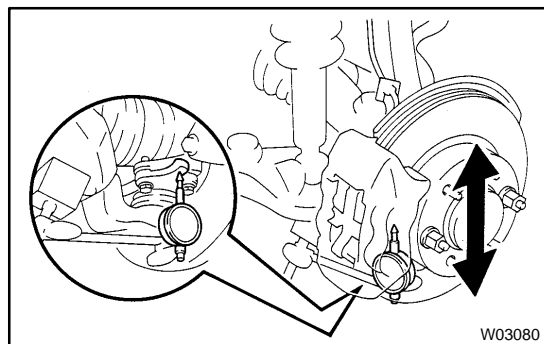
- (a) Remove the front wheel and install the hub nuts to the disc.

- (b) Using a dial indicator, check the lower ball joint for excessive play when you push the hub nuts up and down with a force of 294 N (30 kgf, 66 lbf).

Maximum: 0.5 mm (0.020 in.)
