## **TECHNICAL SERVICE BULLETIN**

SUBJECT:		No: <b>TSB-08-54-007</b>	
<b>NEW ANTENNA BASE SECURING METHOD - SERVICE MANUAL REVISION</b>		DATE: <b>May, 2008</b>	
MODEL: <b>2007-08 Outlander</b>			
CIRCULATE TO:	<input type="checkbox"/> GENERAL MANAGER	<input type="checkbox"/> PARTS MANAGER	<input checked="" type="checkbox"/> TECHNICIAN
<input checked="" type="checkbox"/> SERVICE ADVISOR	<input checked="" type="checkbox"/> SERVICE MANAGER	<input type="checkbox"/> WARRANTY PROCESSOR	<input type="checkbox"/> SALES MANAGER
<b>TSB Revision TSB-08-54-007</b>

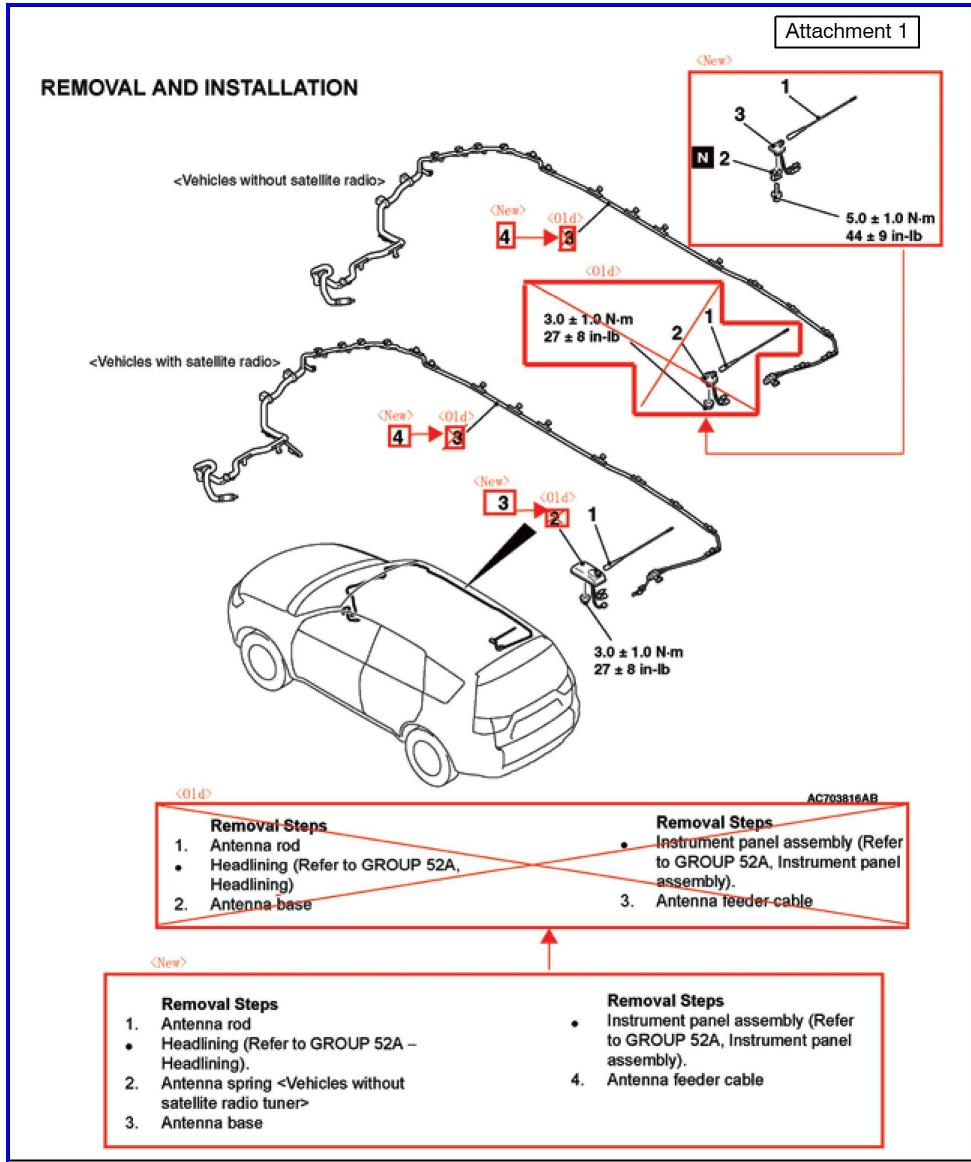
The method for securing the radio antenna base to the vehicle has been changed in production effective August 1, 2007. The securing nut has been replaced with a bolt and spring (see illustration).

Due to this change, the removal and installation steps have been changed in the applicable Service Manual. This Technical Service Bulletin advises those changes. These changes apply to Affected Vehicles and vehicles where the antenna base is replaced with a new part.

Manual	Pub. No.	Description	Attachment
2007 OUTLANDER Service Manual	MSCD-007B-07	Antenna Removal and Installation	1
2008 OUTLANDER Service Manual	MSCD-007B-08	Antenna Removal and Installation	1
