Crankshaft failure analysis of a boxer diesel motor

Article in *Engineering Failure Analysis* · April 2015

M. Fonte, V. Anes, P. Duarte, L. Reis, M. Freitas

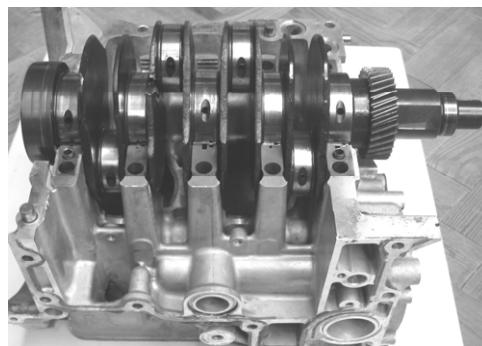
Fig. 2 shows a boxer crankshaft assembled on the bedplate of the half block. The engine is light weighted and compact block. To take account this issue, a hybrid structure of aluminium and iron has been adopted. Cylinders and steel halves of main journal bearings are put into the foundry box to produce an aluminium alloy molten block.

Fig. 2. Boxer crankshaft placed on the bedplate and into the half block's motor.
