### 16 SLOPE CONTROL CHANGE FOR 2003~2004MY VEHICLES

### 10 H6 A/C COMPRESSORS CUTTING OUT

### 01 FADED OR GHOSTED FLUKE ORIGINAL 80 SERIES DISPLAY

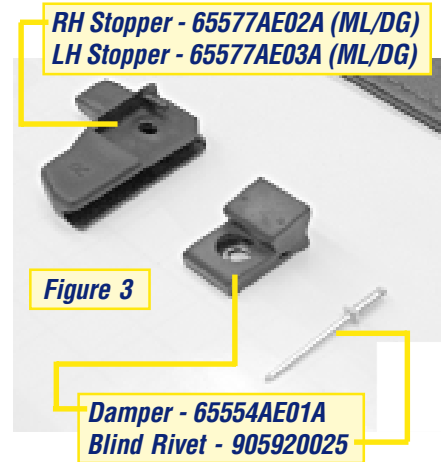
**Figure 3**

**Damper - 65554AE01A**  
**Blind Rivet - 905920025**

cover assembly. Simply order the hook ends, damper and rivet (see figure 3 for part number applicability).

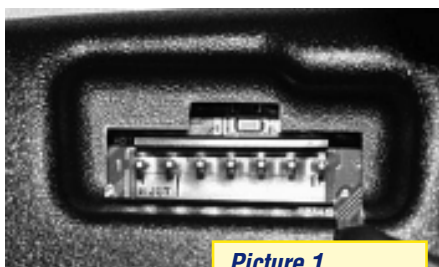
**Picture 1**

- 1) The internal components and circuitry have been revised on all models. The updated mirror is less susceptible to outside influences.
- 2) The 7-pin connector to the mirror is now recessed on all models (see picture 1 below).

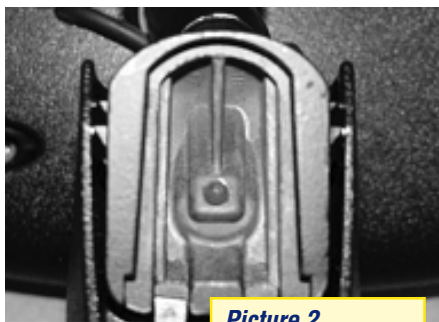
**Picture 2**

- 3) The mounting for the 2004 Legacy, Outback, and Baja has changed. It now uses a mounting plate and setscrew (see picture 2 below) instead of a camlock (see picture 3).

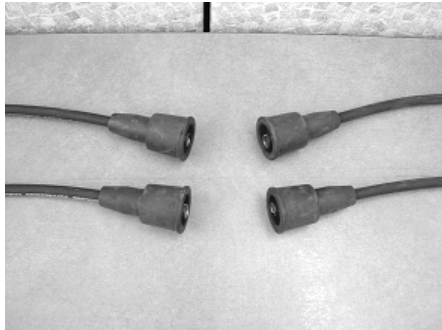
SOA430Q121 (pictured above) is the Correct Part Number for the 1998 Forester model.

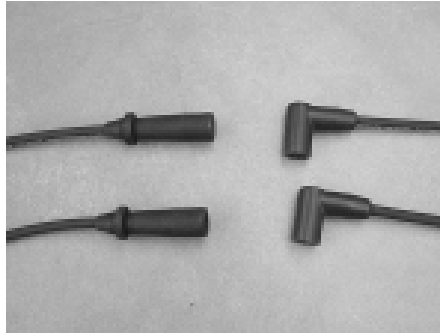
SOA430Q122 (pictured above) is the previously listed part number which is not applicable to the 1998 Forester model.

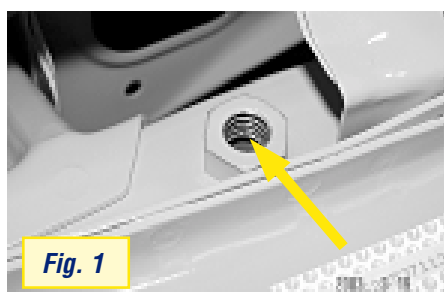
Before installing the trailer hitch on the Baja, please ensure that the silicone plugs are taken out of the weld nut on the bumper beam (see Fig. 1).

If the bumper plugs are not removed, this may cause difficulty in properly installing the trailer hitch bolt. It may be a good idea, when initially threading the bolt into the bumper beam weld nut, to start it by hand. This will avoid cross-threading the bolt. For proper installation instructions, please download the information from <http://www.subarunet.com>

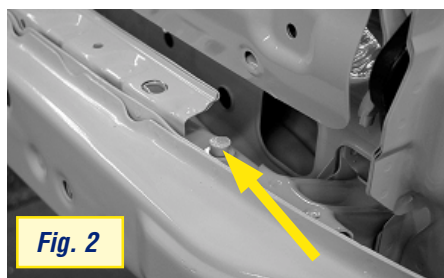
The bumper beam plugs are installed at the factory to prevent the inside on the threads from being painted (see Fig. 2 and 3).

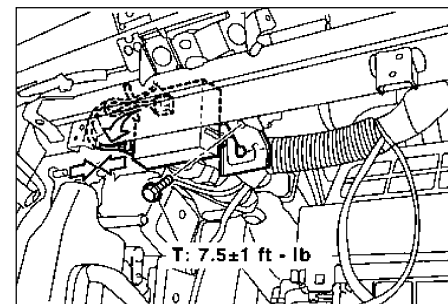
This article is to reinforce the importance of the specific torque specifications for the 2004 STi security system module. The security module is mounted behind the glove box and servicing it requires the removal and reinstallation of one passenger side air bag bolt (see pictures).

system module bolt is torqued to 7.5  $\pm$  1 ft. lbs (torque specification of the bolt is normally 5.4 ft. lbs.). For detailed installation guidelines, please refer to the installation guide supplied in kit # H7110SS200 or download the information from: [http://www.subarunet.com/fixed\\_operations/accessories](http://www.subarunet.com/fixed_operations/accessories).

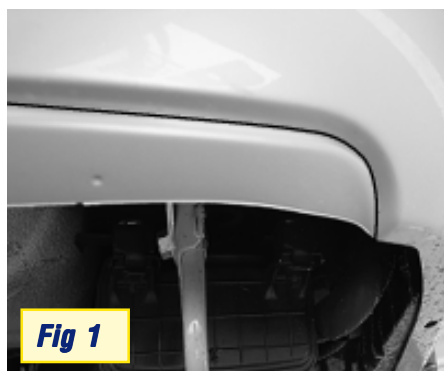
There is new cutting procedure for installing a trailer hitch on a 04 Impreza. When a technician makes the cut to the bumper fascia, caution must be taken to ensure that the plastic tabs on the left and right side of the bumper do not get cut off. The left and right side plastic tabs act as reinforcement and help hold the bumper in place.

Fig. 1 shows an Impreza wagon bumper before cutting. Fig. 1 also has a rough line drawn in to identify the line when cutting.

Fig. 2 and Fig. 3 depict a finished cut and expose the right side tabs. Be sure when you cut the bumper fascia to keep the tool parallel to the ground. This avoids cutting the tabs. Some of the tools that can be used to cut the bumper fascia are pictured in fig. 4.

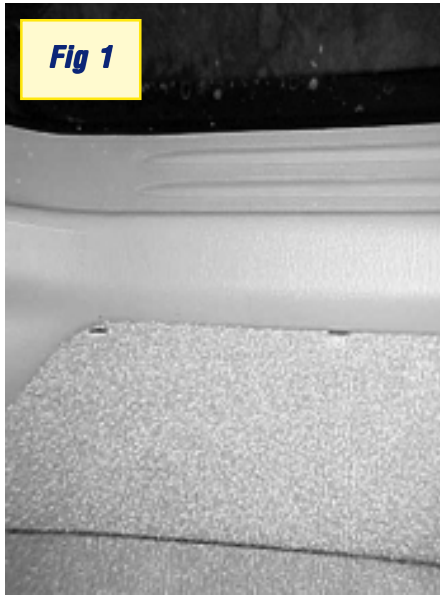
**Fig 1**

Only noticeable on the right front passenger side of the vehicle, a customer may have a concern with carpet staple visibility (see fig. 1, below). Please check the location of the rear harness. If the harness is aligned properly (see fig. 2), the carpet staples are located under the side-sill trim cover and cannot be visible. If you find the problem (see fig. 3), please remove the side-sill trim cover and realign the harness. You do not need to replace any parts.

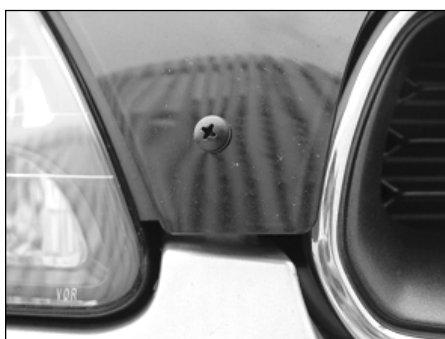
**New installation with metal clip and screw**

The new Deflector design, featuring three metal clips with one in the center, replaces the previous design, and fits 2000MY-2004MY Legacy and Baja vehicles.

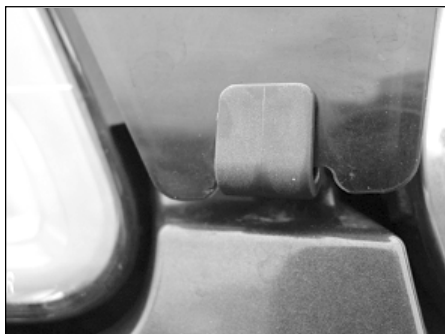
**Old installation with plastic "W" clip**

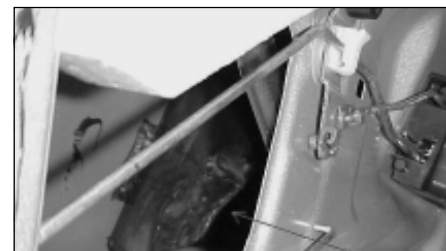
If a customer complains of a rattle in the door panel (with the window lowered) or an asphalt like substance stuck on the outside of the door glass, the cause may be the result of the sound-dampening pad not being fully secured to the inner door shell. See photos below.

**Pad Properly Installed**

door shell and applying adequate pressure over the entire surface of the pad will solve the problem. In the event that the pad is severely distorted or will not adhere to the door shell, the sound-dampening pad will need to be replaced. The dampening pad part number is 90841AC000, and is applicable to 2000 to current Legacy, Outback and Baja vehicles.

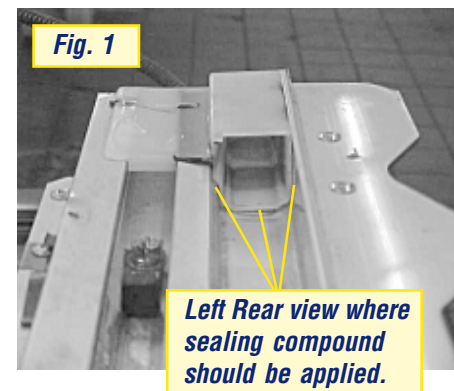
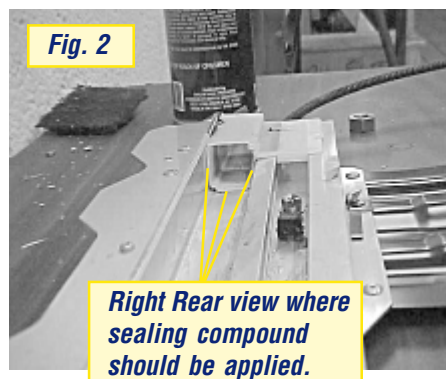
If you encounter any evidence of water leaks in the roof trim panel and/or headliner, it may be caused by a shortage of sealing compound at the end of the rear drain caps. You will need to lower the sunroof assembly to access the end of the rear drain caps. Please see instructions below to access the rear drain caps without removing the sunroof assembly. See chart below for vehicle applicability.

- 1) Retract the sunroof glass all the way open.
- 2) Disconnect the battery ground cable.
- 3) Remove roof trim panel. <Ref. to service manual and/or Subaru STIS web-site for removal instructions>
- 4) Disconnect the rear drain tubes from the sunroof frame.
- 5) Disconnect the sunroof harness connector.
- 6) Remove the rear bolts from the sunroof assembly to lower the assembly enough to access the rear end caps through the sunroof opening.
- 7) Apply a small bead of 3M Heavy Drip-Chek Sealer (**3M P/N 05113508531**) or equivalent between the rear drain cap and the water channel (see fig. 1 and 2 for an illustration of application points).

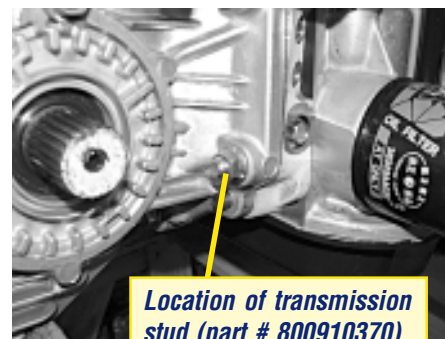
While diagnosing a transmission leak on a Phase II 4EAT, it is advisable to inspect the left-side transmission stud area (see fig. 1 for illustration). If the transmission leak originates from this stud, please perform the following repair.

Location of transmission stud (part # 800910370) on main case (left-hand side).

**NOTE:** Regardless of the method used to retract the stud from the main case, be sure to inspect the stud for damage and replace if necessary.

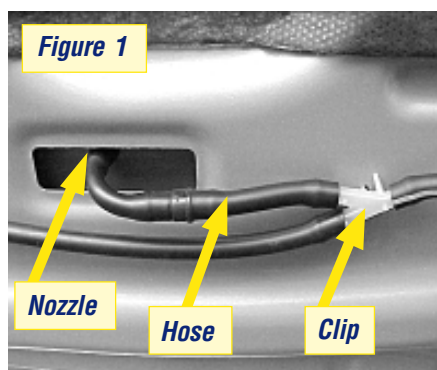
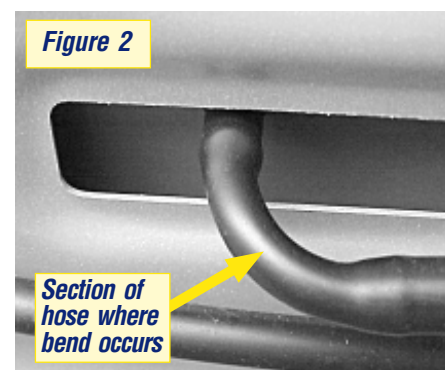
In the event that you encounter poor discharge from the Left Front Windshield Washer, replacement of the washer hose between the nozzle and clip may be necessary (See Figure 1). The hose could be bent near the nozzle. See Figure 2 for the suspect area. Prior to replacing this part, be sure to inspect the LF washer nozzle for obstruction and all other related components for proper operation.

- 1) Replace "Hose LH" between nozzle and clip with new one (part # 86659SA010)
- 2) Please pay special attention not to twist the hose when installing it. A ribbed hose is provided to prevent twisting the hose
- 3) Test the system for proper operation of windshield washer components.
