**M/T - 6 Speed MTM Difficulty Selecting Gears**  
**TRANSMISSION & [CLUTCH](#)**  
 TC002-01

Title:  
 6-SPEED MTM

Models:  
 '00 - '01 Celica GTS

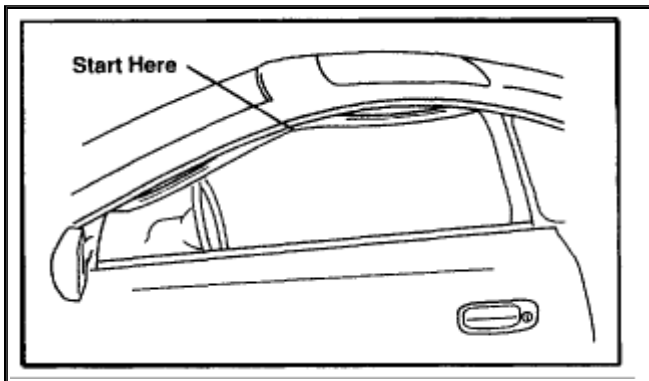
1. Check weatherstrip for deformation. Installation and/or damage.

2. If the weatherstrip is in good condition, start by installing the weatherstrip in the No. 2 corner. If the weatherstrip is damaged, replace the weatherstrip.

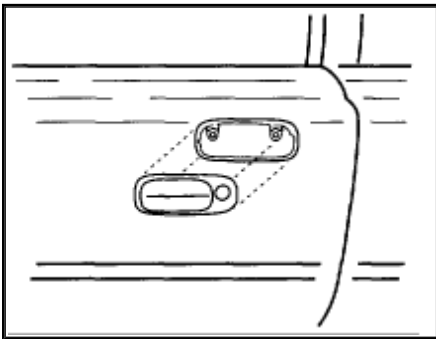
The outer [door handle](#) on some 2000 model year Celica vehicles may appear to be loose due to a gap between the door handle and door panel. A production countermeasure has been implemented. Use the following procedures to reduce outer door handle movement concerns.

1. Remove the door trim panel. (Refer to the 2000 MY Celica Repair Manual, page BO-12.)
2. Peel back the moisture barrier.
3. Disconnect the door lock rod.
4. Disconnect the [door handle](#) rod.

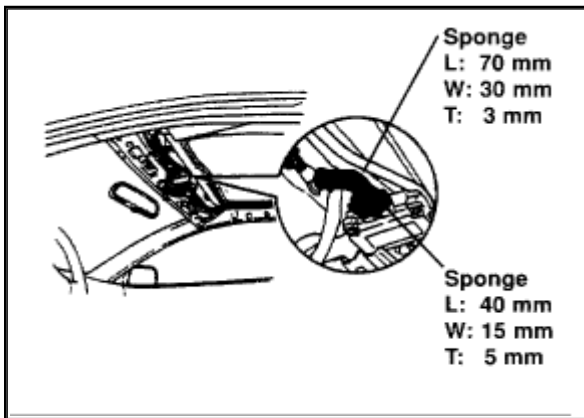
To eliminate the rattle noise from the front roof headliner (around the map light):

1. Lower front of headliner. (Please refer to 2000 MY Celica Repair Manual pages BO-88 to BO-90.)
2. Wrap two urethane sponge pieces 70 mm x 30 mm x 3 mm and 40 mm x 15 mm x 5 mm to the [sliding roof motor](#) connector and wire as shown.
3. Reassemble the vehicle in the reverse order of disassembly.

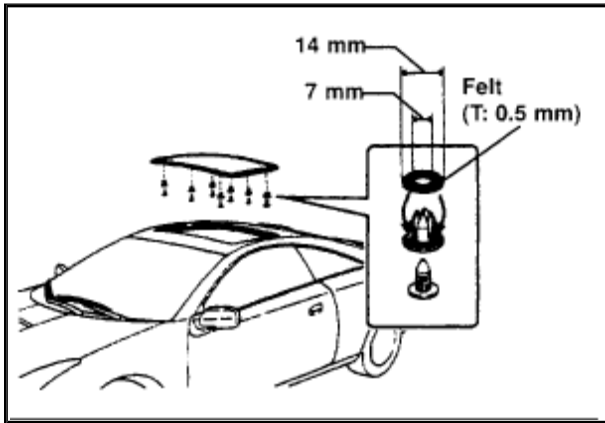
[Sliding Roof](#) Rattle Noise

To eliminate the rattle noise from the [sliding roof](#) area:

1. Remove [sliding roof](#) glass.
2. Remove 7 clips on the [sliding roof](#) glass.
3. Make and install felt washers (ID: 7 mm, OD: 14 mm, Thickness: 0.5 mm) under clips or replace all 7 clips with part number 90467-07152-CO as shown.

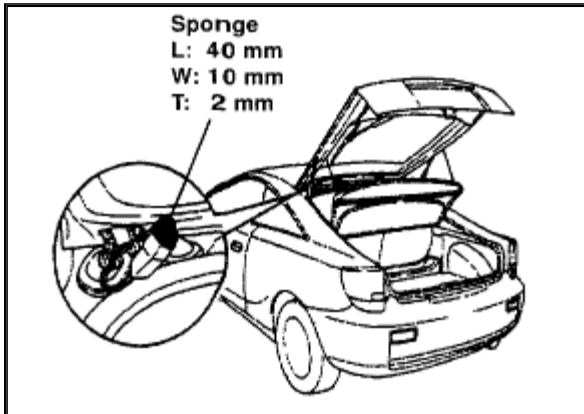
Back Door Front Left Area Rattle Noise

To eliminate the rattle noise from the back door front left area:

Wrap a urethane sponge piece 40 mm x 10 mm x 2 mm to the center stop light connector as shown.

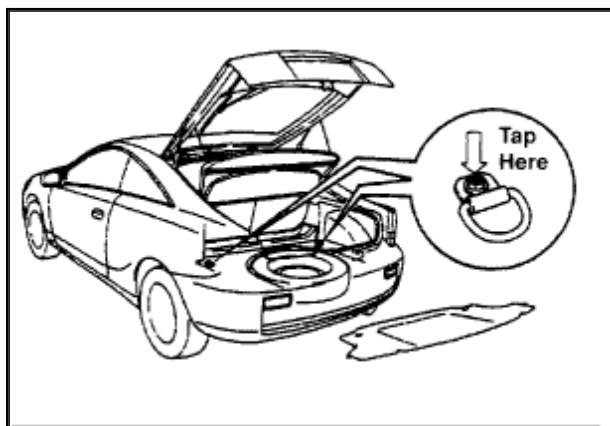
Luggage Compartment Rattle Noise around Tie-down Hook (for vehicles without Deck Floor Box)

Tap the head of the tie-down hook bolts lightly with a rubber hammer.

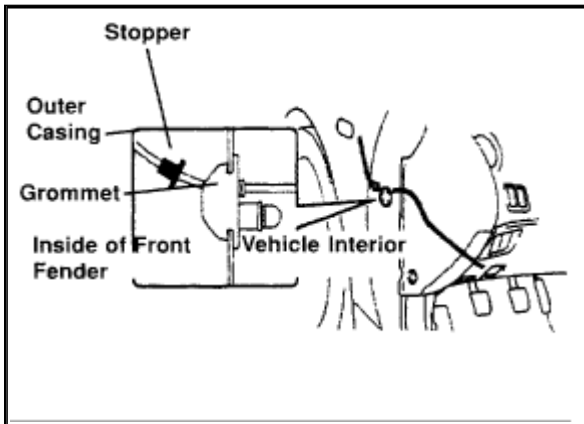
Buzz Noise from Instrument Panel  
(Hood Lock Control Cable)

1. Pull the outer casing of the hood lock control cable as shown until the stopper bottoms on the grommet.

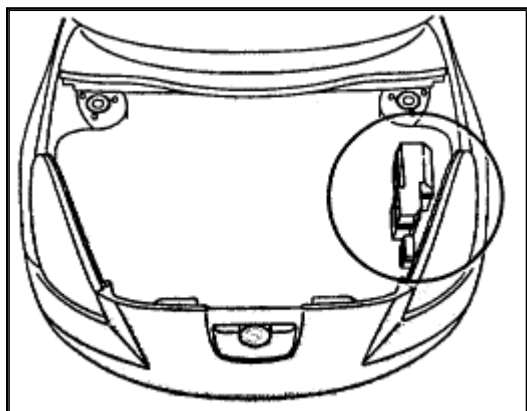
On the 2000 model year Celica the [tachometer](#) and speedometer needles will fluctuate when the ignition switch is turned on with the DCC 25 Amp fuse removed. Initial installation of this fuse should occur during PDS (Pre-Delivery Service). Tachometer/speedometer needle movement is a normal condition for this model with the DCC 25 Amp fuse removed.

If a vehicle exhibits this condition, check that the DCC 25 amp fuse is in the Junction Block as shown.

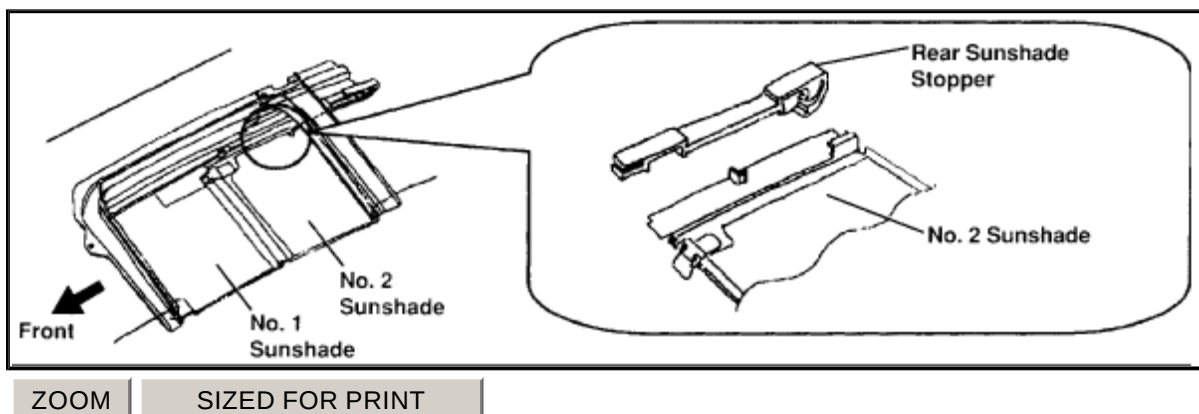
To eliminate a rattle noise when the sunshade is in a closed position:

- Remove the headliner (please refer to the 2000 Celica Repair Manual, pages BO-88 through BO-90).
- Remove the [sliding roof](#) assembly (please refer the the 2000 Celica Repair Manual, page BO-71).
- Remove the rear sunshade stoppers.
- Replace the No. 2 sunshade.
- Replace the rear sunshade stoppers.
- Reassemble in the reverse order of disassembly.

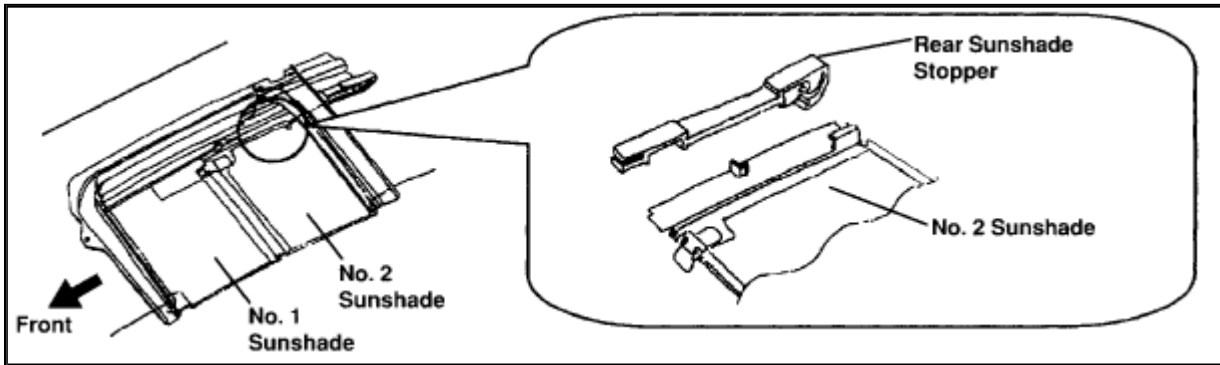
### 2. No. 1 Sunshade Separates From No.2 Sunshade When Opening

- A. Remove the headliner (please refer to the 2000 Celica Repair Manual, pages BO-88 through BO-90).
- B. Remove the [sliding roof](#) assembly (please refer the the 2000 Celica Repair Manual, page BO-71).
- C. Remove the rear sunshade stoppers.
- D. Replace the No. 2 sunshade.
- E. Replace the rear sunshade stoppers.
- F. Reassemble in the reverse order of disassembly.

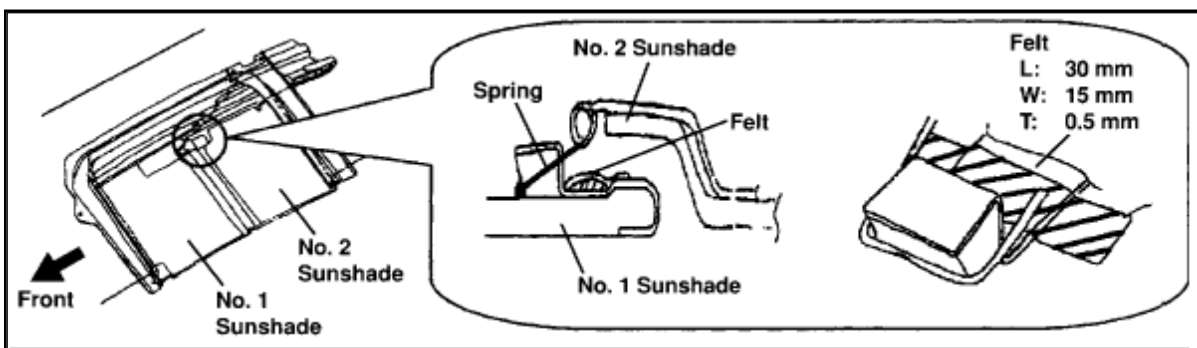
To reduce high operating force when opening/closing the sunshade;

- A. Remove the headliner (please refer to the 2000 Celica Repair Manual, pages BO-88 through BO-90).
- B. Remove the [sliding roof](#) assembly (please refer the the 2000 Celica Repair Manual, page BO-71).
- C. Remove the rear sunshade stoppers.
- D. Replace the No. 2 sunshade.
- E. Replace the rear sunshade stoppers.
- F. Reassemble in the reverse order of disassembly.

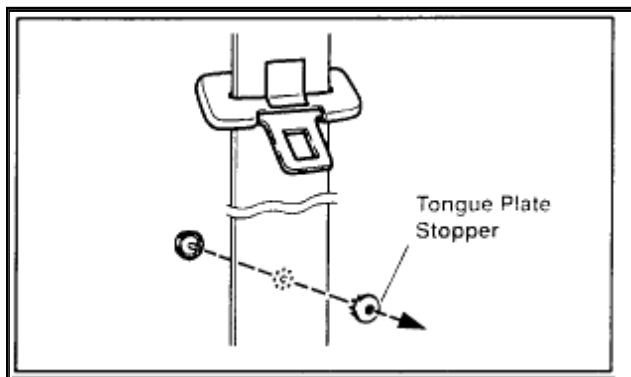
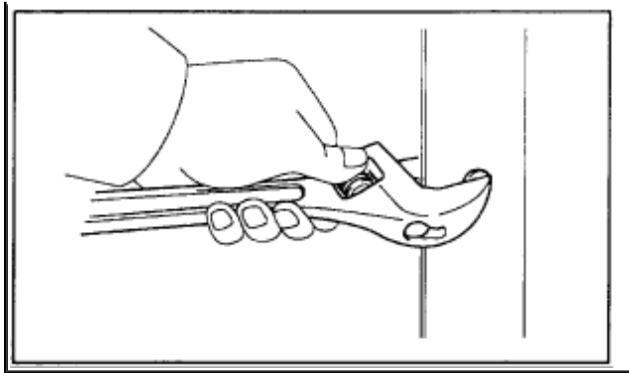
A new service part for the seat belt tongue plate stopper has been introduced. Installation procedures are provided to supplement the Repair Manual.

A. Install a new Tongue Plate Stopper in the hole of the webbing.

**NOTE:** Be aware of the installation direction of the Tongue Plate Stopper as shown in the illustration.

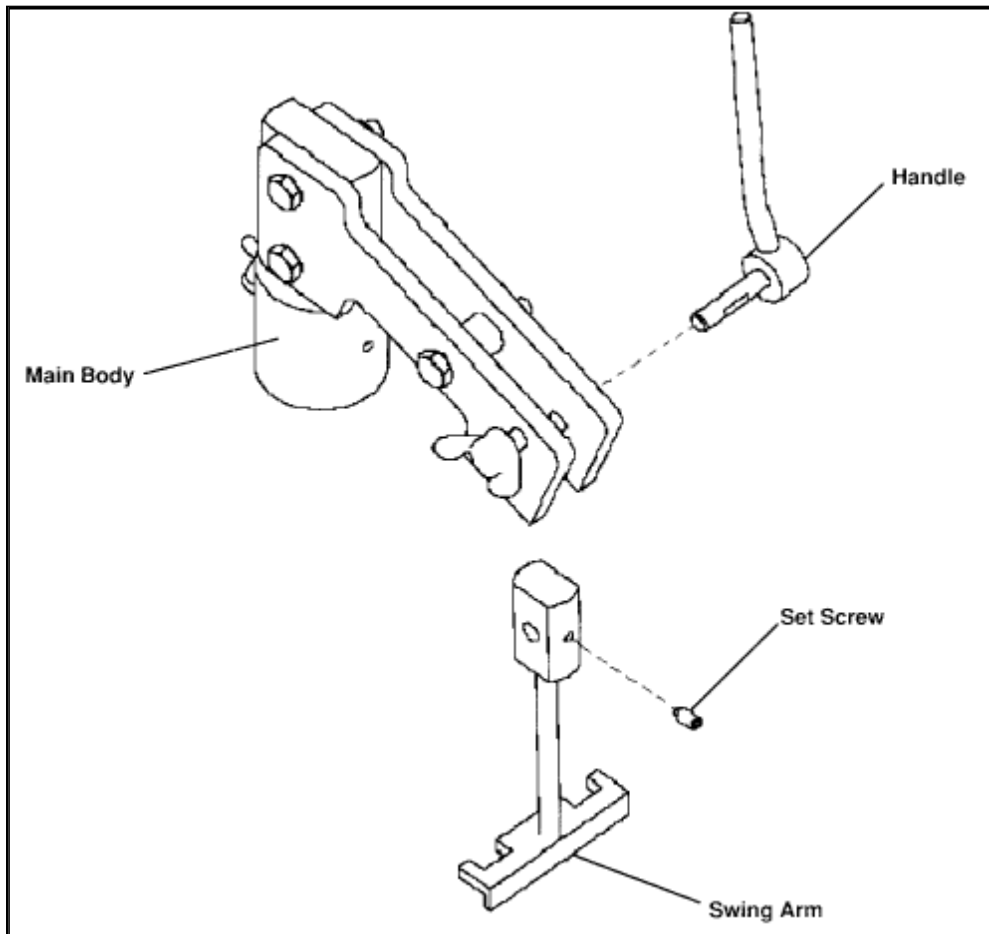
**Retrofit Procedure**

As a result of tolerance stack, some of the subject [Valve Clearance](#) Adjusting Compressor SSTs, P/N 09248-07010-01, will not fully compress the valve follower on the 2000 Celica GTS with 2ZZ-GE engine, making it difficult or impossible to remove the valve adjusting shim. To correct this condition, a new swing arm will be distributed to all Toyota dealerships. The swing arms are zinc-plated for easy identification.

A revised design swing arm will replace the existing swing arm on the [Valve Clearance](#) Adjusting Compressor. This new swing arm is approximately 0.2" longer than the original and is zinc-plated for identification purposes.
