PGM-FI System

Engine Control Module (ECM)

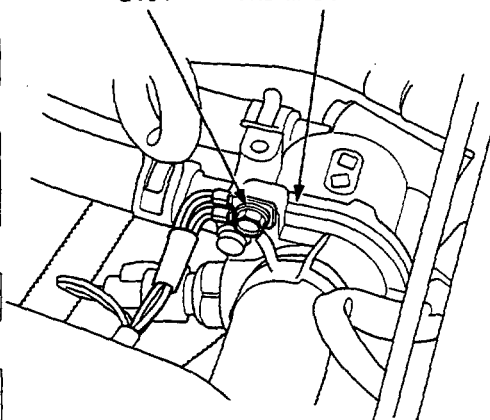
G101 THERMOSTAT HOUSING

Measure voltage between body ground and the following terminals individually: A23, A24.

Is there less than 1.0 V?

Repair open in BLK wire(s) between ECM and G101 (located at thermostat housing) that had more than 1.0 V.

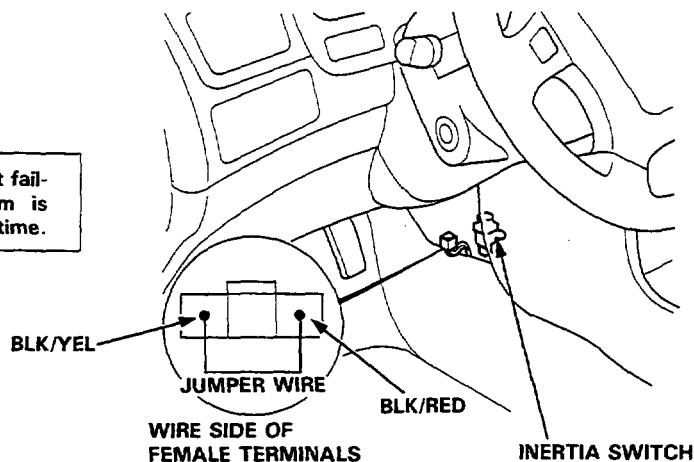
Disconnect the 2P connector from the inertia switch.

Connect BLK/YEL terminal to BLK/RED terminal.

LHD type is shown, RHD type is symmetrical.

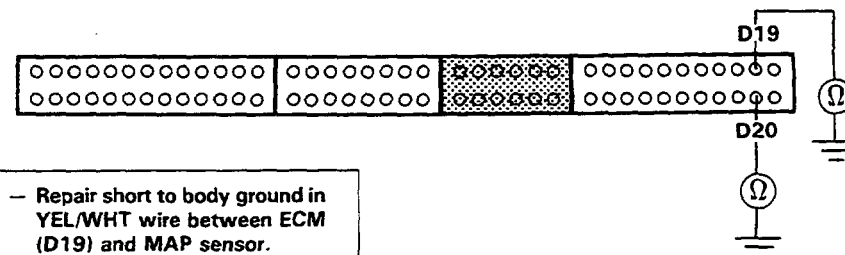
Check for continuity between body ground and D19, D20 terminals.

- Repair short to body ground in YEL/WHT wire between ECM (D19) and MAP sensor.
- Repair short to body ground in YEL/BLU wire between ECM (D20) and TP sensor or EGR valve lift sensor.

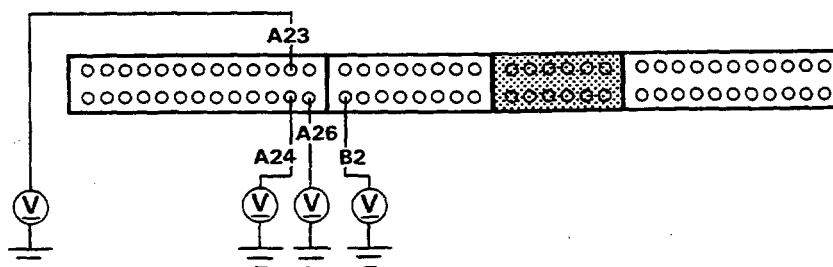
Measure voltage between body ground and the following terminals individually: A23, A24, A26, B2.

- Repair open in BLK wire between ECM (A23, A24) and G101 (located at thermostat housing).
- Repair open in BRN/BLK wire between ECM (A26, B2) and G101.
