PGM-FI System

Engine Coolant Temperature (ECT) Sensor

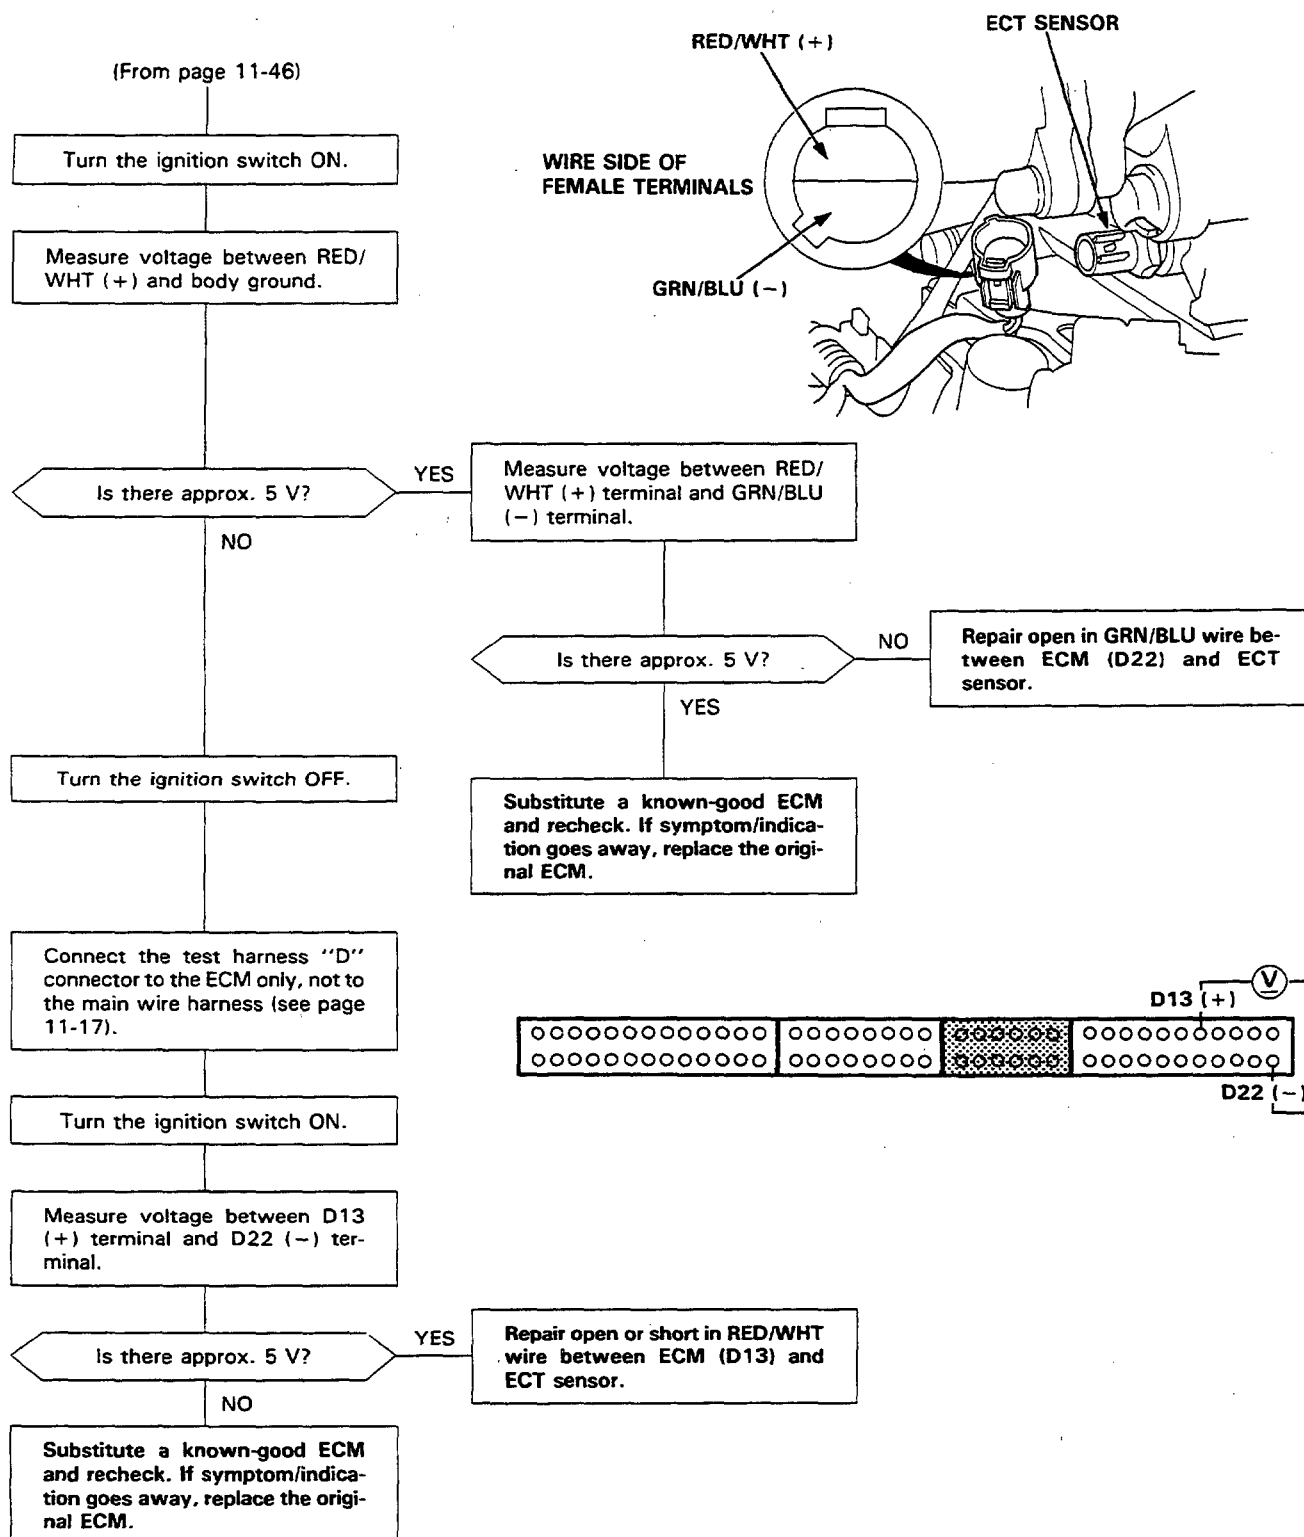
The ECT Sensor is a temperature dependant resistor (thermistor). The resistance of the thermistor decreases as the engine coolant temperature increases as shown below.

THERMISTOR

RESISTANCE
(k Ω)

-20 0 20 40 60 80 100 120 (°C)
-4 32 68 104 140 176 212 248 (°F)

ENGINE COOLANT TEMPERATURE

Disconnect the 2P connector from the ECT sensor.

Measure resistance between the 2 terminals on the ECT sensor.

Is there 200—400 Ω ?
