| <b>DTC</b> | <b>B1248</b> | <b>AVC-LAN COMMUNICATION IMPOSSIBLE</b> |

## CIRCUIT DESCRIPTION

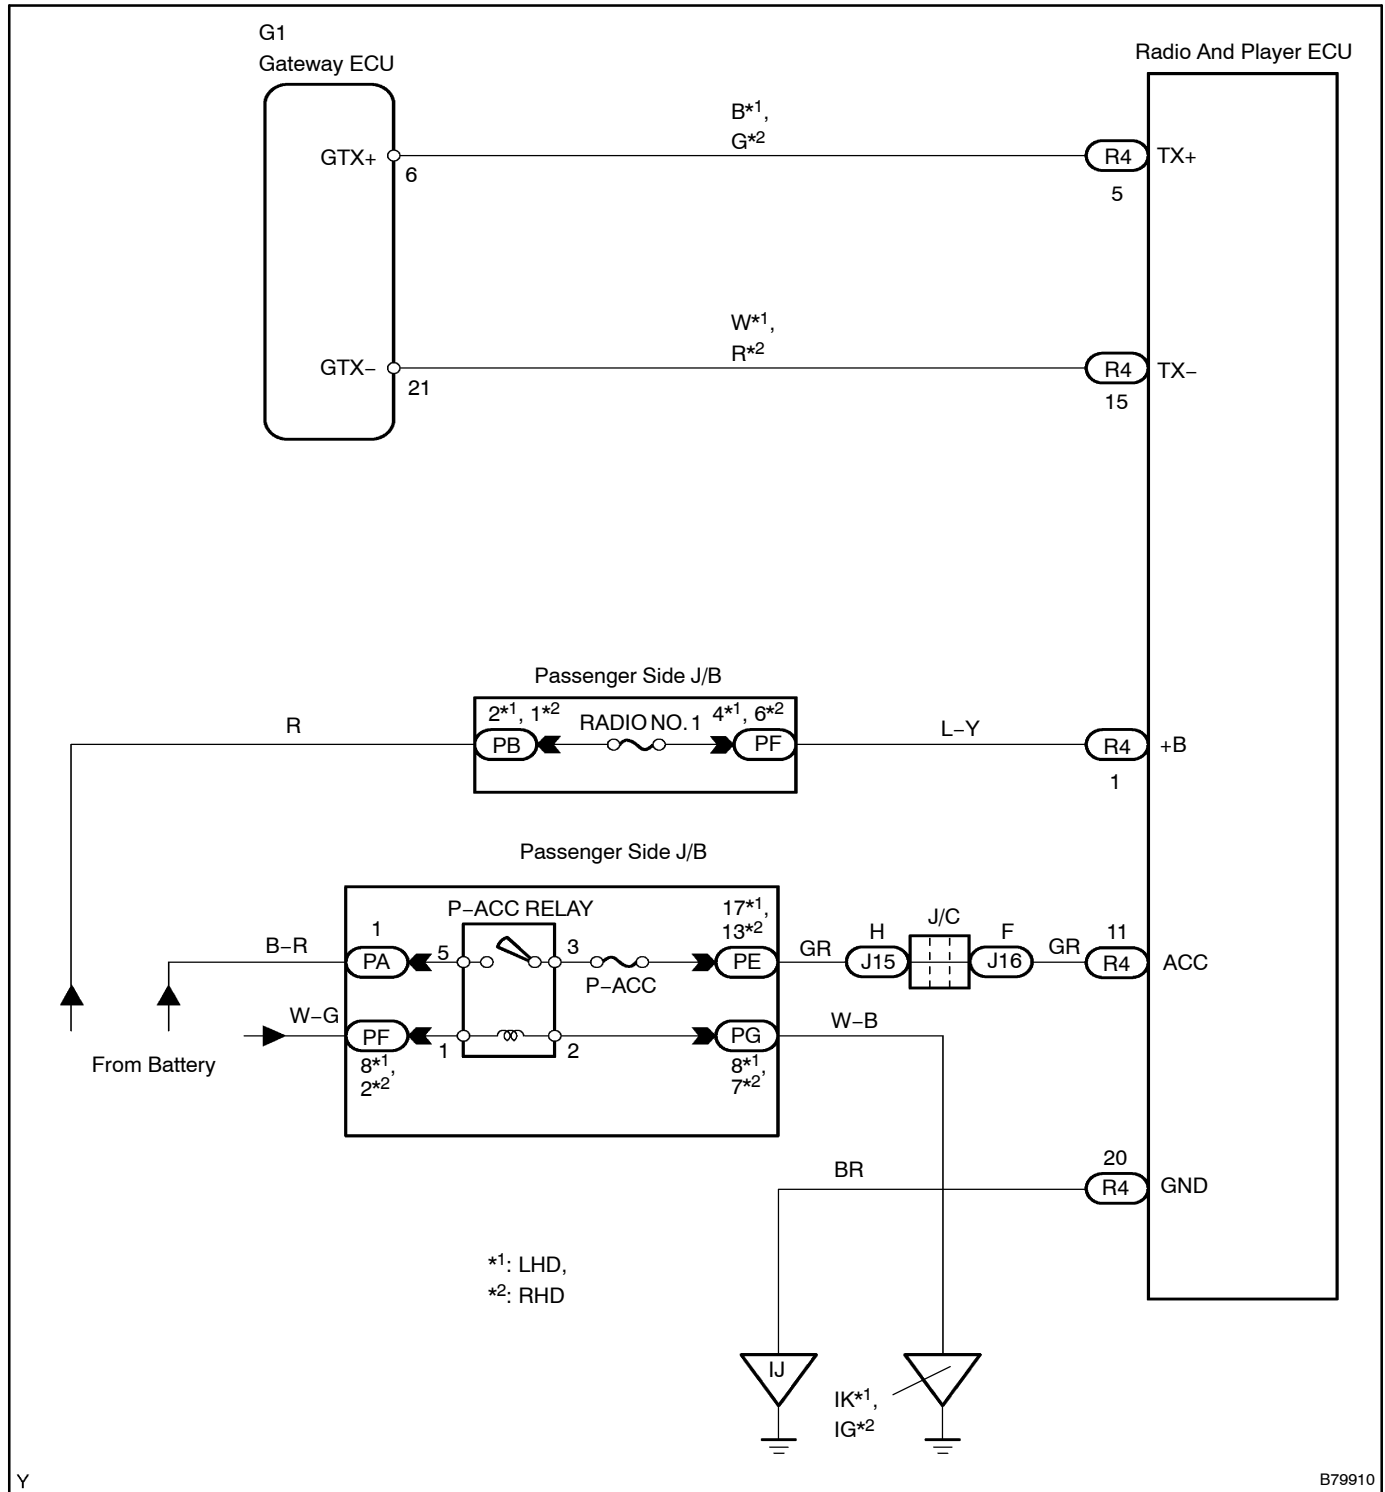
## WIRING DIAGRAM

This DTC is detected when communication is impossible between the radio and player ECU and gateway ECU.

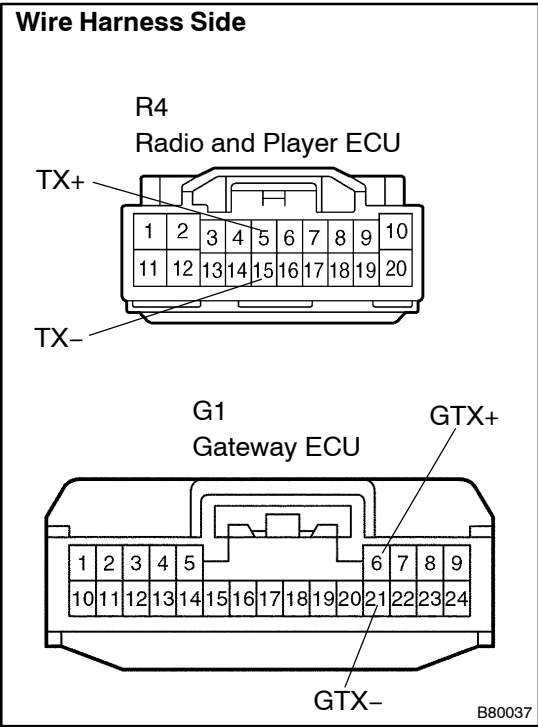
2 CHECK RESISTANCE OF COMMUNICATION LINE

- (a) Disconnect the R4 and G1 ECU connectors.  
(b) Measure the resistance between the wire harness side connectors.

| Tester Connection | Specified Condition |
|---|---|
| R4-5 (TX+) - G1-6 (GTX+) | Below 1 $\Omega$ |
| R4-15 (TX-) - G1-21 (GTX-) | Below 1 $\Omega$ |
