| <b>DTC</b> | <b>B1269</b> | <b>Theft deterrent ECU communication stop</b> |

## CIRCUIT INSPECTION

This DTC is output when communication stops between the theft deterrent ECU and the gateway ECU.

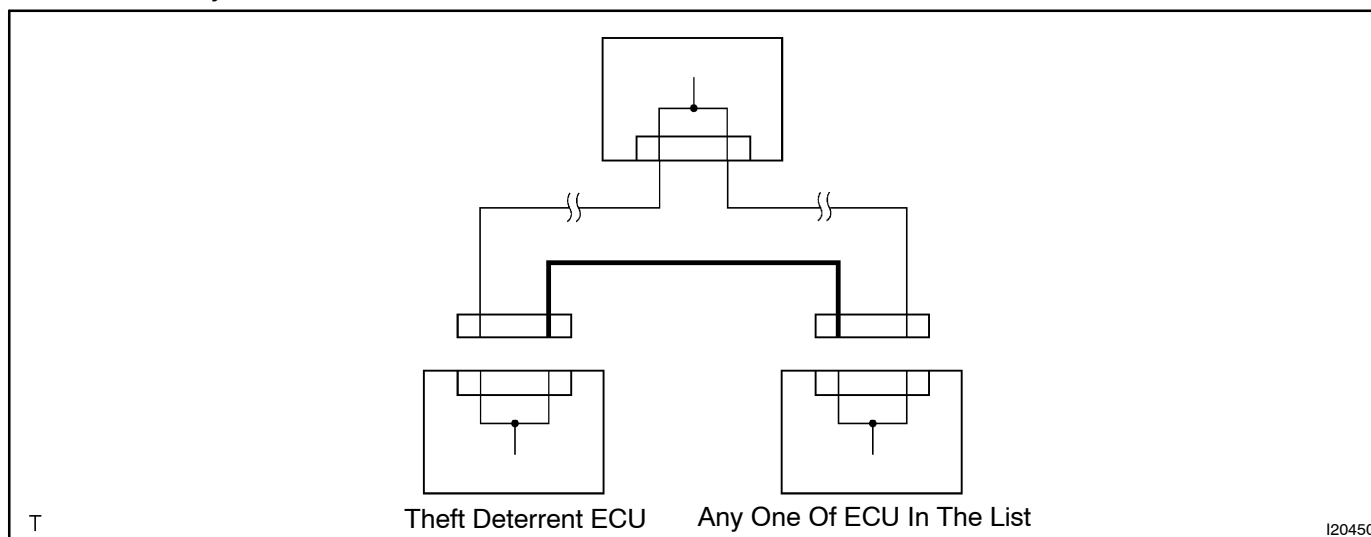
| Wire harness side connector of ECU | Terminal |
|---|---|
| Theft deterrent ECU - Gateway ECU | MPX2 (T5-33) - MPD1 (G1-4) |
| Theft deterrent ECU - Transponder key ECU (w/o Smart key system) | MPX1 (T5-13) - MPX2 (T9-5) |
| Theft deterrent ECU - Steering lock ECU (w/ Smart key system) | MPX1 (T5-13) - MPX2 (S27-6) |

### CHECK:

Check continuity of the wire harness between the connectors.
