| SERVICE BULLETIN | | No.: MSB-00E00-003 | |
| Subject: YEAR MODEL CHANGES FOR 2001 L200 | | | |

This Service Bulletin informs you of the year model changes for the 2001 L200

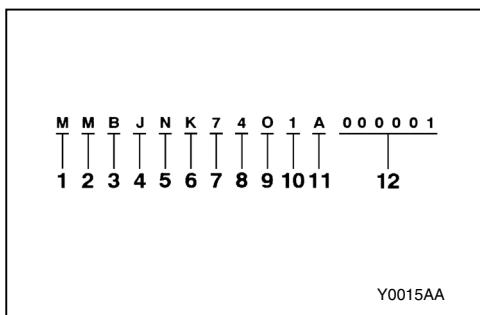
CHASSIS NUMBER

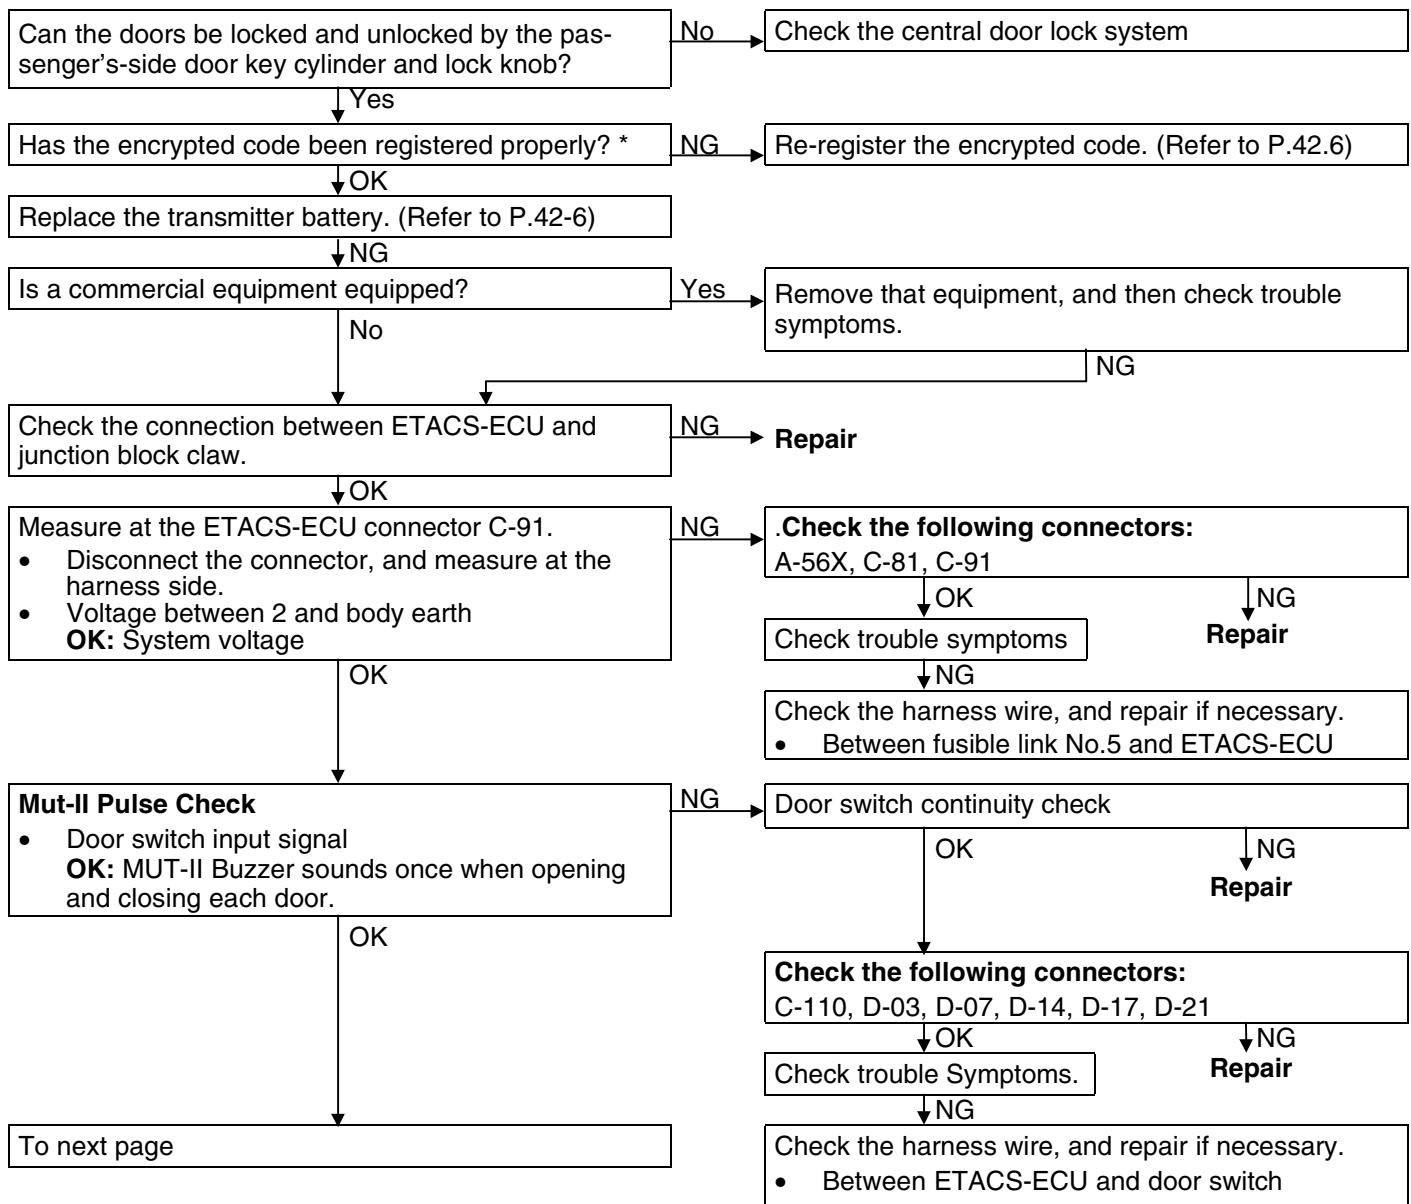
| None of the doors can be locked or unlocked using the transmitter. | Probable cause |
| <p>The cause may be a malfunction of the transmitter or ETACS-ECU, defective connection between ETACS-ECU and junction block, defective power supply voltage to ETACS-ECU input line due to commercial equipment, or the lock and unlock signals are not being sent to the ETACS-ECU.</p> | <ul style="list-style-type: none"> • Malfunction of transmitter • Malfunction of ETACS-ECU • Malfunction of key reminder switch • Malfunction of wiring harness or connector • Malfunction of door switch • Defective connection between ETACS-ECU and junction block • Defective power supply voltage to ETACS-ECU input line due to commercial equipment |

*: This should be done if a transmitter, receiver or ETACS-ECU has been replaced, and if a secret cod has not been registered properly

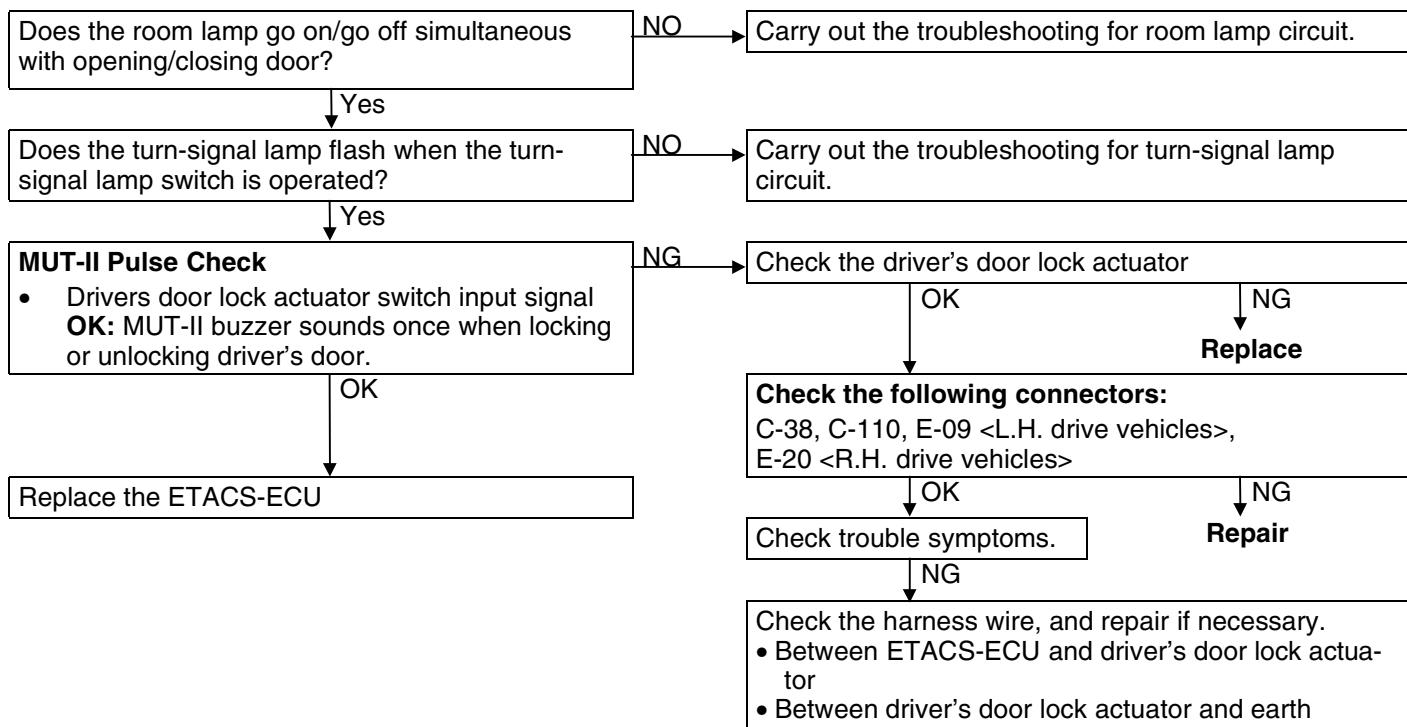
INSPECTION PROCEDURE 2

| All of the doors can be locked and unlocked using the transmitter, but the room lamp or turn-signal lamp does not flash or illuminate. (However, the room lamp operates normally when the doors are opened and closed.) | Probable cause |
| <p>If neither room lamp nor turn-signal lamp flash/illuminate, the cause may be a malfunction of the ETACS-ECU or driver's-side door lock actuator.</p> <p>If either room lamp or turn-signal lamp does not flash/illuminate, the cause may be a malfunction of the room lamp circuit or turn-signal lamp.</p> | <ul style="list-style-type: none"> Malfunction of ETACS-ECU Malfunction of driver's door lock actuator Burnt turn-signal lamp bulb Malfunction of connector or wiring harness |

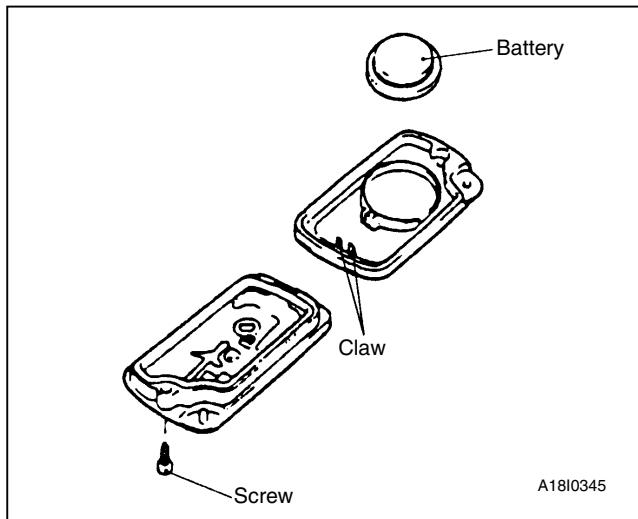
HOW TO REPLACE A BATTERY OF THE TRANSMITTER

1. Remove the set screw to remove the battery from the transmitter.
Install a battery with its (+) side face-down.
2. **Battery required for replacement:**
Coin type battery CR2032
3. Insert the claw, and then assemble the transmitter.
Caution
Do not let water or dust stick to the inside of the transmitter when it is open. Also, do not touch the precision electronic device.
4. Check to see if the keyless entry system operates.

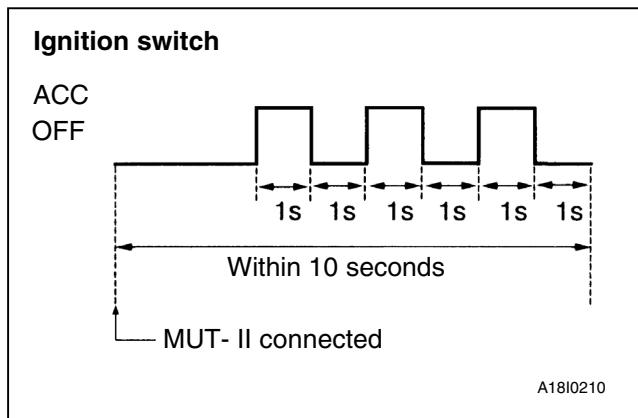
Always turn the ignition switch to OFF before connecting and disconnecting the MUT-II

3. Within 10 seconds after connecting the MUT-II, turn the ignition switch to ACC ON for 1 second and then to OFF for 1 second; repeat this procedure three times.

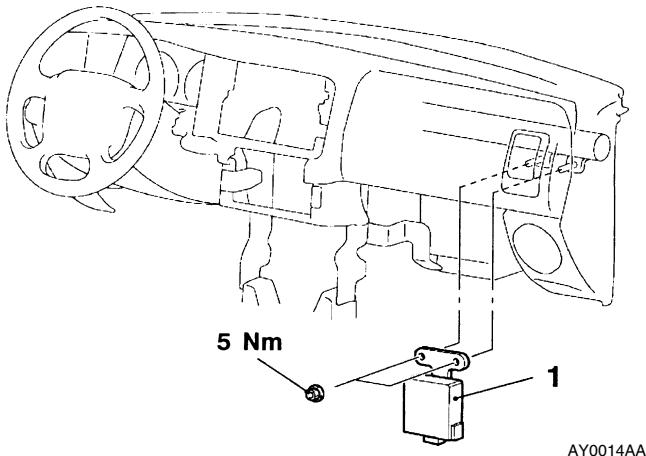
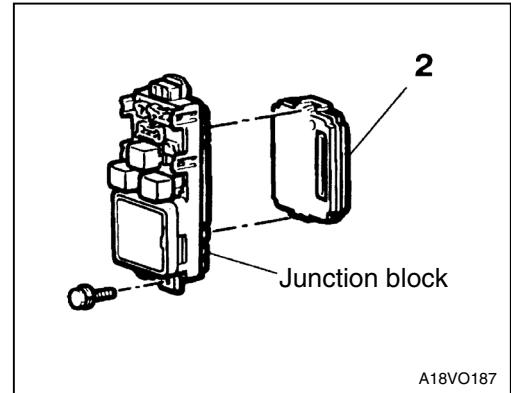
KEYLESS ENTRY SYSTEM REMOVAL AND INSTALLATION

Keyless entry receiver-ECU removal steps

- Glove box assembly (Refer to GROUP 52A*.)
- 1. Keyless entry receiver-ECU

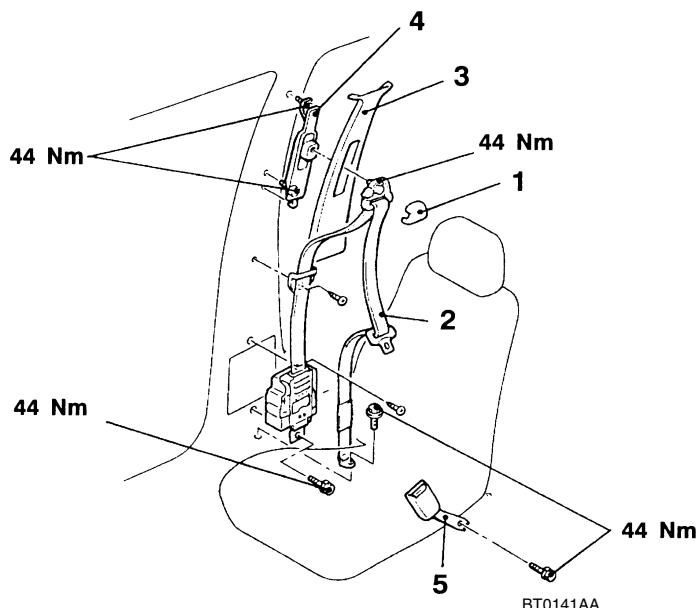
FRONT SEAT BELT REMOVAL AND INSTALLATION

Outer seat belt removal steps

- Center pillar trim, lower or quarter trim, lower (refer to P.52A*.)
- 1. Sash guide cover
- 2. Outer seat belt
- 3. Center pillar trim, upper or quarter trim, upper (refer to P.52A*.)
- 4. Adjustable seat belt anchor.

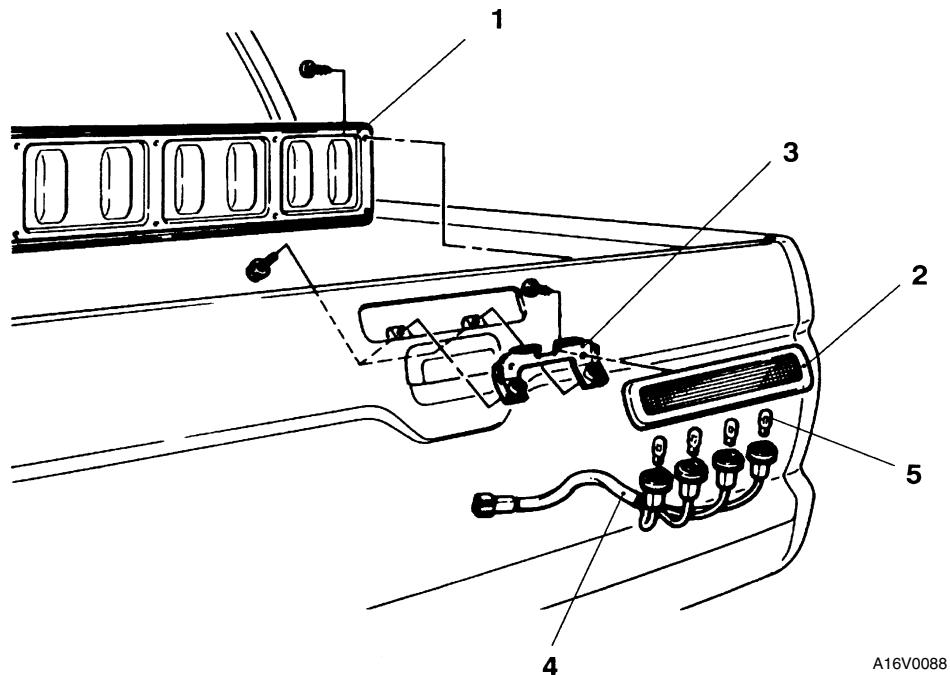
**HIGH-MOUNTED STOP LAMP
REMOVAL AND INSTALLATION**

A16V0088

Removal steps
