LANCER
***Evolution* VIII**
MR

SERVICE MANUAL

Supplement

'04-2
No.1036K10

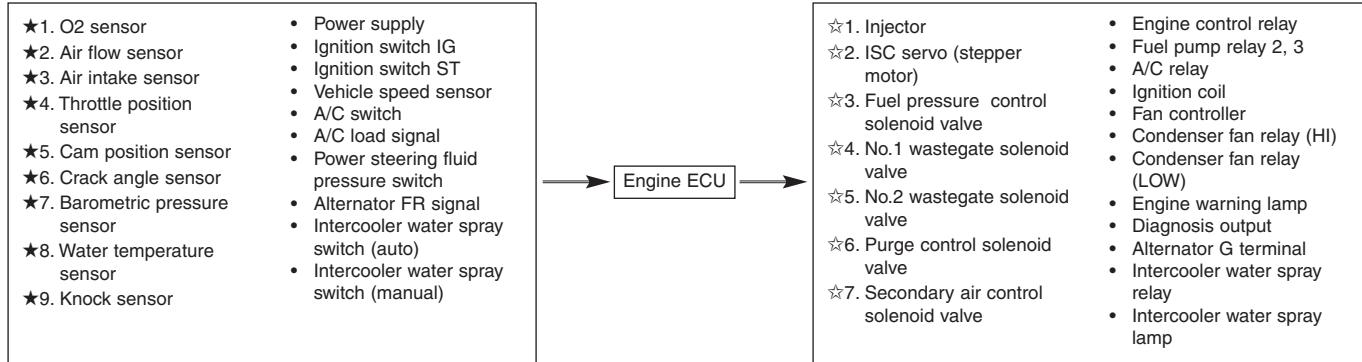
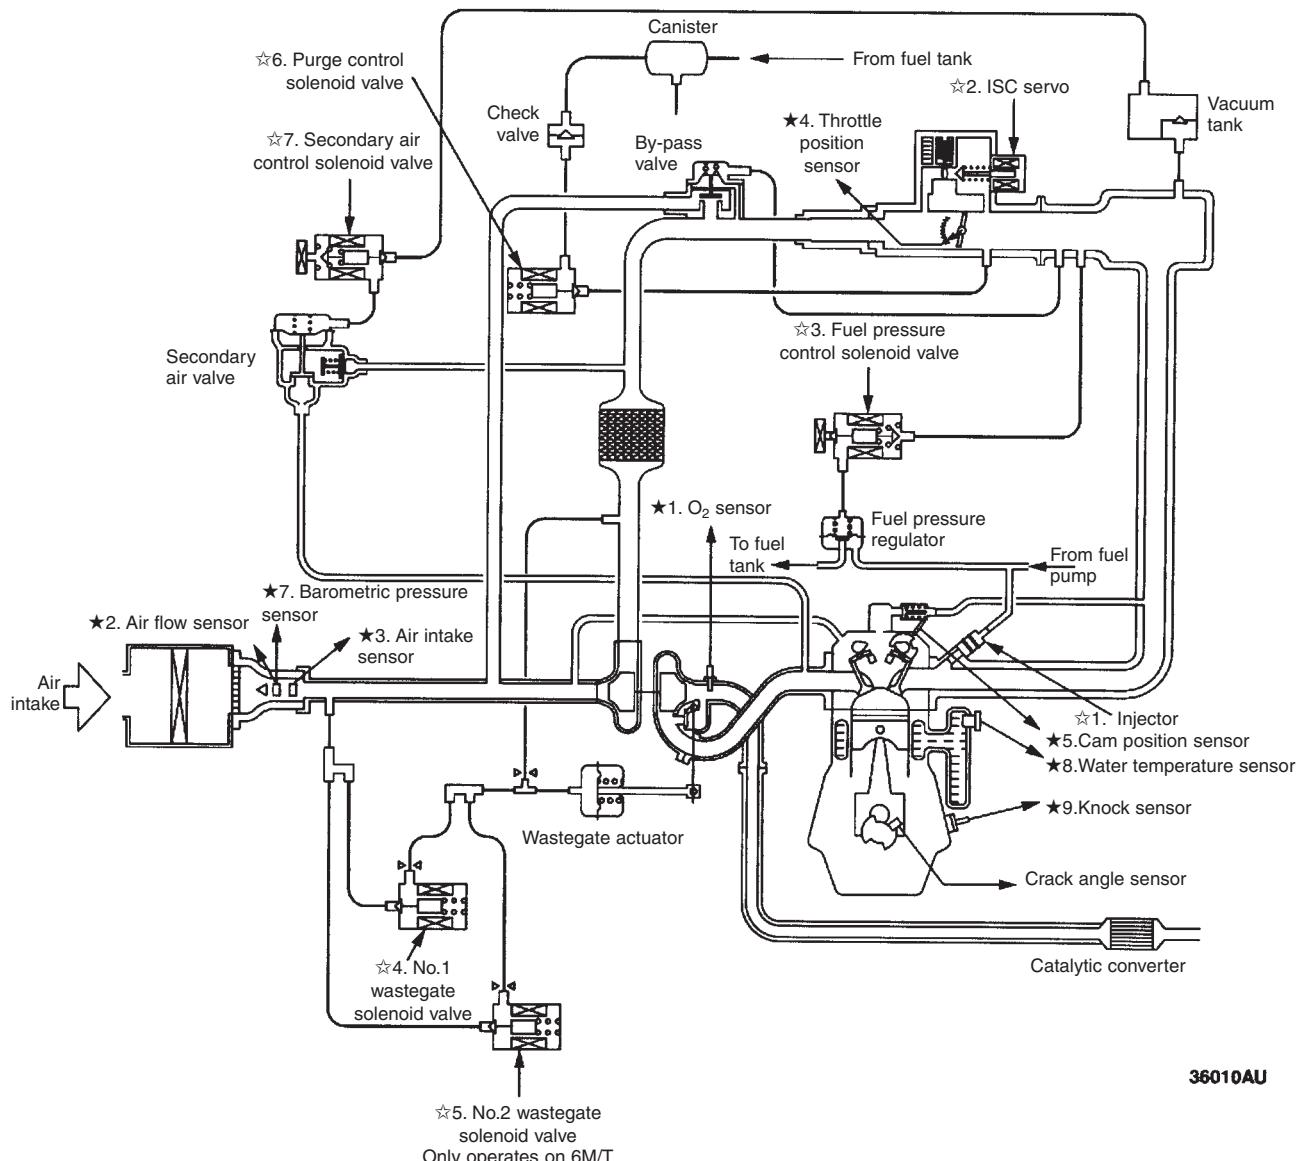
MPI system diagram

- Change from one to two wastegate solenoid valves. However, the No.2 wastegate solenoid valve on the 5 M/T is not functional.
- Diagnosis code No. P1500 changed to P0622. <6M/T>

Only operates on 6M/T

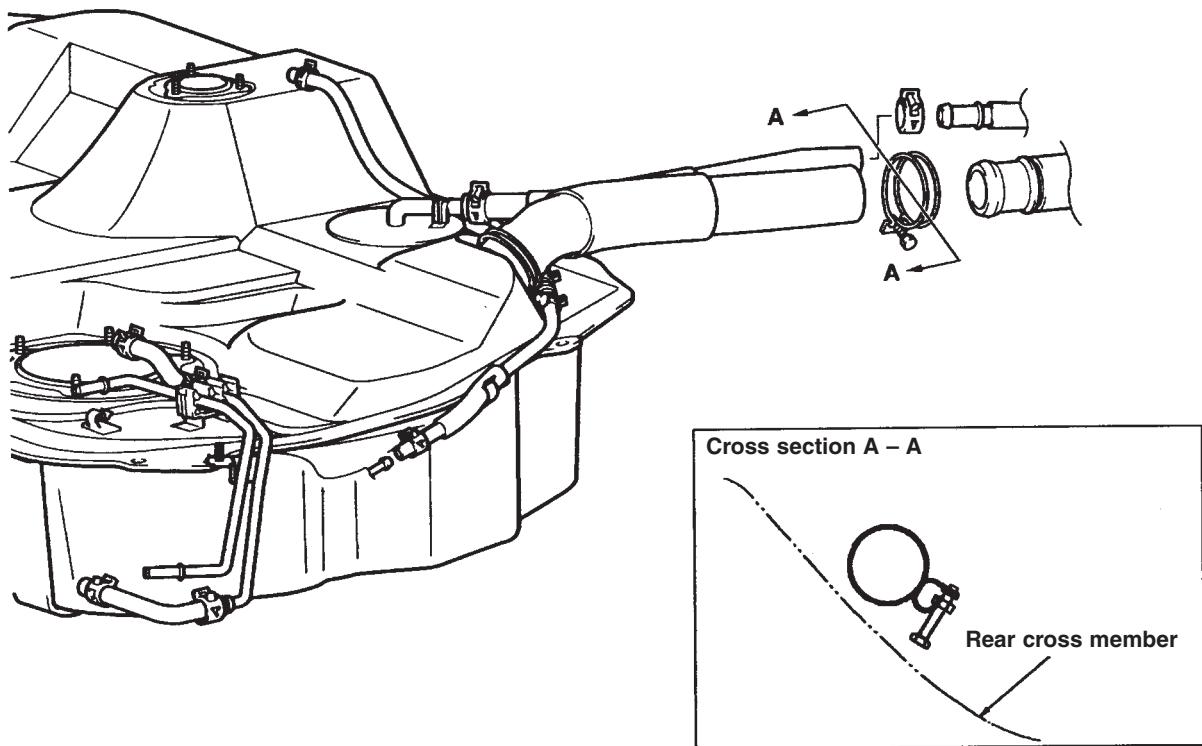
AC400023AB

As well as changing the filler neck hose clamp from an M6 x 39 to M6 x 49, the mounting position has been changed. There were no changes other than the following.

Fit the filler neck hose clamp so that it does not interfere with the rear cross member.

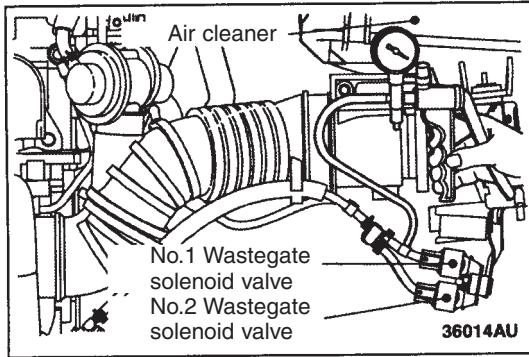
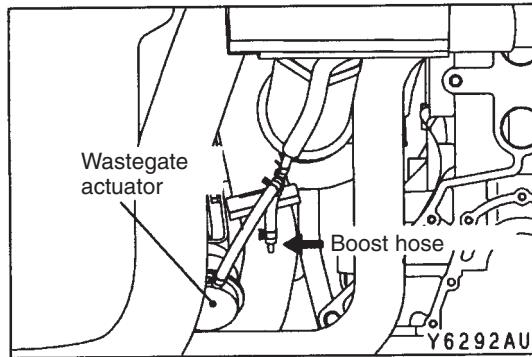
- (1) Remove the hose (black) from the No.1 wastegate solenoid valve, and fit the pressure gauge to this hose. Fit a plug to solenoid valve nipple from which the hose (black) has been removed.
- (2) Remove the No.2 wastegate solenoid valve connector.
- (3) Accelerate at full throttle in 2nd gear, and then take the boost pressure measurement when engine speed gets to at least 3,000rpm.

- (4) When the boost pressure is lower than the standard value, the cause could be one of the following:
 1. Wastegate actuator misoperation
 2. Boost pressure leak
 3. Turbocharger NG
- (5) When boost pressure is higher than standard value, the boost pressure control may be faulty, so please check the following points.

- 1) Wastegate actuator misoperation
- 2) Wastegate valve misoperation
- 3) Wastegate actuator rubber hose detachment, cracking.

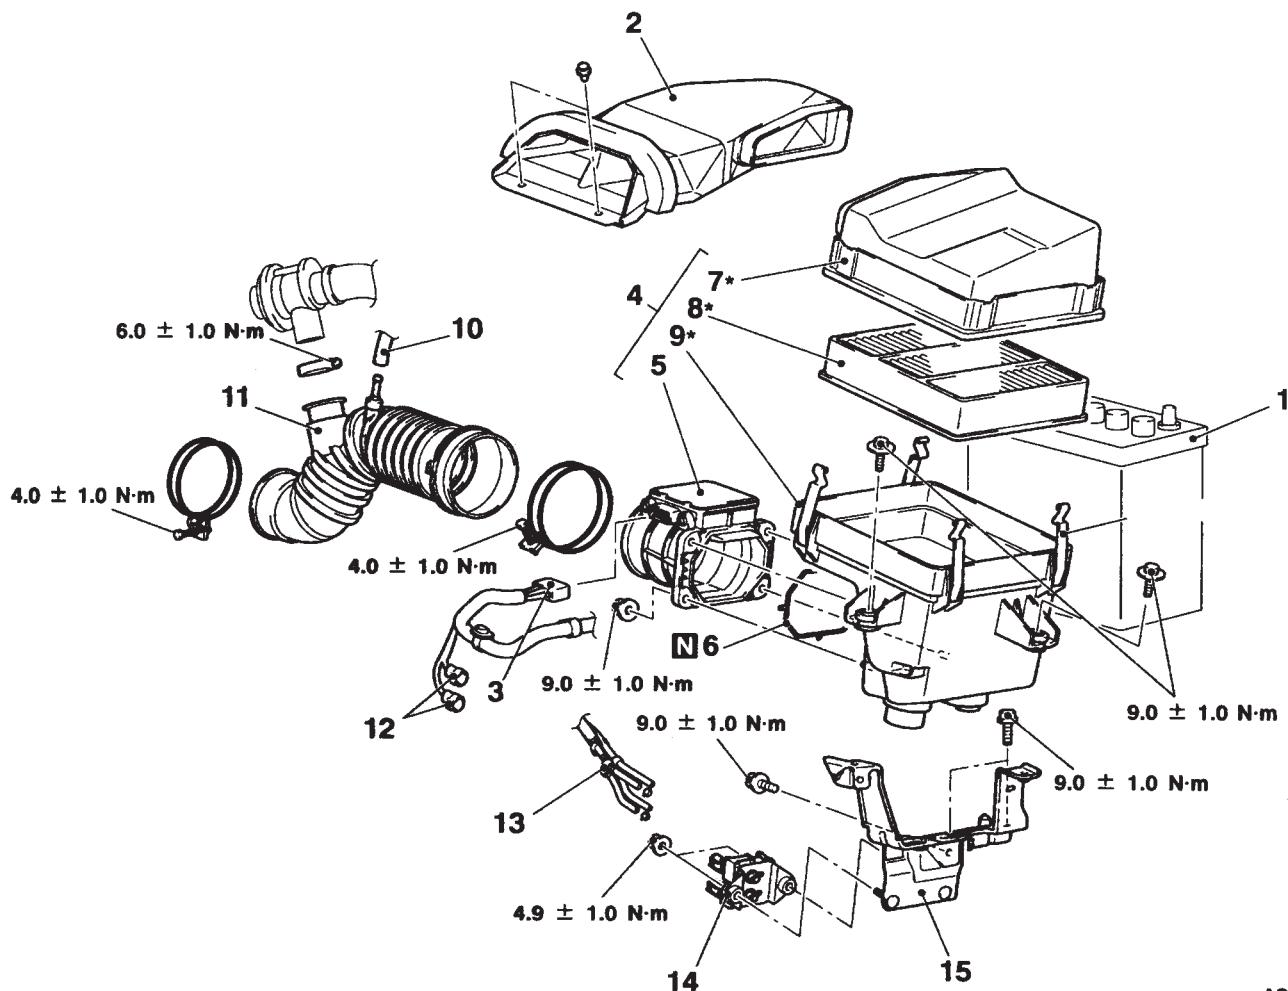
AC314157AB

The parts marked with a ★ symbol are plastic components which contain recycled paper. Please note the following:

1. Battery
2. Air duct
3. Air flow sensor connector
4. Air cleaner assembly
5. Air flow sensor
6. Gasket
7. Air cleaner cover
8. Air cleaner element
9. Air cleaner body assembly
10. Vacuum hose

- Air pipe E, air hose D, air by-pass valve assembly, air by-pass hose.
- Oil level gauge assembly
- 11. Air intake hose
- 12. Wastegate solenoid valve connector
- 13. Vacuum hose connection
- 14. Wastegate solenoid valve assembly
- 15. Air cleaner bracket

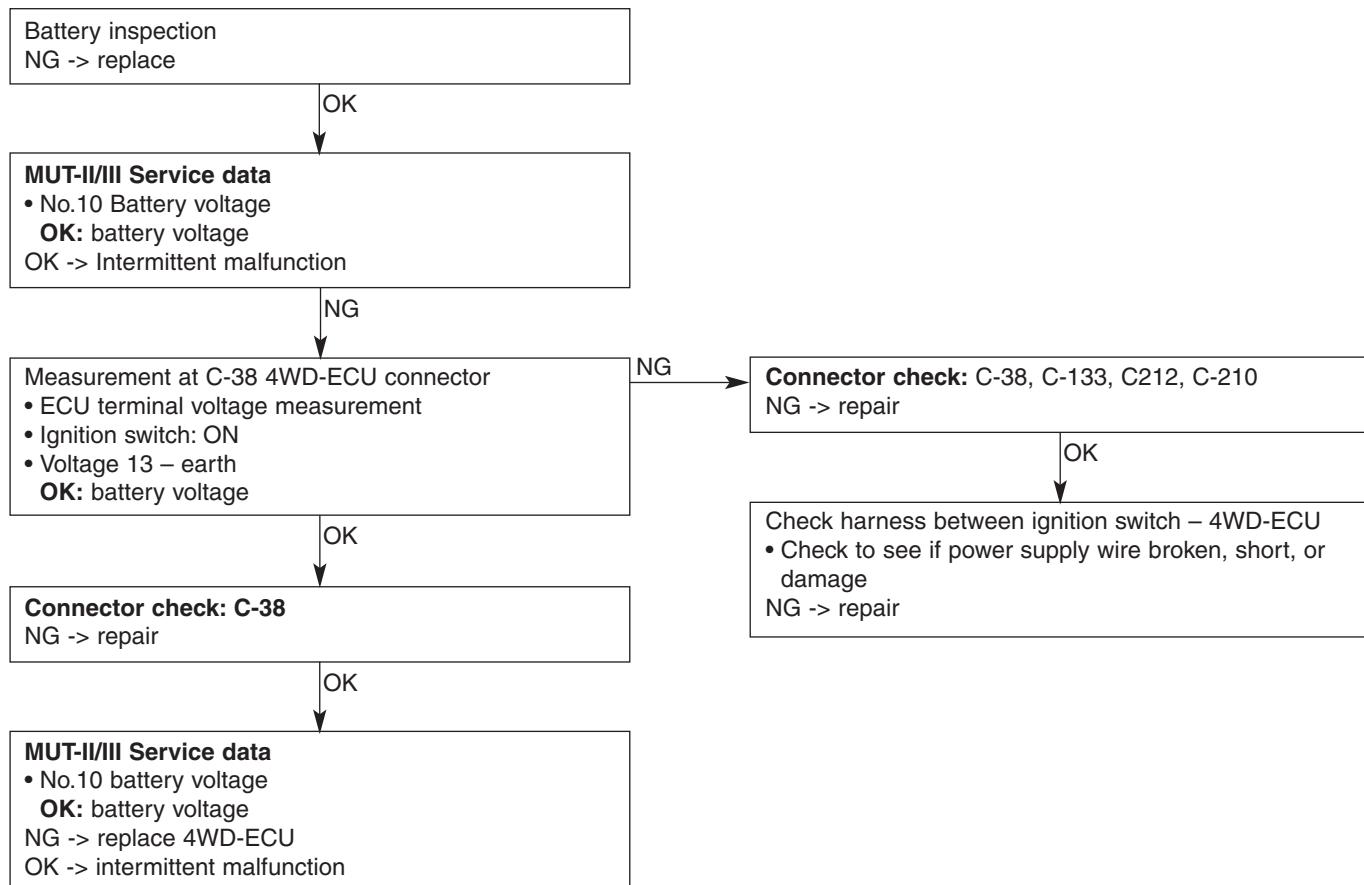
Code No.12 Power supply voltage (valve power supply) system	Assumed cause of concern
If the 4WD-ECU power supply voltage drops below 9V or rises above 18V, Code No.12 is output, indicating either a broken wire in the power supply circuit, a short, or a drop in the battery voltage.	<ul style="list-style-type: none"> • battery malfunction • harness, connector malfunction • 4WD-ECU malfunction

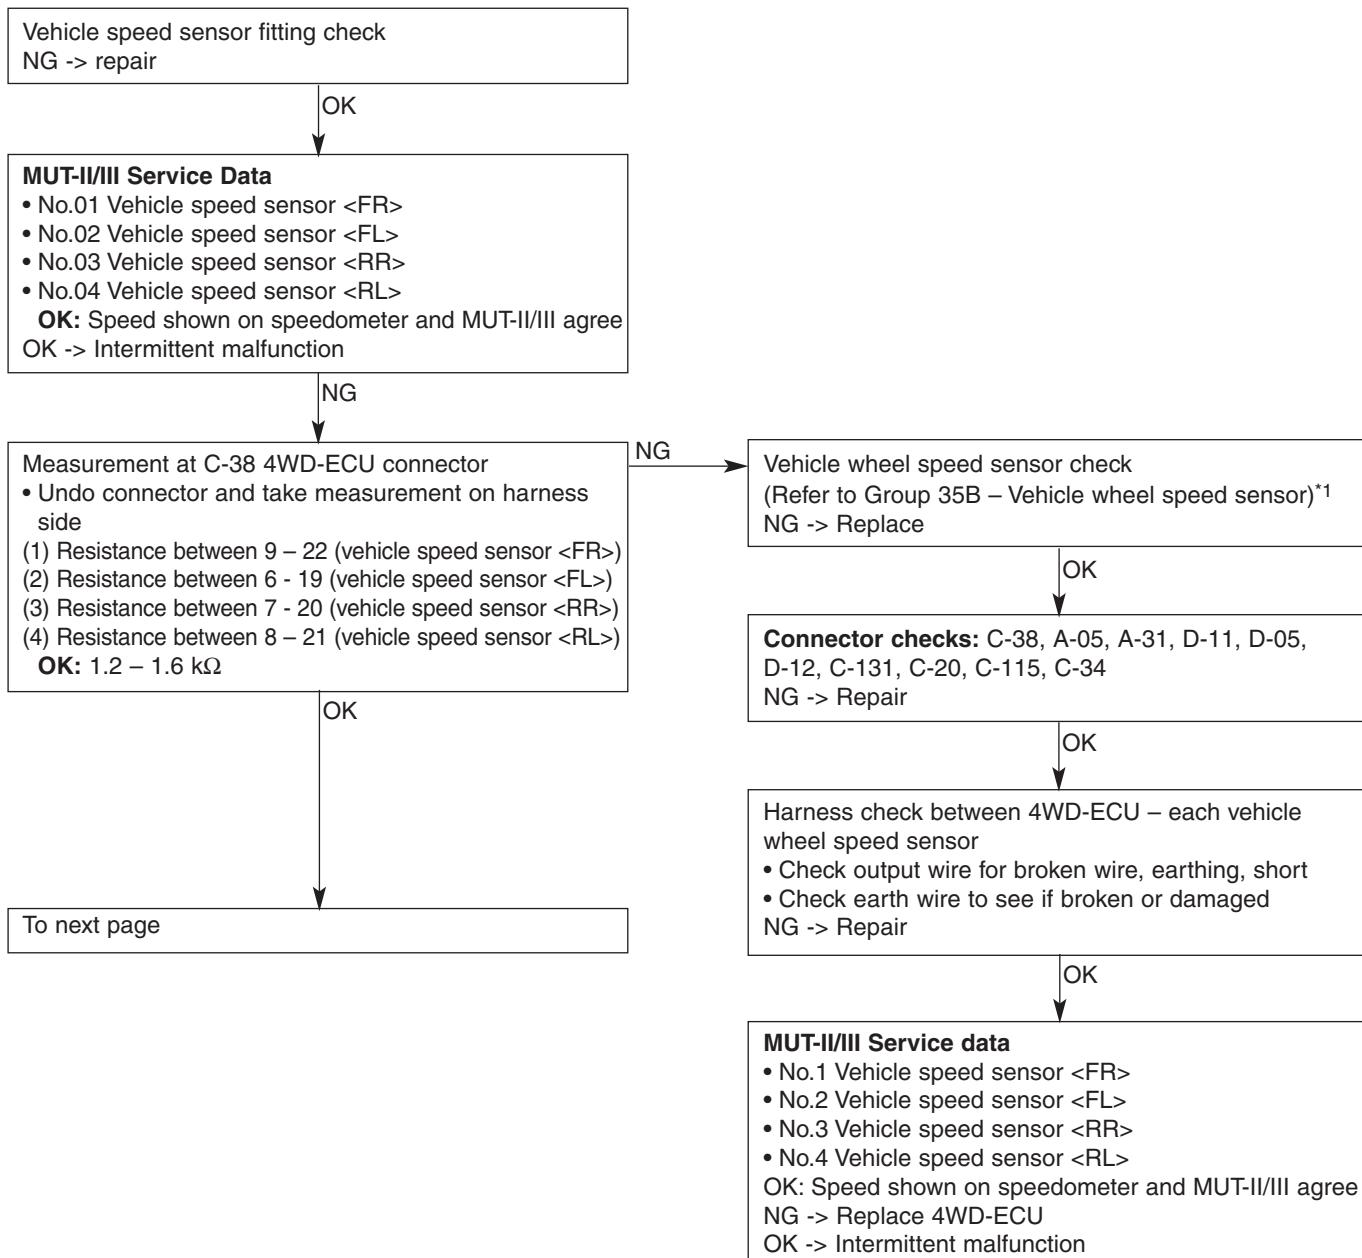
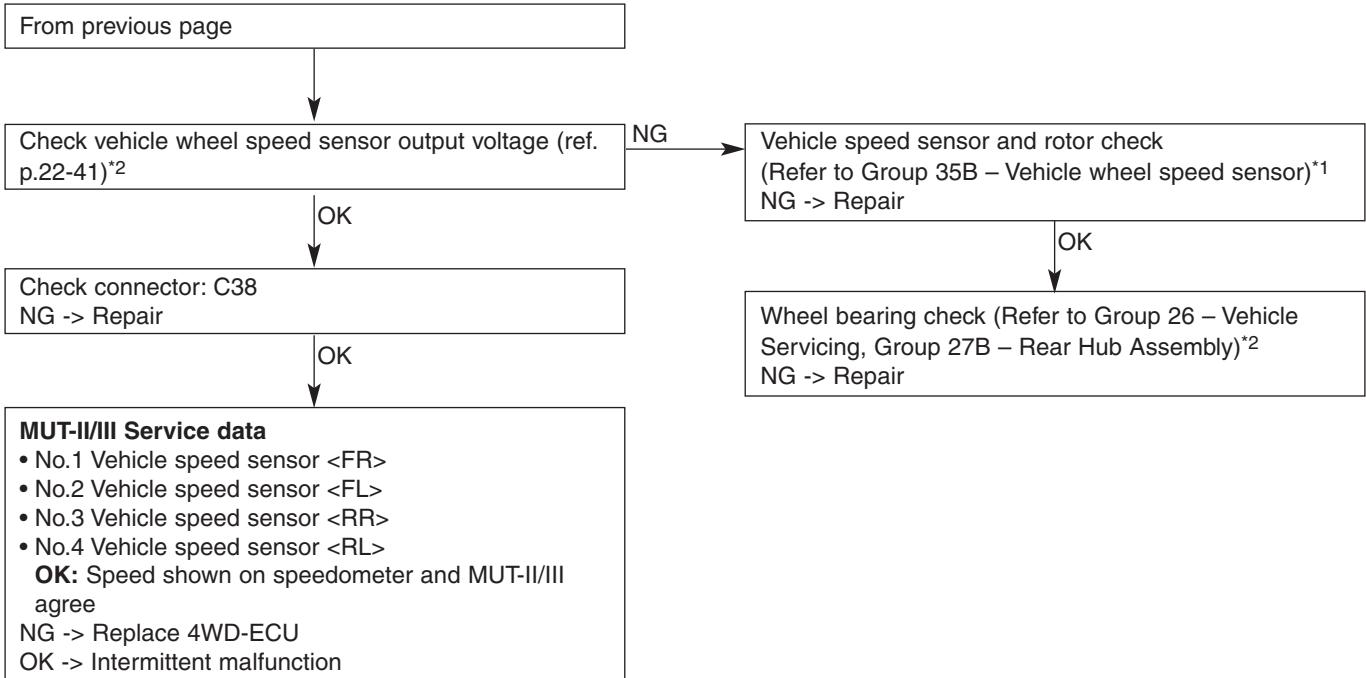
Code No.21 Vehicle wheel speed sensor <FR> systems Code No.22 Vehicle wheel speed sensor <FL> systems Code No.23 Vehicle wheel speed sensor <RR> systems Code No.24 Vehicle wheel speed sensor <RL> systems	Assumed cause of concern
When one of the vehicle wheel speed sensors detects a vehicle speed of 15kph or more, and when even one of the remaining 3 sensors cannot detect vehicle speed, the diagnosis code for wheel speed sensor broken wire or short is output.	<ul style="list-style-type: none"> • Wheel speed sensor malfunction • Rotor malfunction • Wheel bearing malfunction • Harness, connector malfunction • 4WD-ECU malfunction

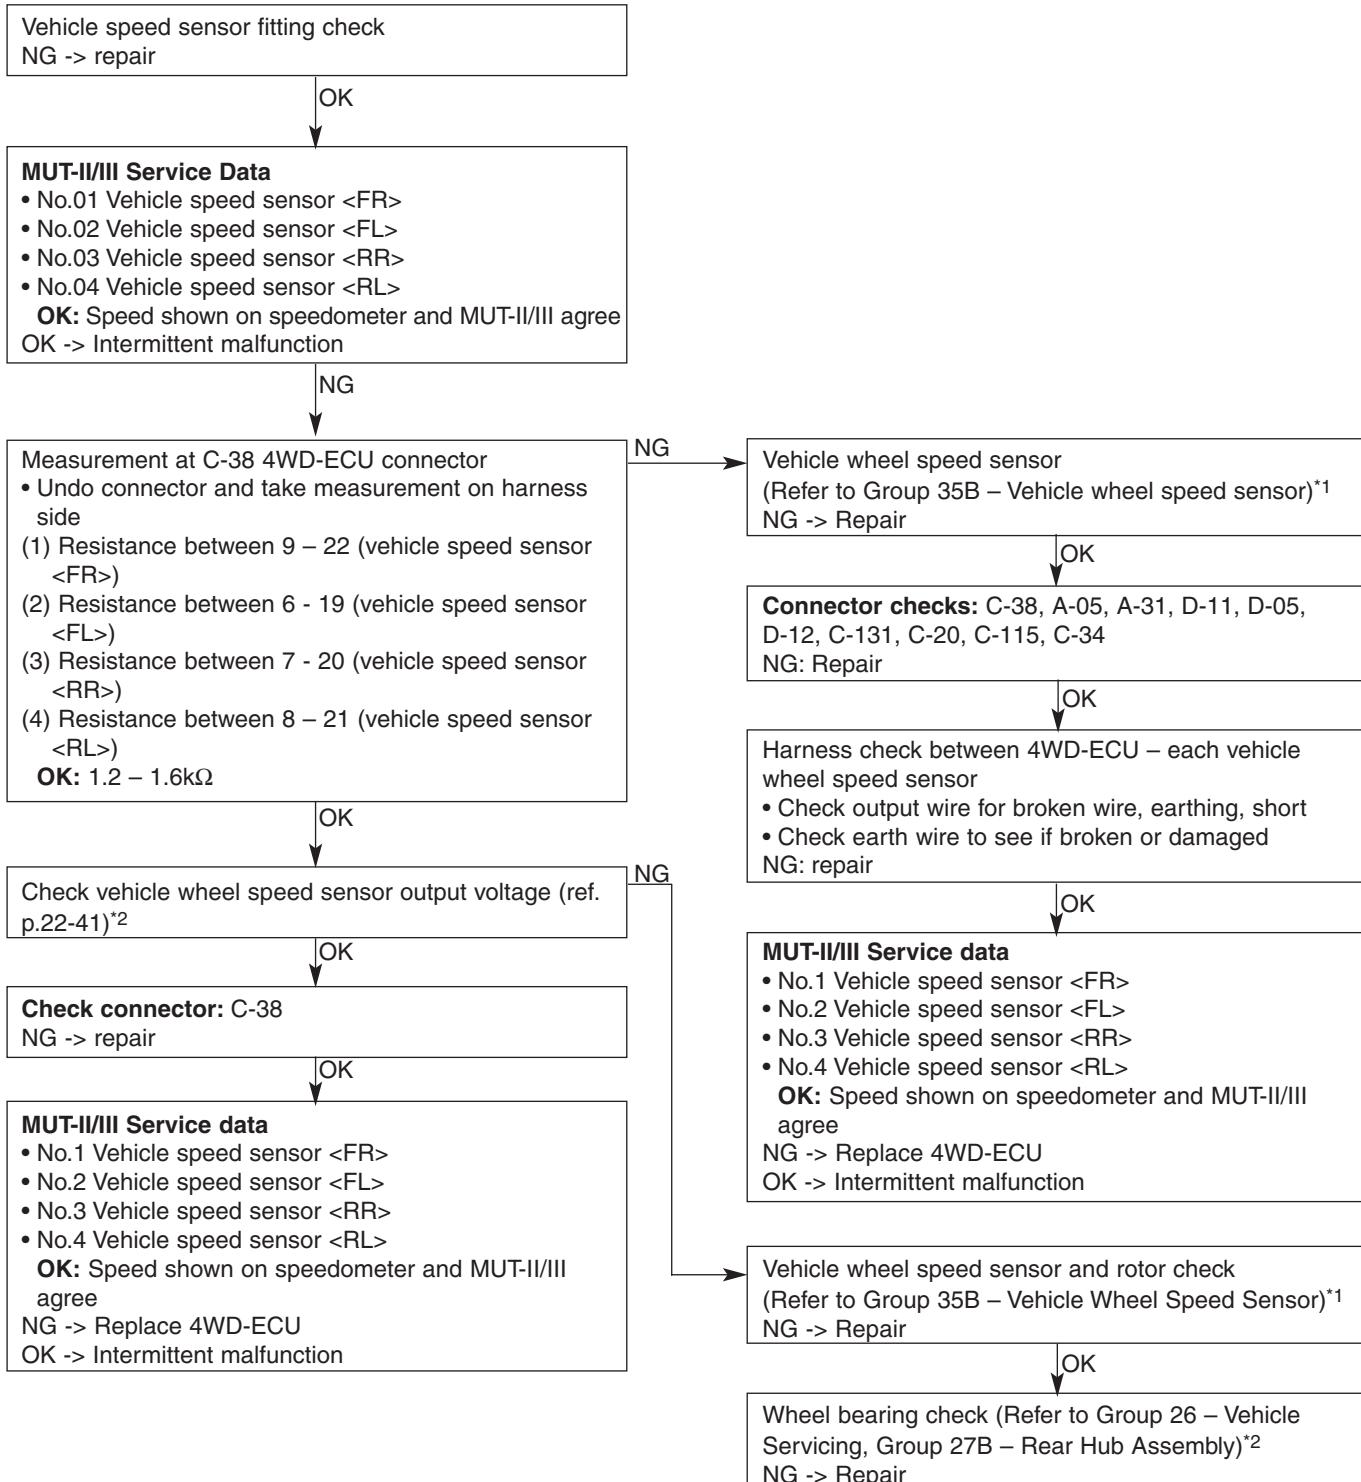
Code No.25 Abnormal tyre diameter	Assumed cause of concern
Abnormal tyre Code No. 25 is output in cases where, when the steering wheel is in a central position, and vehicle speed is 20kph or more, there is a discrepancy between one of the vehicle wheel speed sensors and the average of the 4 wheel speed sensors, in that it is outside the specified range. However, the warning lamp does not come on.	<ul style="list-style-type: none"> • Tyre malfunction • Vehicle speed sensor malfunction • Rotor malfunction • Wheel bearing malfunction • Harness, connector malfunction • 4WD-ECU malfunction

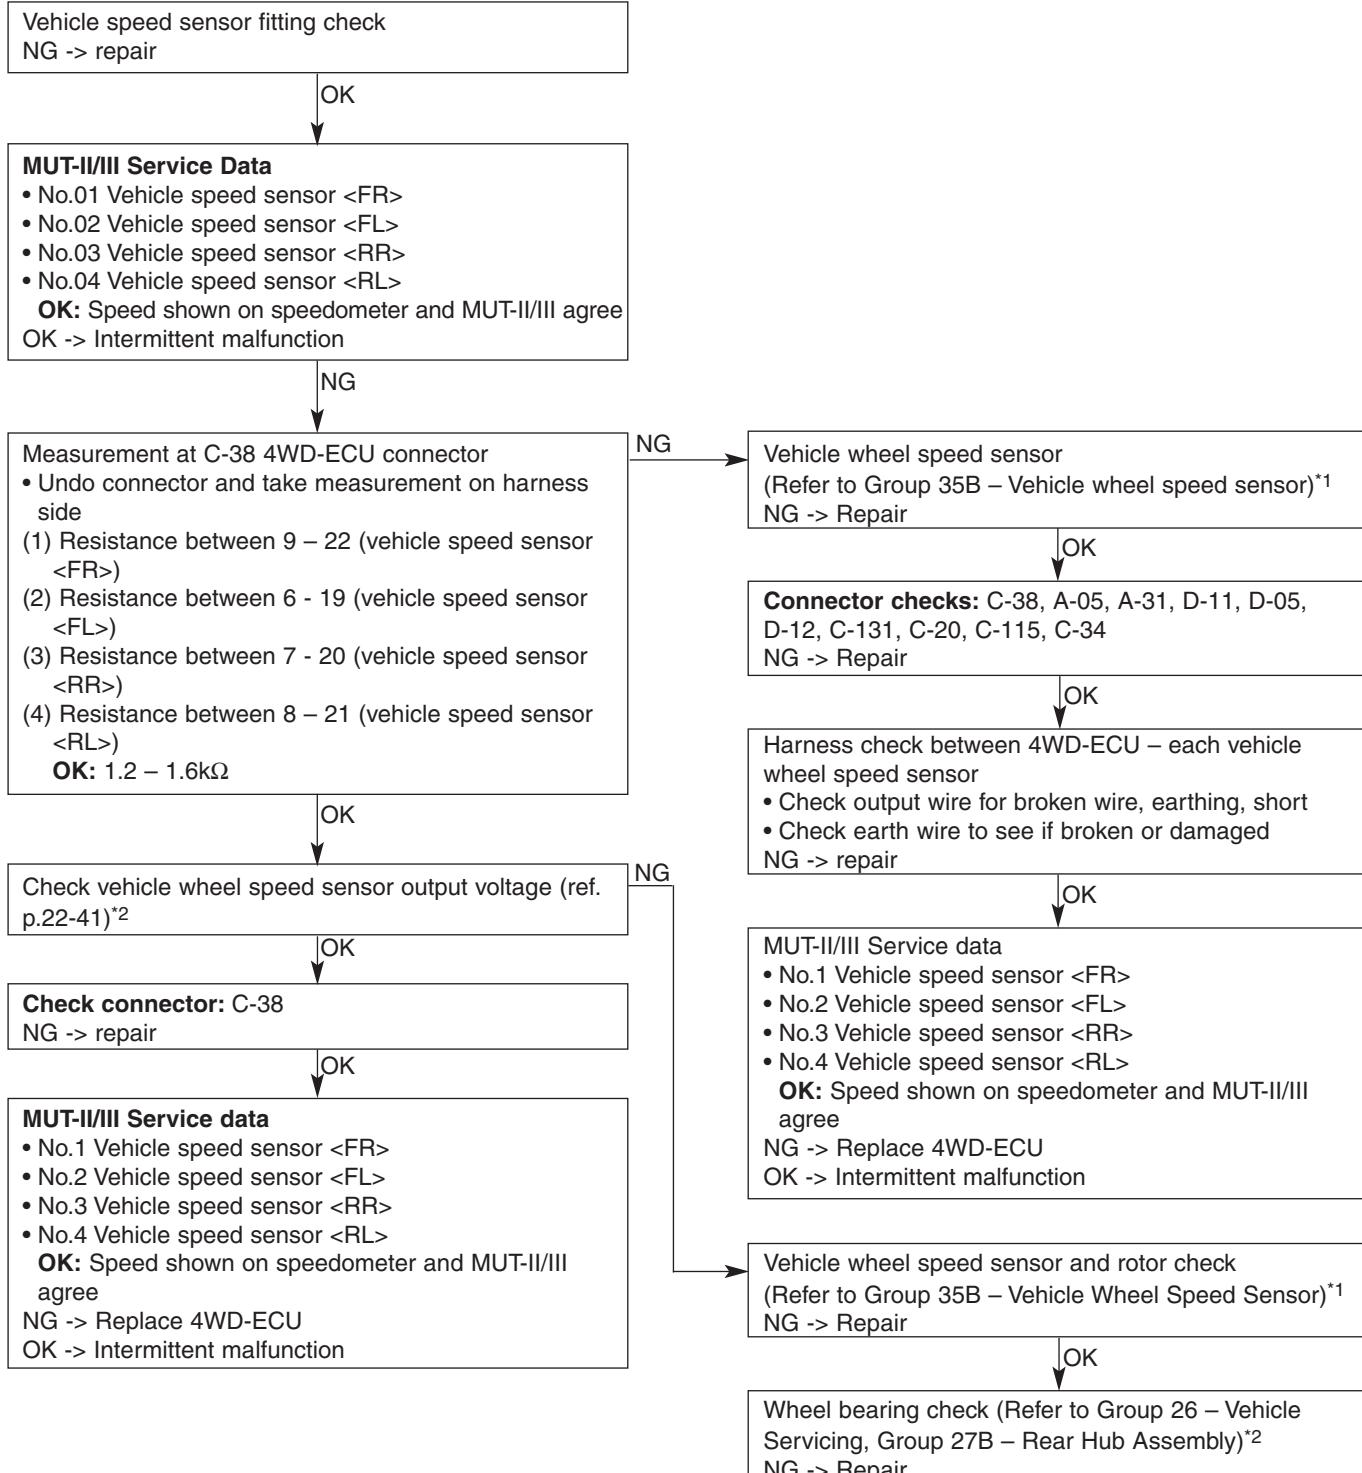
Code No.26 Vehicle wheel speed sensor system (output signal abnormal)	Assumed cause of concern
Abnormal vehicle wheel speed sensor Code No. 26 is output in cases where, when the vehicle speed is 20kph or more, one of the vehicle wheel speed sensors is outside the specified range. However, the warning lamp does come on.	<ul style="list-style-type: none"> • Tyre malfunction • Vehicle speed sensor malfunction • Rotor malfunction • Wheel bearing malfunction • Harness, connector malfunction • 4WD-ECU malfunction

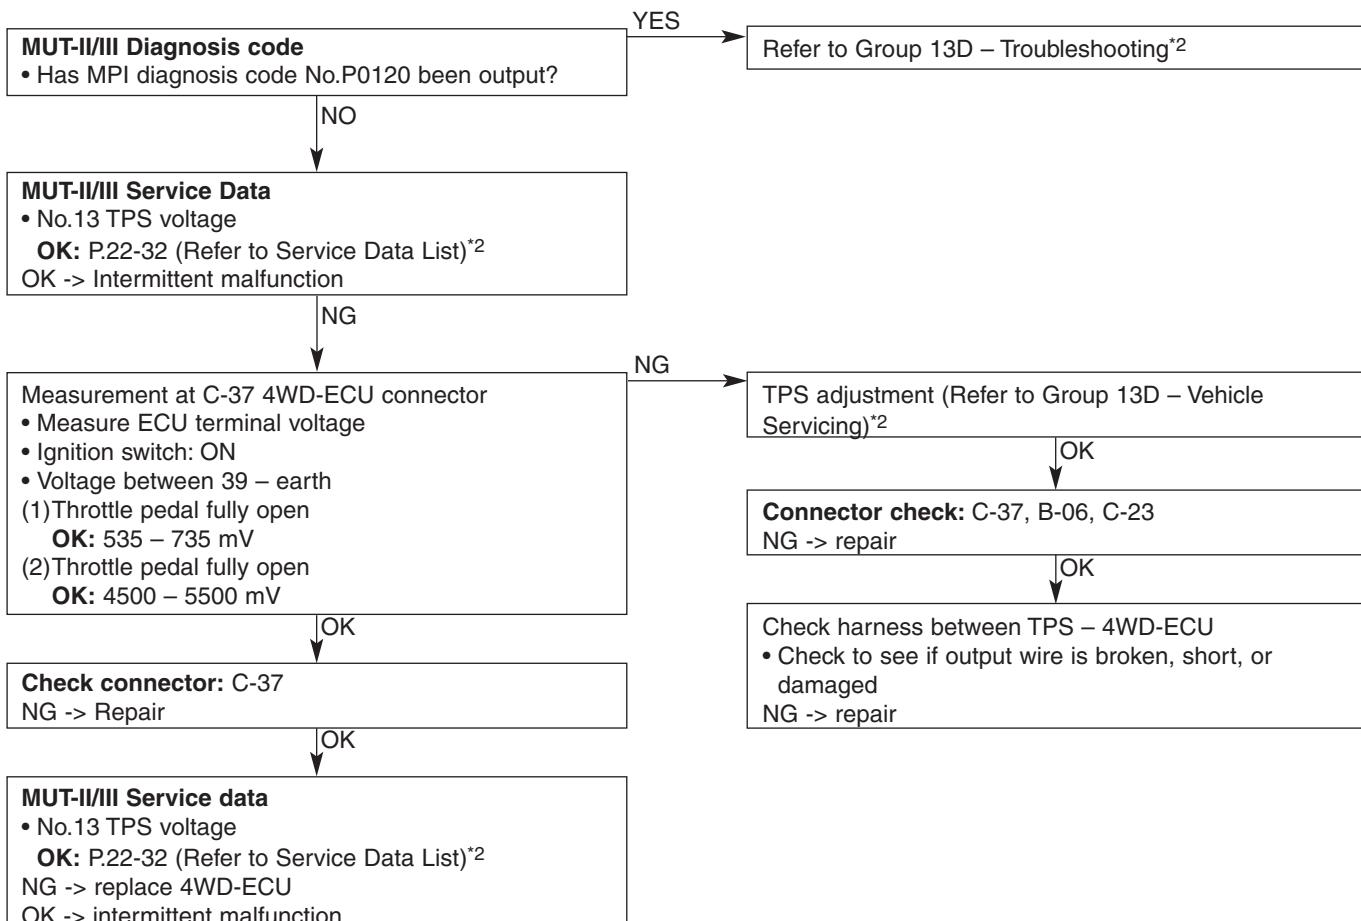
Code No.41, 42 TPS system	Assumed cause of concern
<p>If, when idling, TPS output is 0.2V or less, code No.41 is output, indicating that output is too low. If, at 10kph or less, TPS output is 4.8V or more for a period of 2 minutes or more, code No.42 is output, indicating output is too high.</p>	<ul style="list-style-type: none"> • TPS malfunction • Harness, connector malfunction • 4WD-ECU malfunction

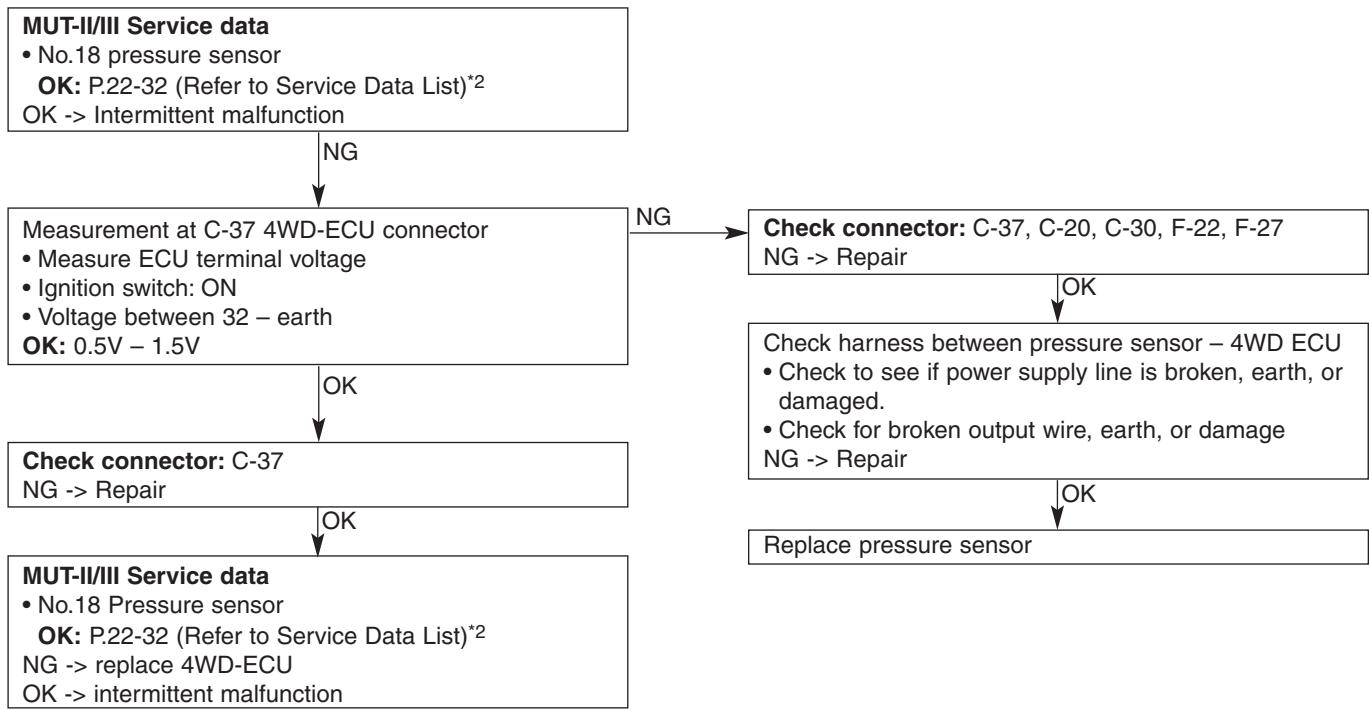
Code No.45 Pressure sensor system (broken wire or earth)	Assumed cause of concern
Code No.45 is output when output signal from pressure sensor is 0.2V or less.	<ul style="list-style-type: none"> • Harness, connector malfunction • Pressure sensor malfunction • 4WD-ECU malfunction

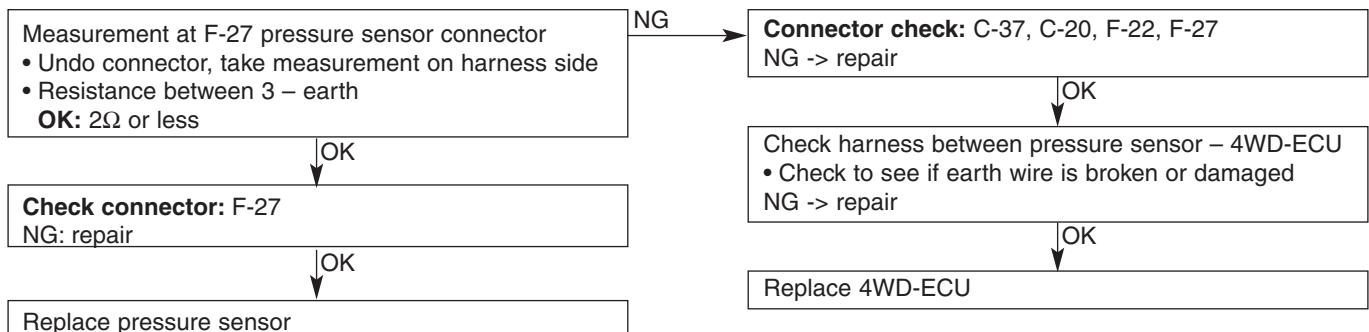
Code No.46 Pressure sensor system (earth wire broken)	Assumed cause of concern
Code No.46 is output when output signal from pressure sensor is 2.0V or more.	<ul style="list-style-type: none"> • Harness, connector malfunction • Pressure sensor malfunction • 4WD-ECU malfunction

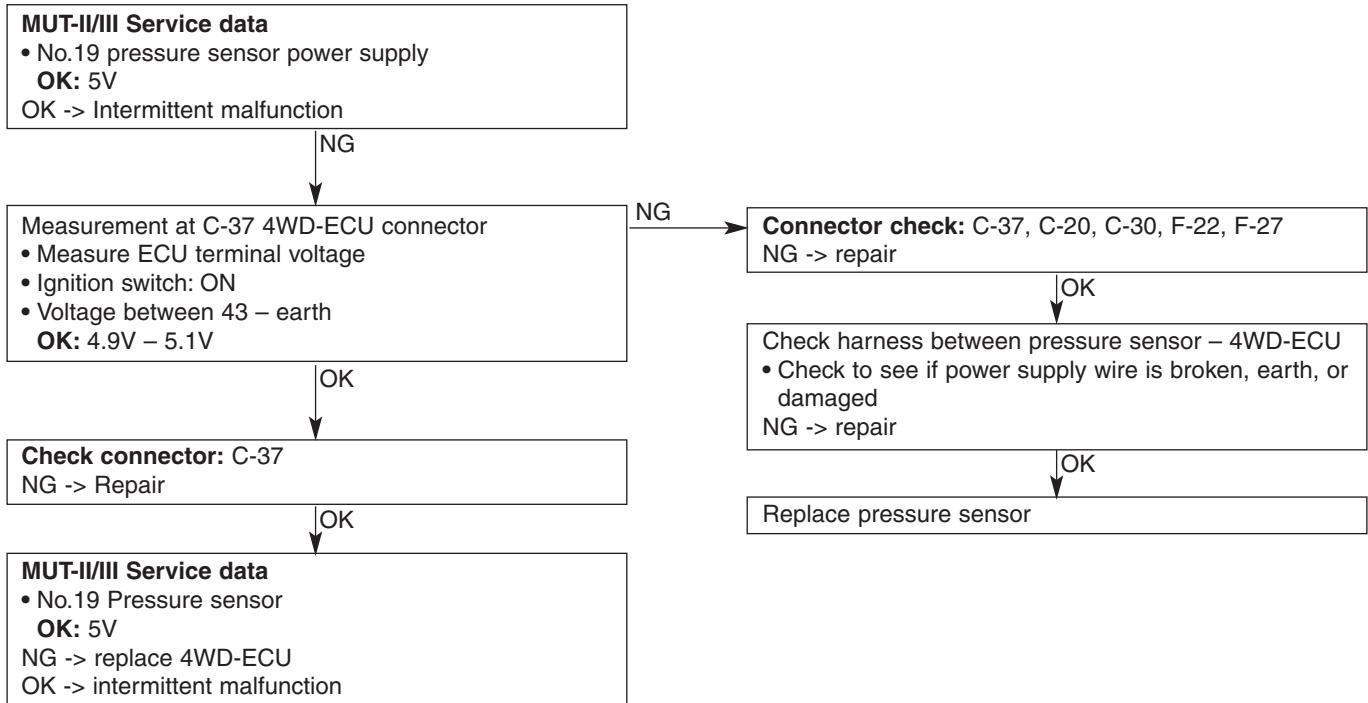
Code No.47 Pressure sensor system (abnormal power supply)	Assumed cause of concern
Code No.47 is output when, with pressure sensor power supply OFF, the pressure sensor power supply voltage is 4.0V or more, and when pressure sensor power supply is ON, the pressure sensor power supply voltage is 4.0V or less.	<ul style="list-style-type: none"> • Harness, connector malfunction • Pressure sensor malfunction • 4WD-ECU malfunction

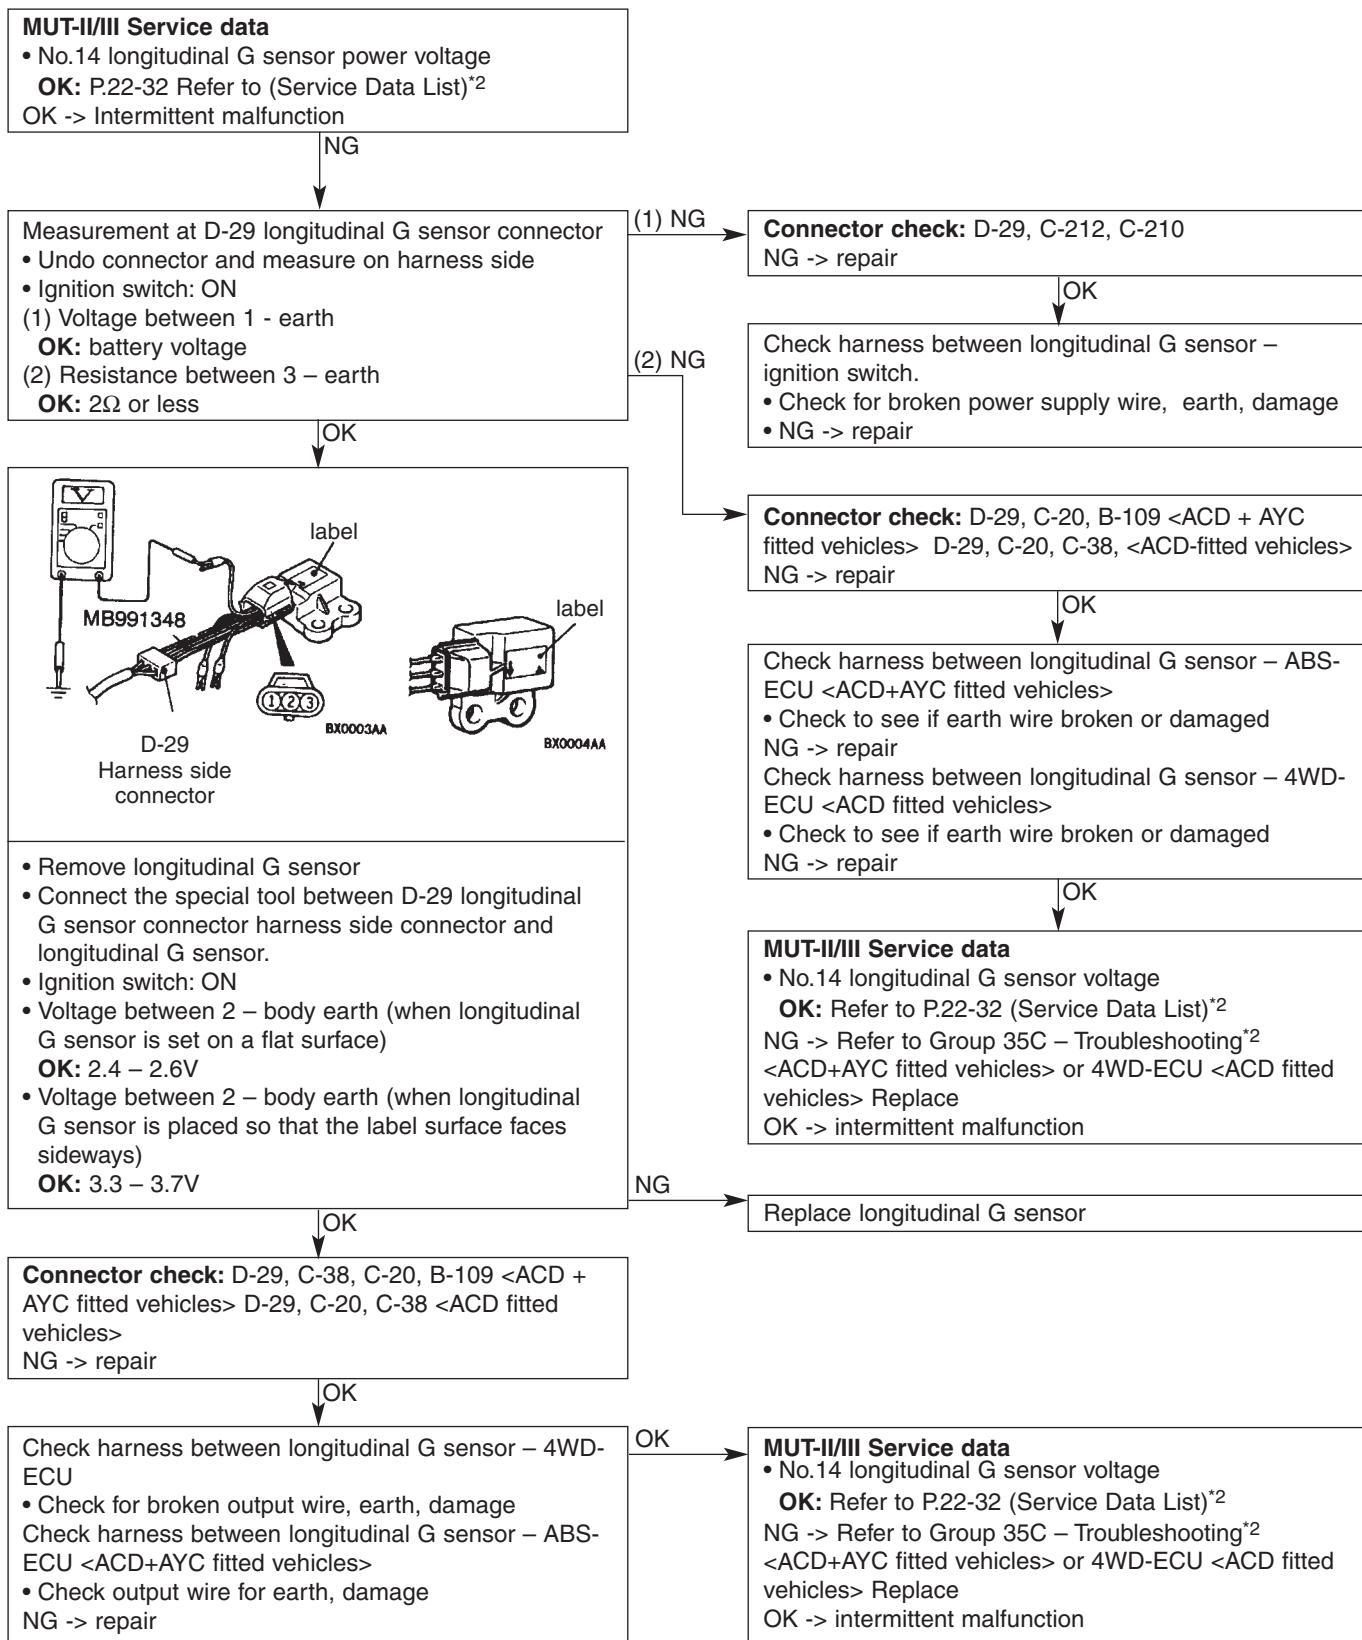
Code No.51 Longitudinal G sensor system	Assumed cause of concern
Code No.51 is output when the longitudinal G sensor signal falls below 0.5V or rises above 4.5V.	<ul style="list-style-type: none"> • Harness, connector malfunction • Longitudinal G sensor malfunction • ABS-ECU malfunction <AYC fitted vehicles> • 4WD-ECU malfunction

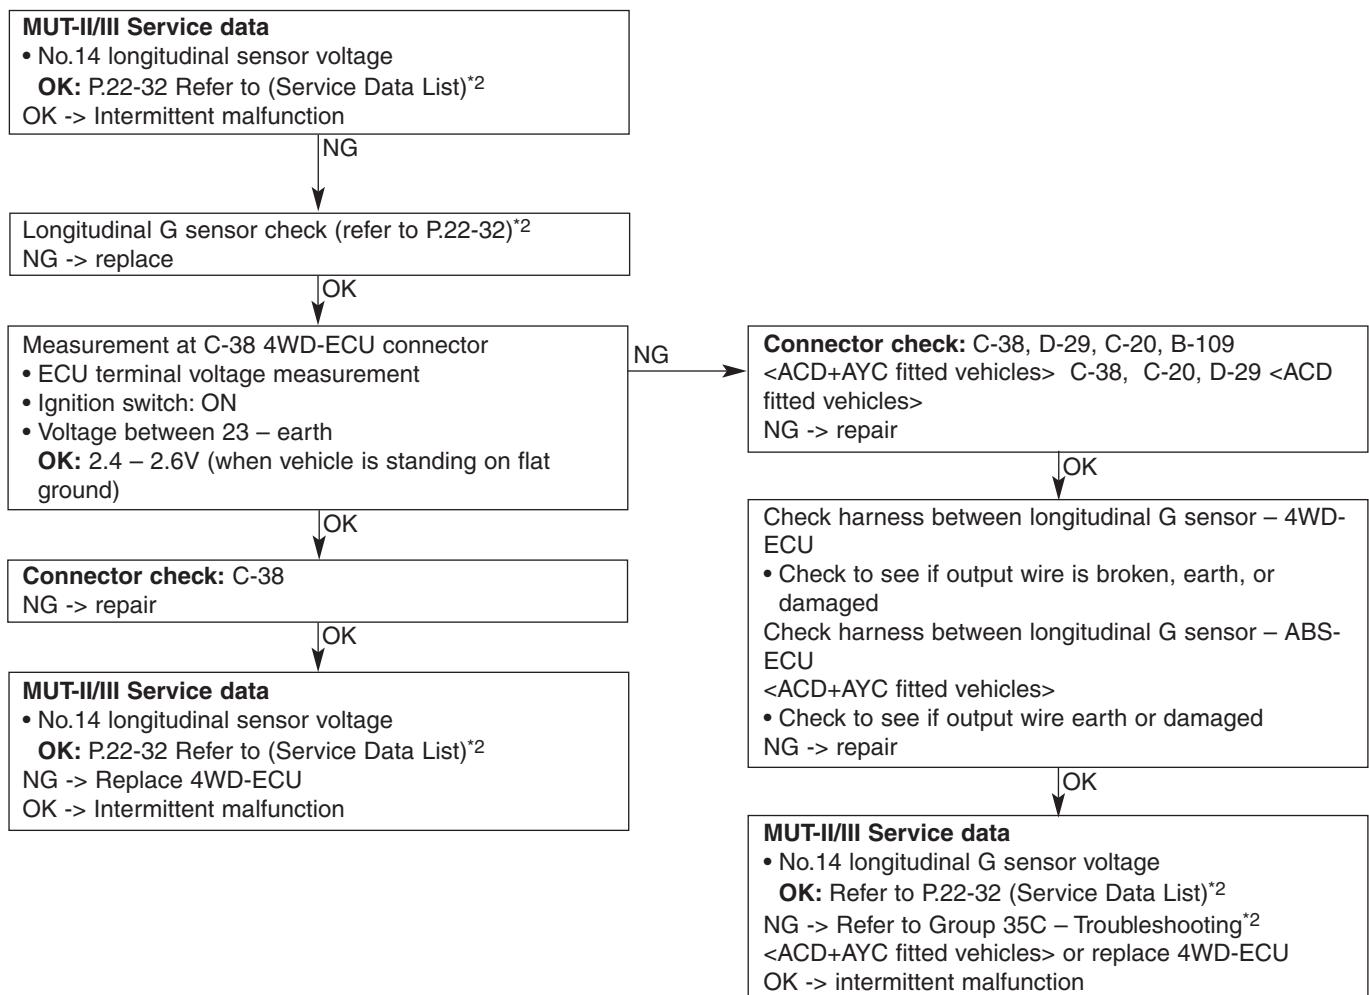
Code No.52 Longitudinal G sensor system	Assumed cause of concern
<p>At 10kph or over, with ABS and brakes not applied, code No. 52 is output in cases where G sensor indicates higher than specified value.</p>	<ul style="list-style-type: none"> • Harness, connector malfunction • Longitudinal G sensor malfunction • ABS-ECU malfunction <ACD+AYC fitted vehicles> • 4WD-ECU malfunction
