LANCER
***Evolution* VIII**
MR

SERVICE MANUAL

Supplement

'04-2
No.1036K10

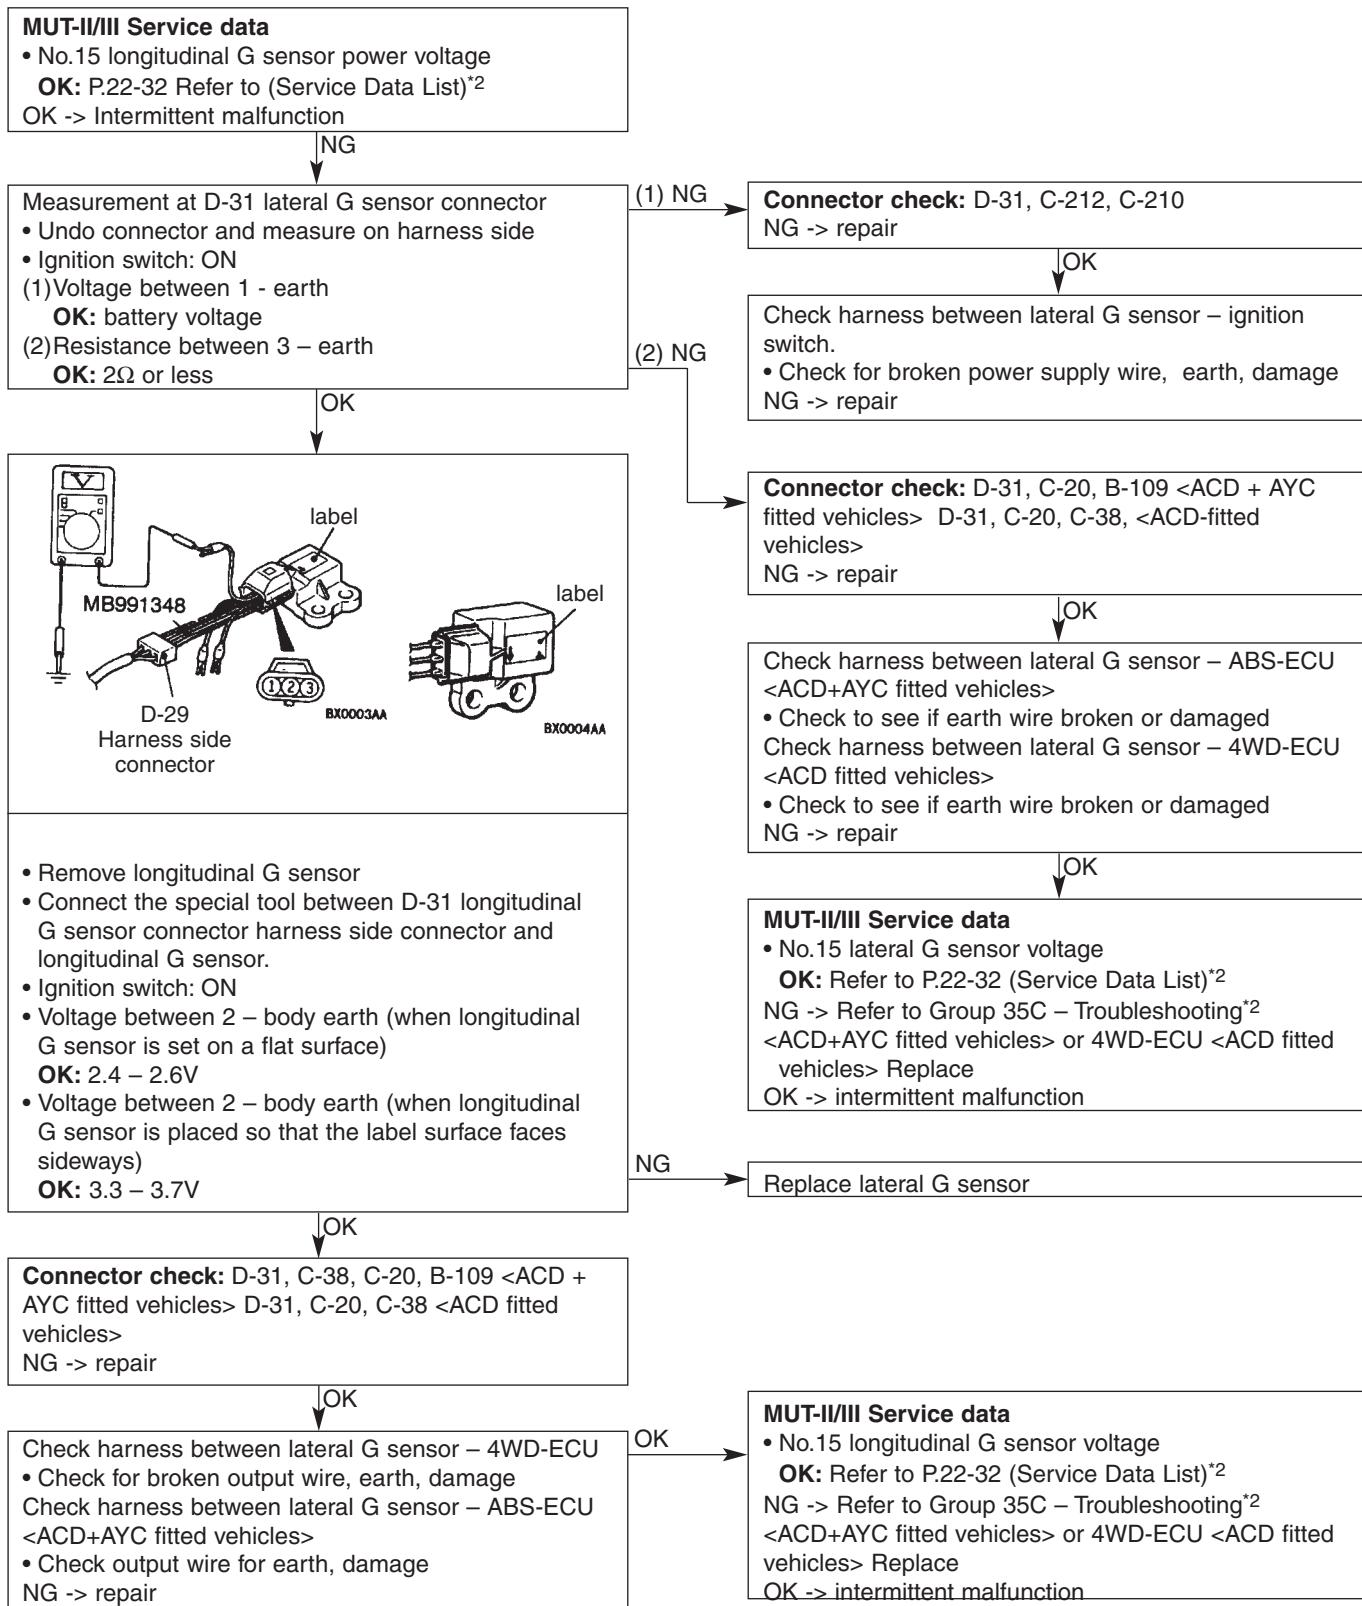
Code No.56 Longitudinal G sensor system	Assumed cause of concern
Code No.56 is output when the longitudinal G sensor signal falls below 0.5V or rises above 4.5V.	<ul style="list-style-type: none"> • Harness, connector malfunction • Longitudinal G sensor malfunction • ABS-ECU malfunction <ACD+AYC fitted vehicles> • 4WD-ECU malfunction

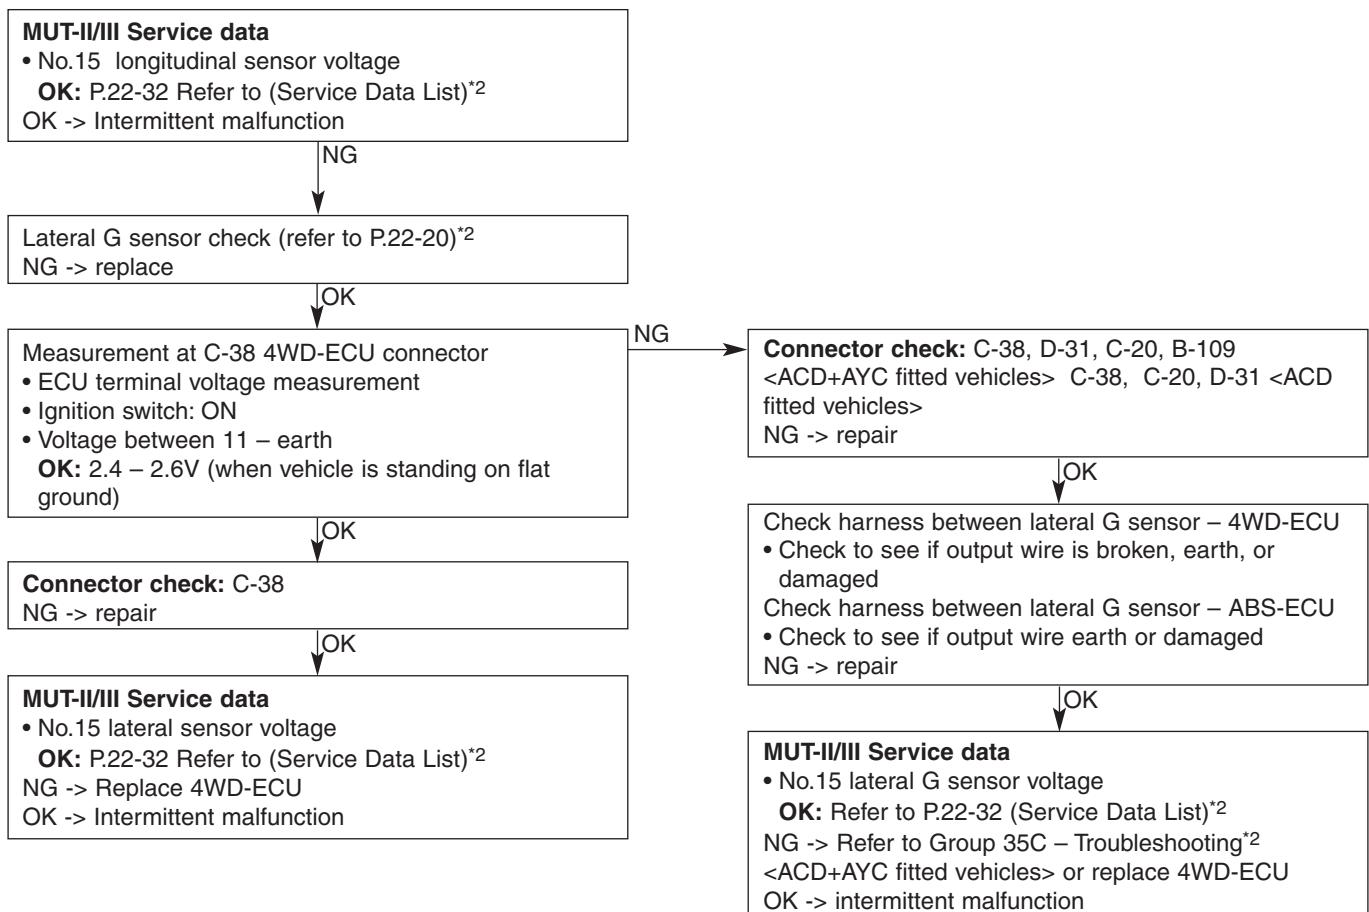
Code No.57 Lateral G sensor system	Assumed cause of concern
<p>At 10kph or over, with ABS and brakes not applied, code No. 57 is output in cases where G sensor indicates higher than specified value.</p>	<ul style="list-style-type: none"> • Harness, connector malfunction • Longitudinal G sensor malfunction • ABS-ECU malfunction <ACD+AYC fitted vehicles> • 4WD-ECU malfunction

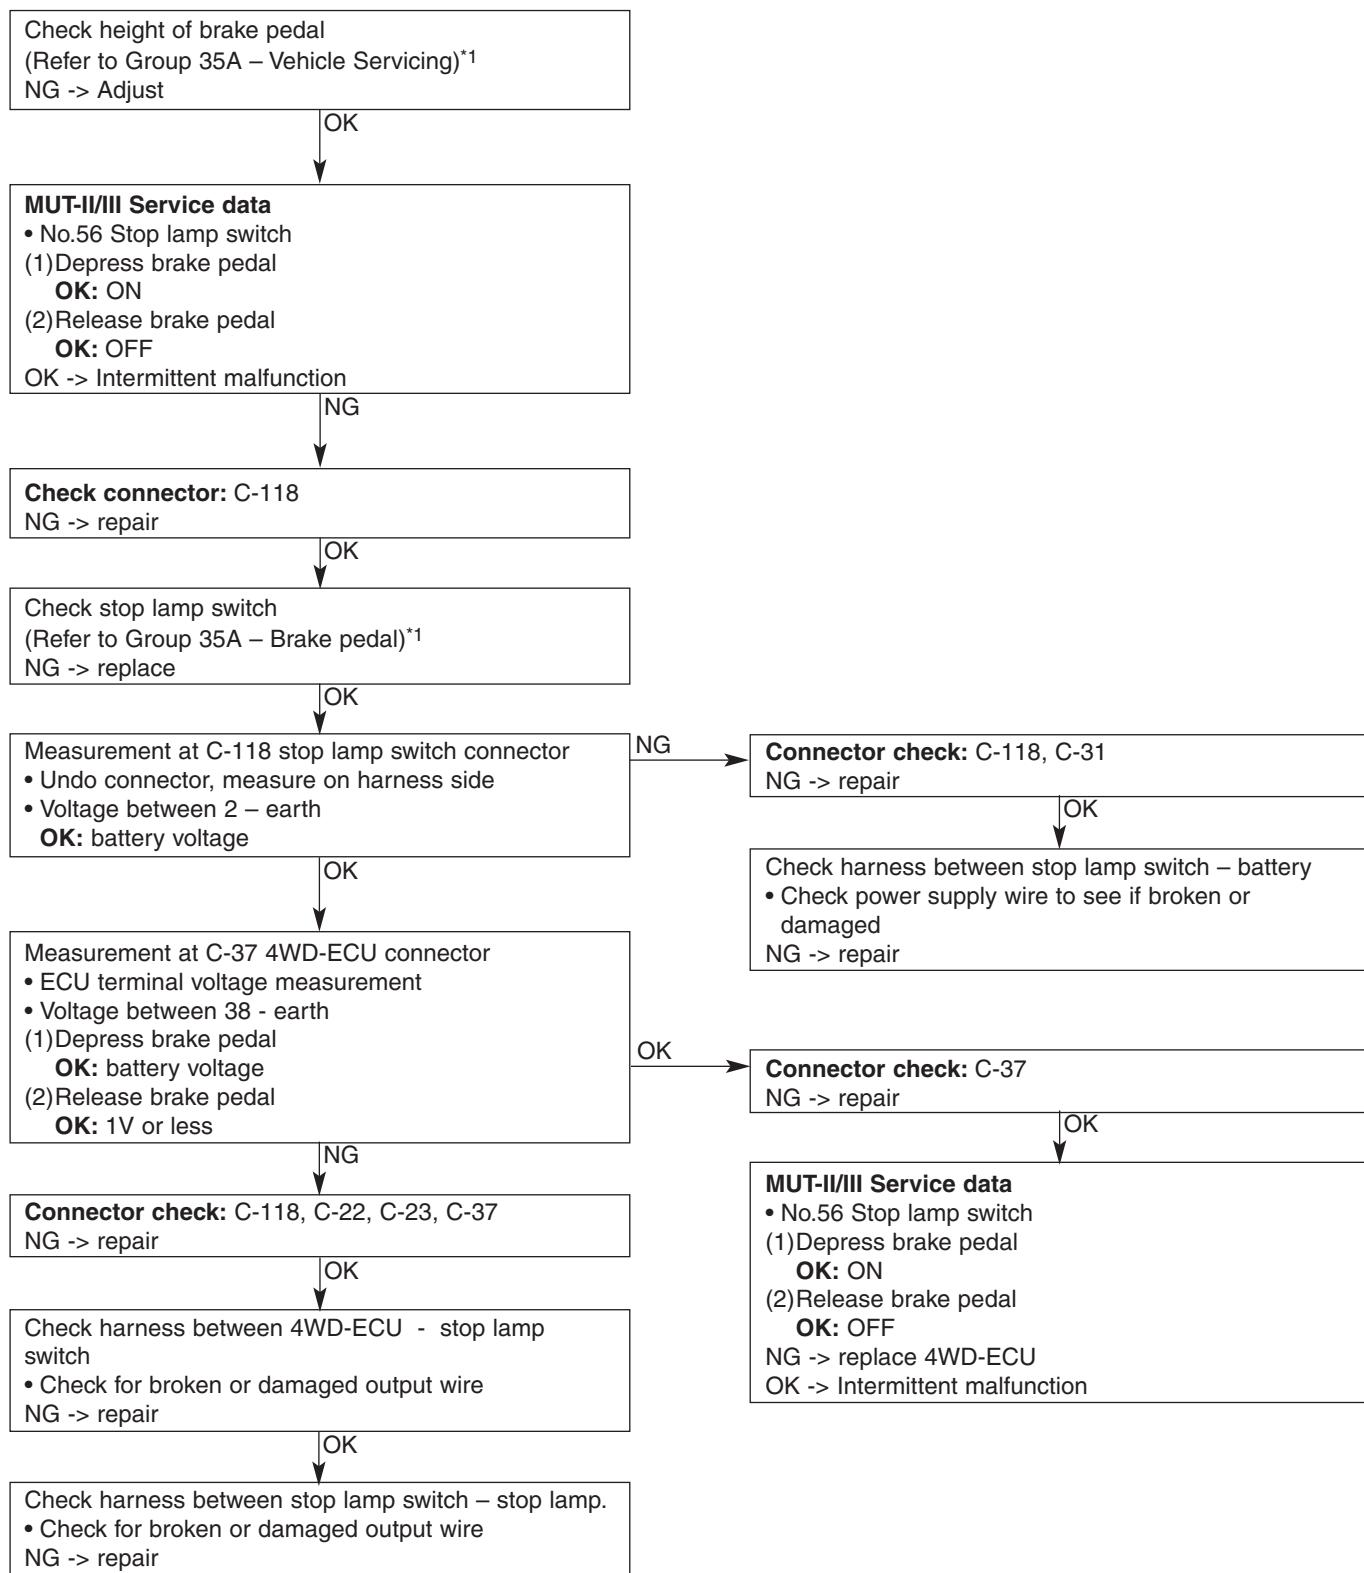
Code No.61 Stop lamp switch system	Assumed cause of concern
In cases where, at 15kph or over, the stop lamp switch stays ON for 15 minutes or longer, code No.61 is output.	<ul style="list-style-type: none"> Brake pedal malfunction Stop lamp switch malfunction Harness, connector malfunction 4WD-ECU malfunction

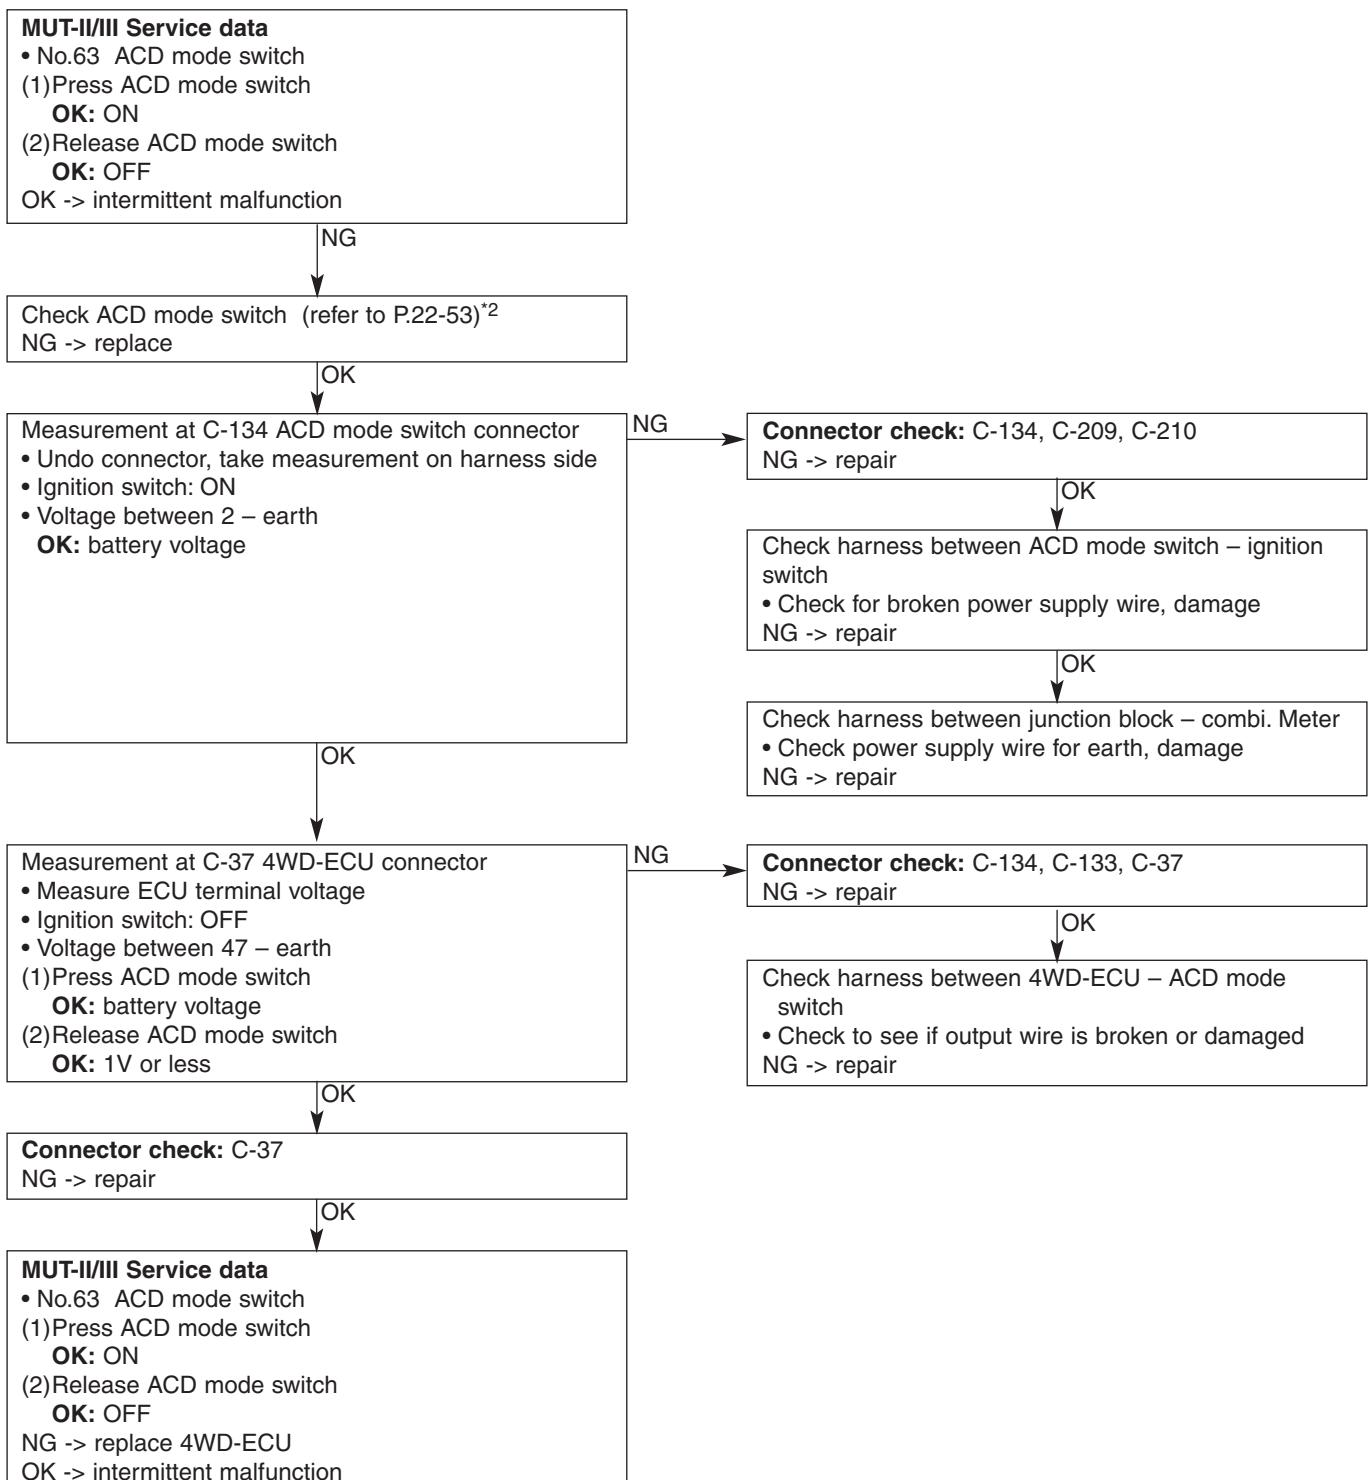
Code No.62 ACD mode switch system	Assumed cause of concern
In cases where the ACD mode switch remains ON for 60 seconds or more, code No.61 is output.	<ul style="list-style-type: none"> • ACD mode switch malfunction • Harness, connector malfunction • 4WD-ECU malfunction

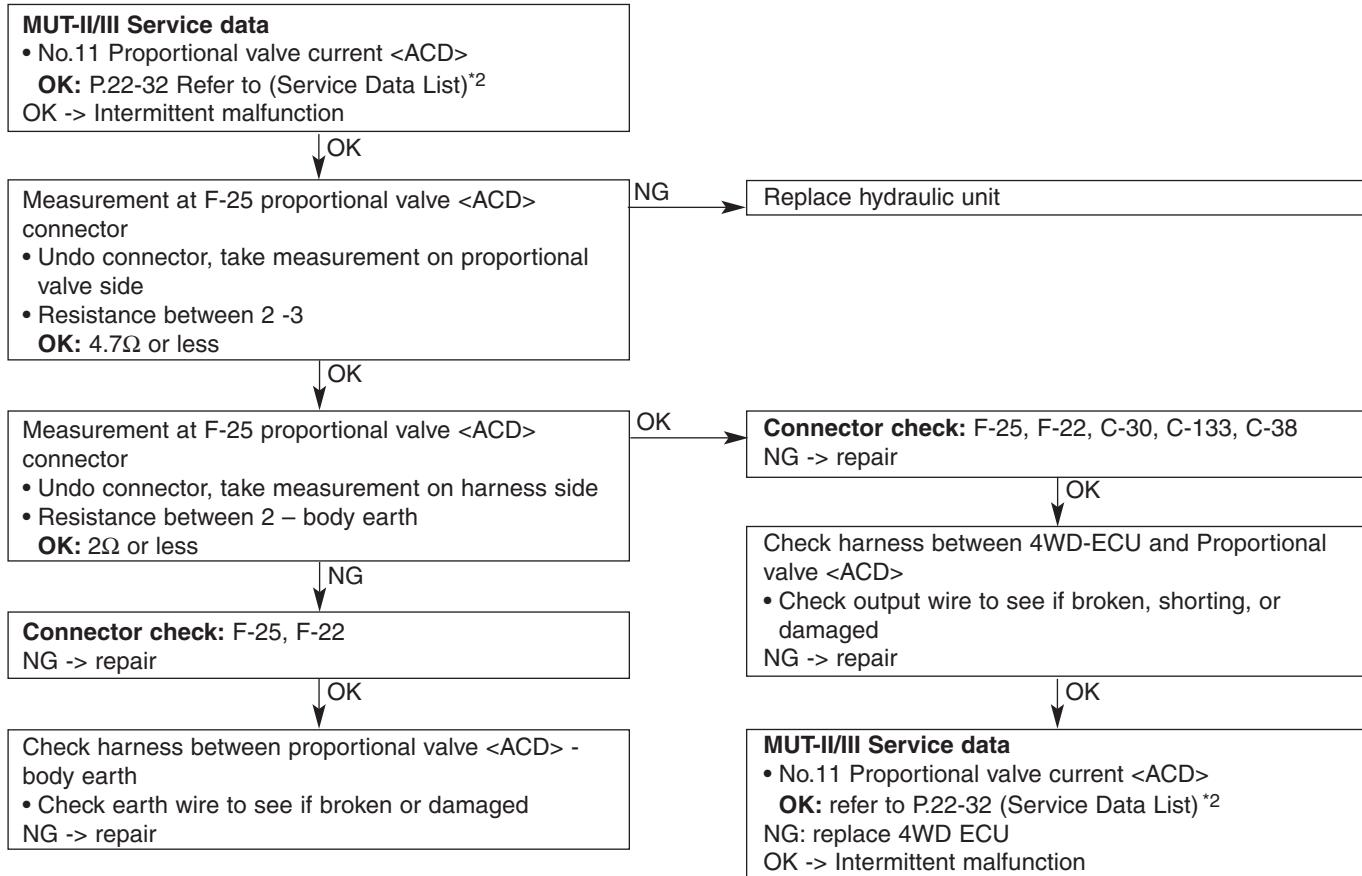
Code No.74 Proportional valve <ACD> system	Assumed cause of concern
In cases where the proportional valve <ACD> control circuit is shorting, code No.74 is output.	<ul style="list-style-type: none"> • Proportional valve <ACD> malfunction • Harness, connector malfunction • 4WD-ECU malfunction

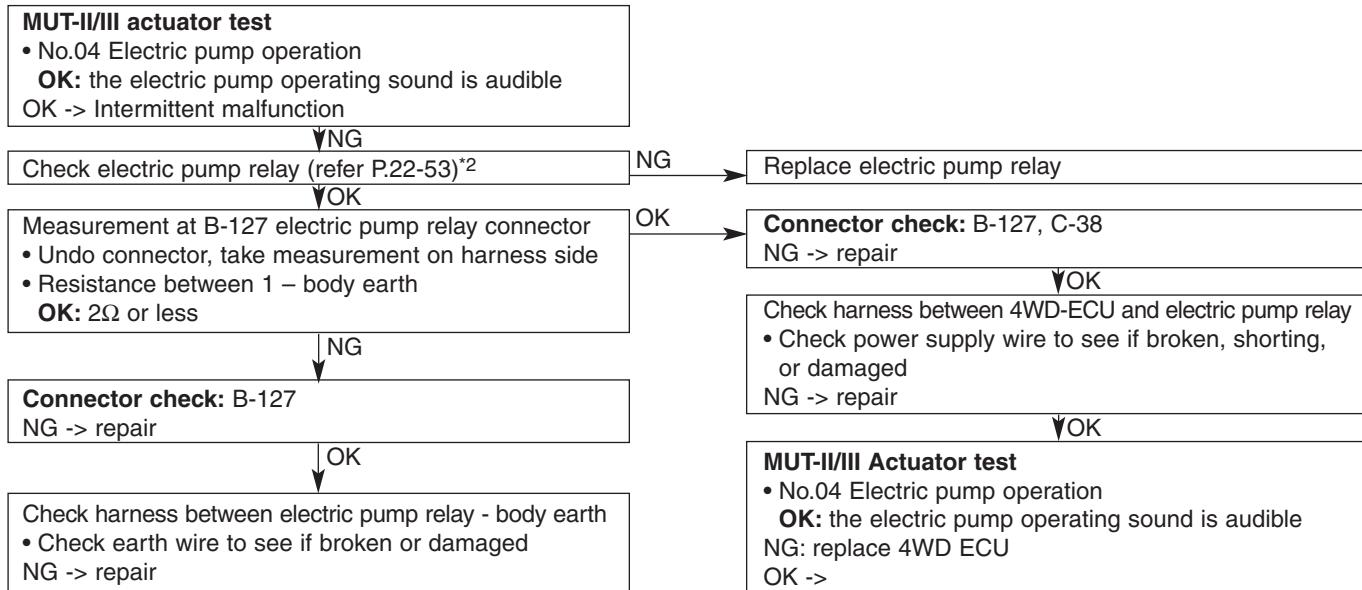
Code No.81 Electric pump relay system	Assumed cause of concern
Output when the circuit on the pump relay coil side is broken or shorting.	<ul style="list-style-type: none"> • Electric pump relay malfunction • Harness, connector malfunction • 4WD-ECU malfunction

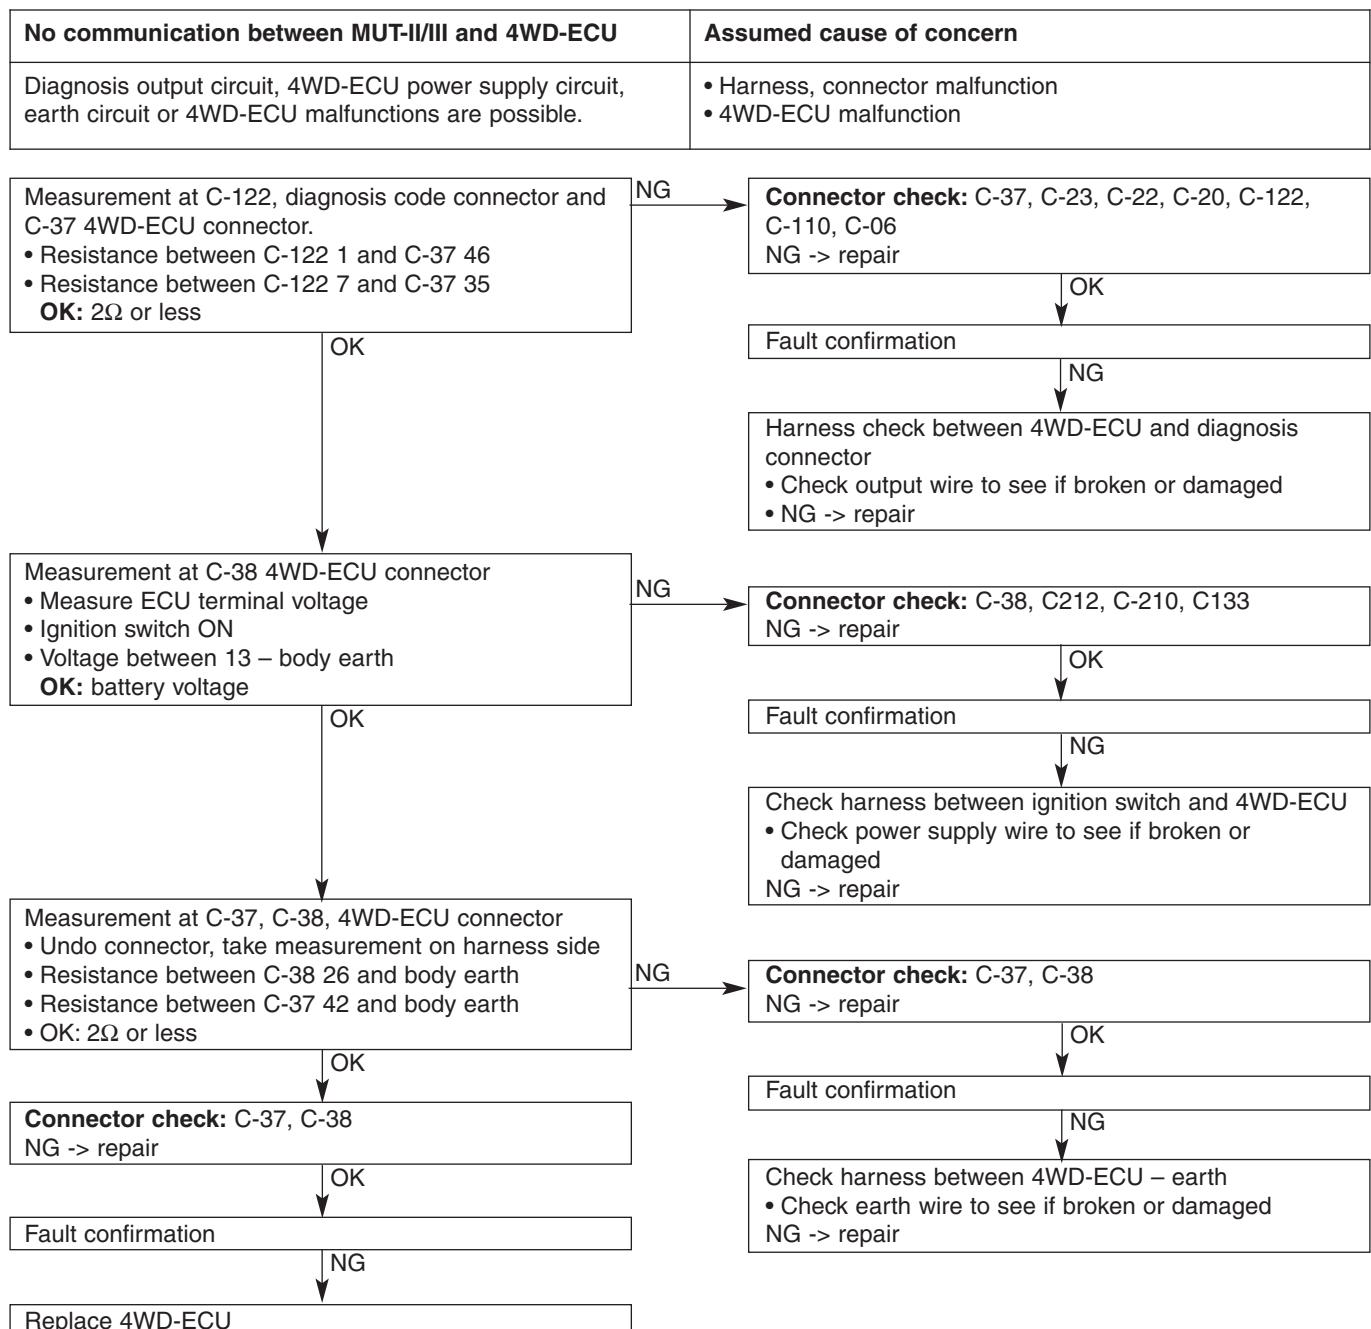
Checking procedure 2

Fault	Check procedure No.	Page ref.
No communication between MUT-II/III and 4WD-ECU	2	22-19
When ignition switch is ON, (engine stopped), ACD mode indicator lamp does not come on.	3	22-20
Even after engine starts, at least 2 ACD mode indicator lamps remain lit	4	22-20

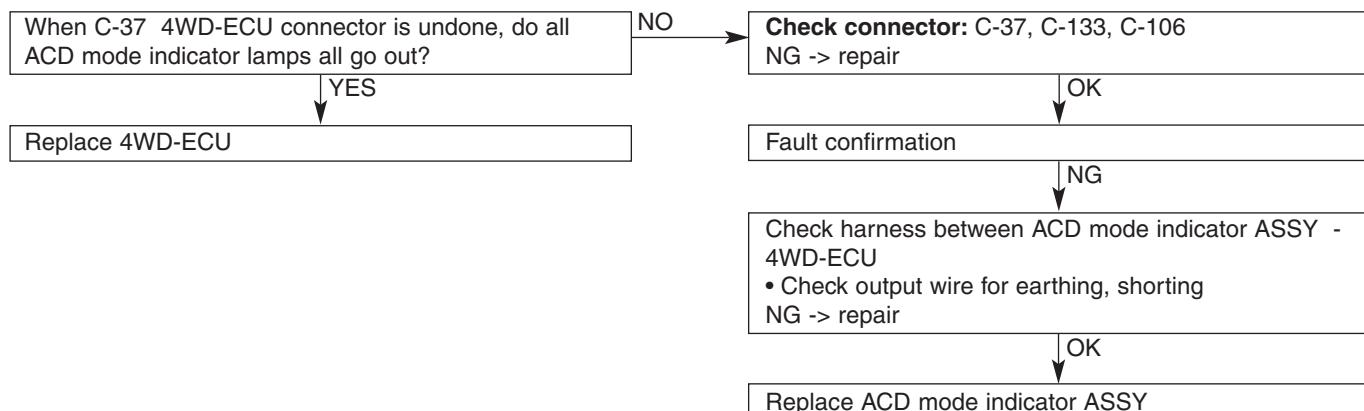
Even after engine starts, at least 2 ACD mode indicator lamps remain lit	Assumed cause of concern
ACD mode indicator lamp output circuit malfunction is possible.	<ul style="list-style-type: none"> • Harness, connector malfunction • 4WD-ECU malfunction • ACD mode indicator lamp ASSY malfunction

This phenomenon is limited to when communication with MUT-II/III is possible (4WD-ECU power supply normal), and diagnosis code is normal/correct.

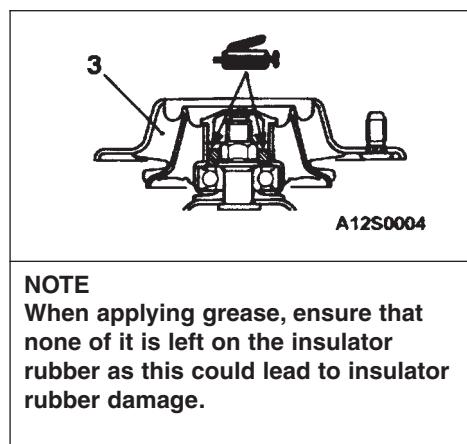
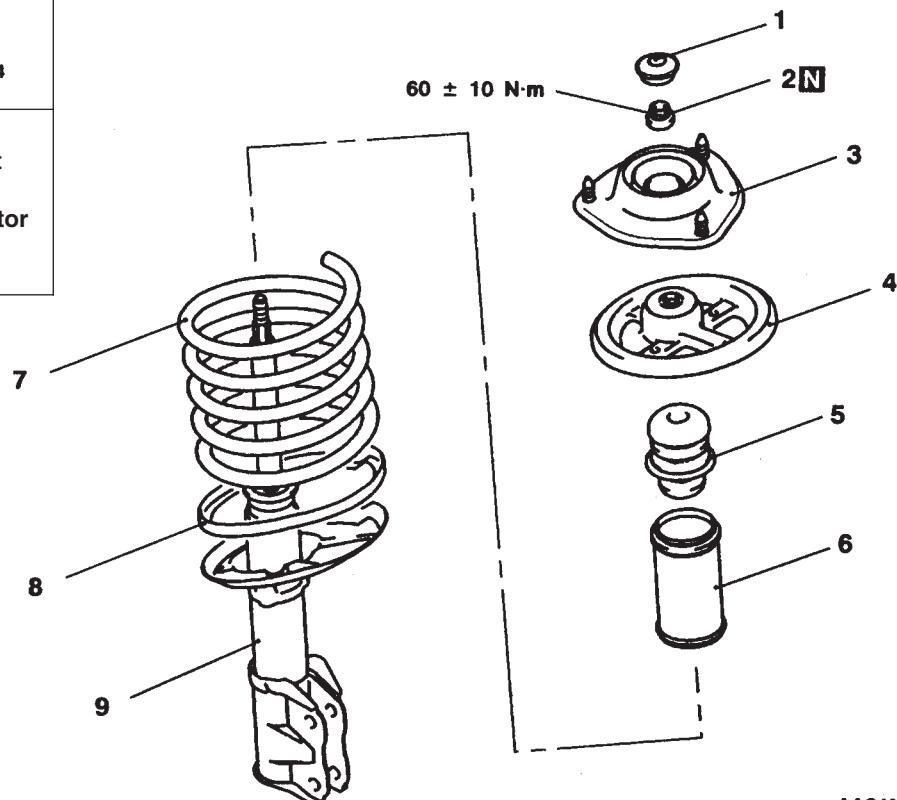
AAC400101

Vehicles fitted with Bilstein shock absorbers

6. Dust cover
7. Coil spring
8. Lower spring pad
9. Strut ASSY

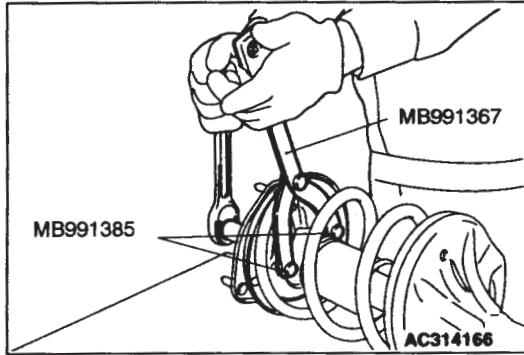
2. Using the following special tools, release the self-locking nut.

- Special spanner (MB991367)
- Pin (MB991385)

There is a danger of the lock nut inside the strut piston rod working loose, so when loosening the self-locking nut, do not use an impact wrench.

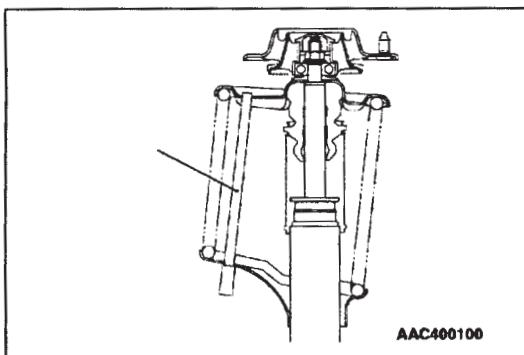
2. Match up strut assembly hole in lower spring seat, and hole in upper spring seat.

Using a lever to align the holes can make this job easier.

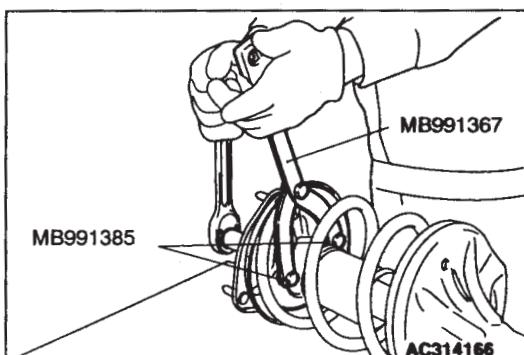
4. Using the special tool, tighten the self-locking nut to the specified torque.

Tightening torque: $60 \pm 10\text{N}\cdot\text{m}$

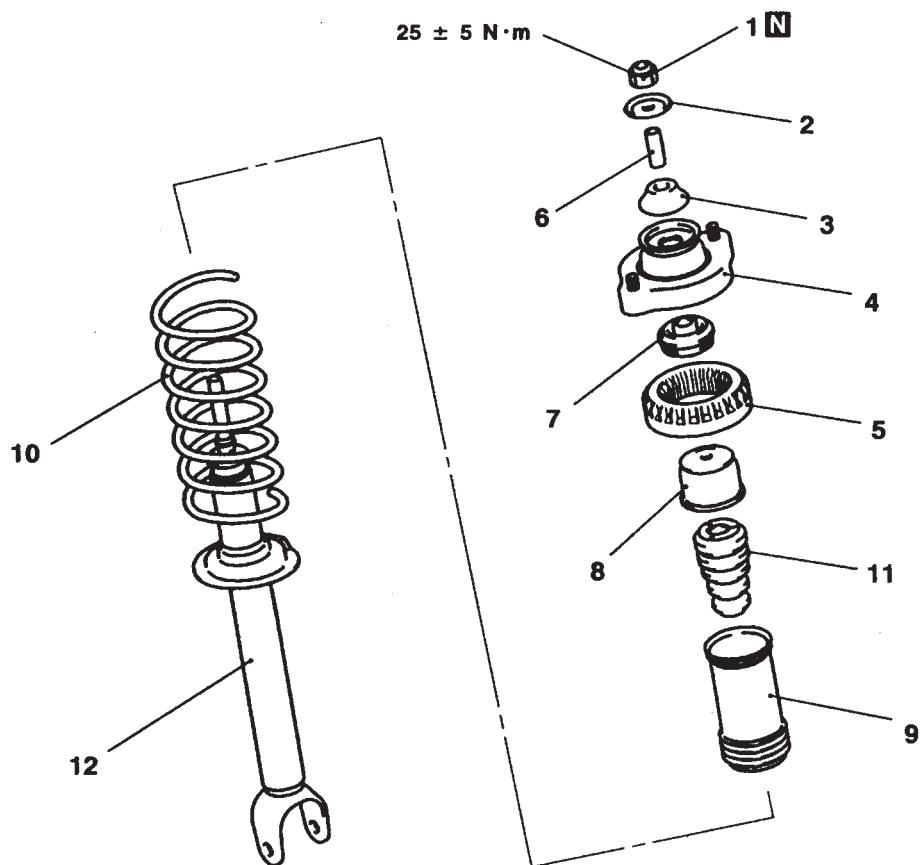
AAC400102

Vehicles fitted with Bilstein shock absorbers

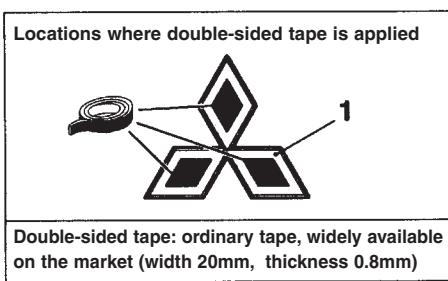
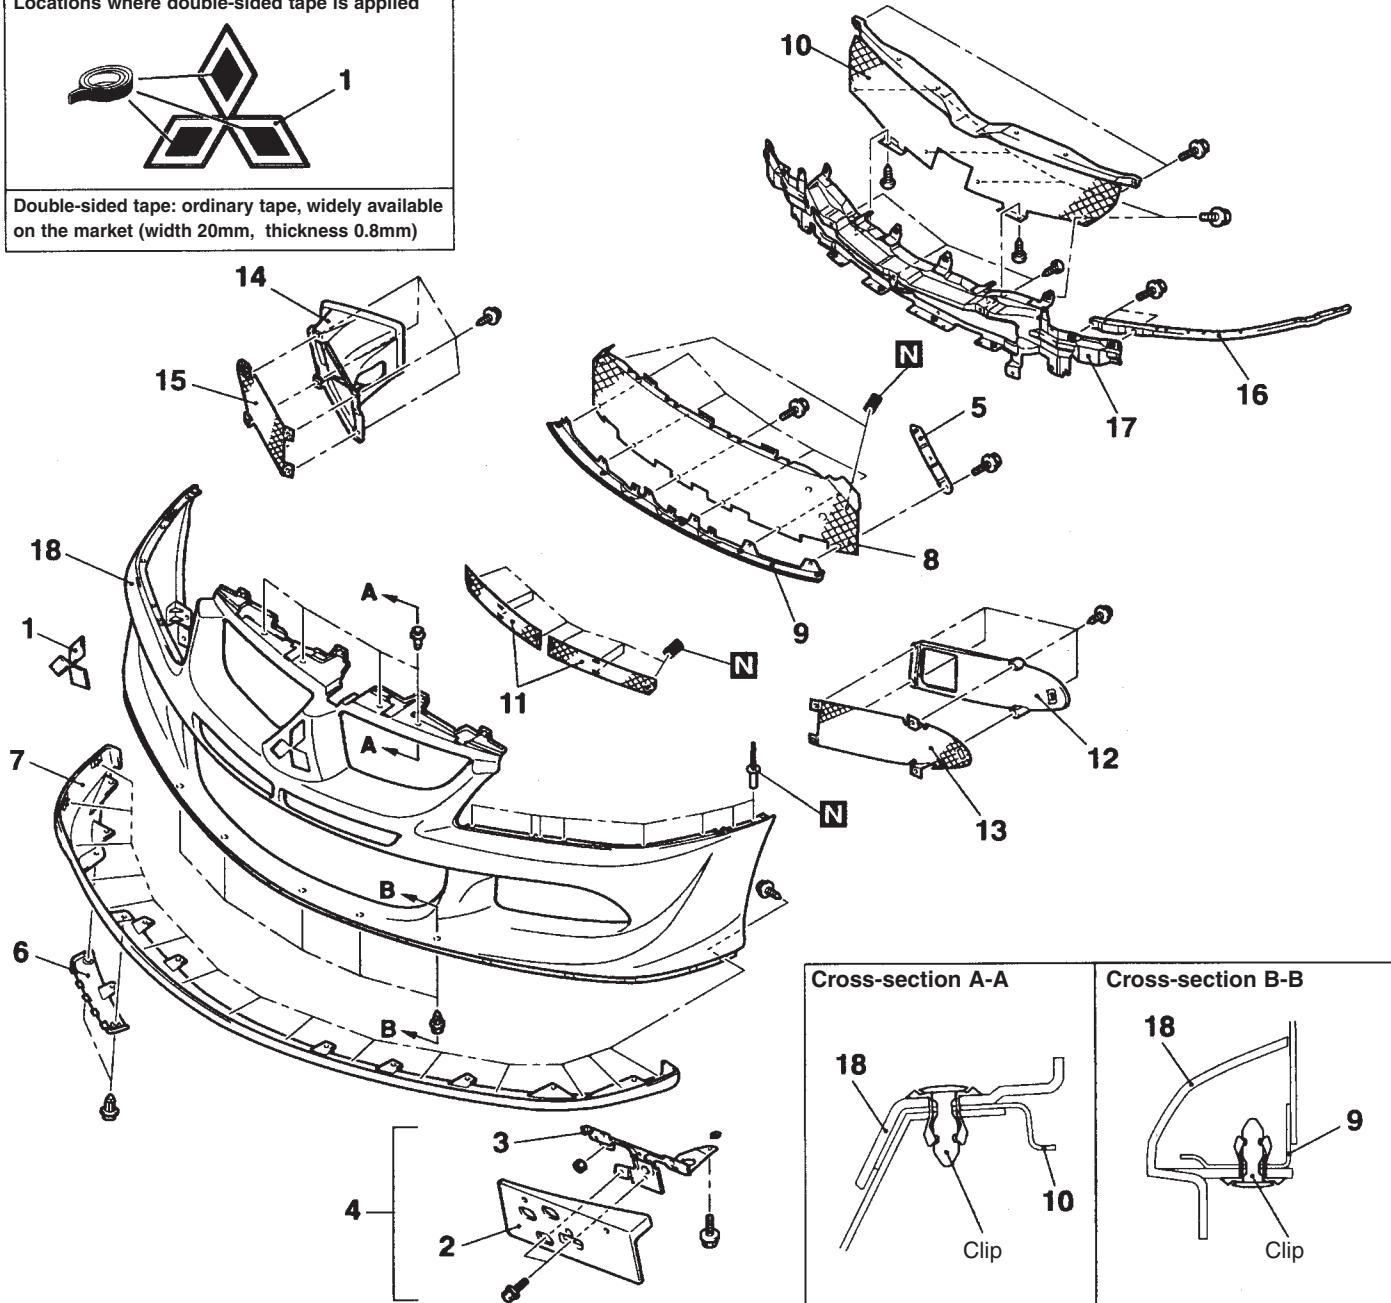
AC314131 AB

Front Bumper

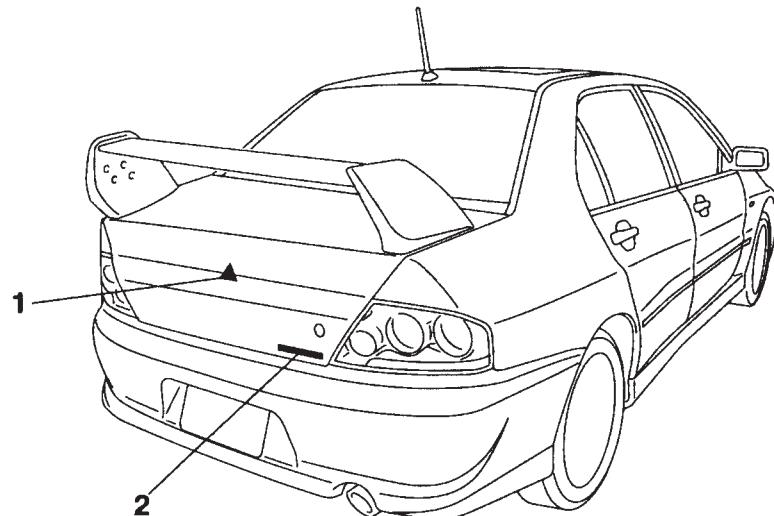
AC314133

Markings

Removal and fixing

►A◀ 1. Three diamonds badge

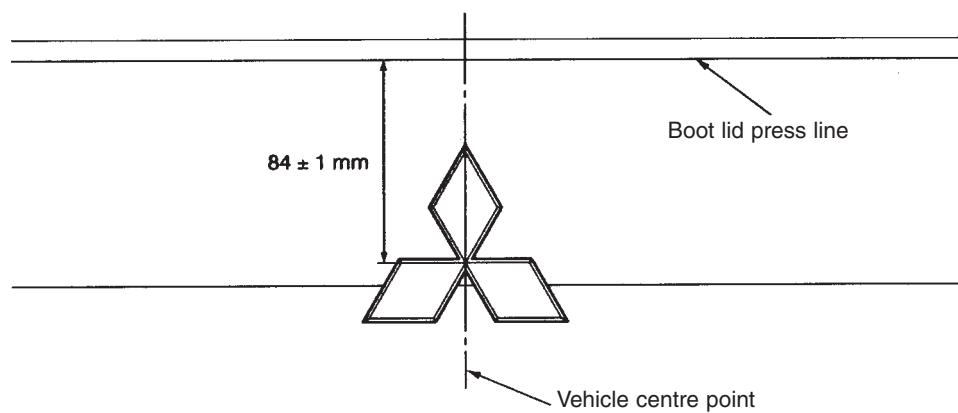
1. Positions

(1) Three diamonds badge

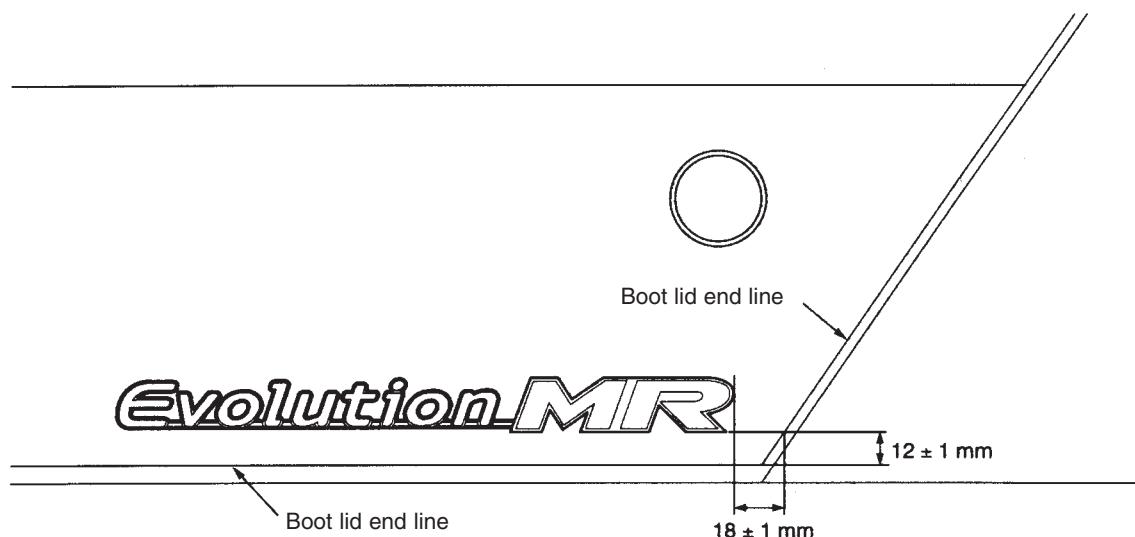
AC314117

(2) EVOLUTION MR MARK
