MEDIC
UPDATE
TECHNICAL SERVICE BULLETIN

SUBJECT:		No: TSB-08-55-002REV	
ENGINE CONTROL MODULE REPROGRAMMING FOR POOR HEATER PERFORMANCE		DATE: April, 2008	
		MODEL: 2007-08 Outlander	
CIRCULATE TO:	<input type="checkbox"/> GENERAL MANAGER	<input checked="" type="checkbox"/> PARTS MANAGER	<input checked="" type="checkbox"/> TECHNICIAN
<input checked="" type="checkbox"/> SERVICE ADVISOR	<input checked="" type="checkbox"/> SERVICE MANAGER	<input checked="" type="checkbox"/> WARRANTY PROCESSOR	<input type="checkbox"/> SALES MANAGER

To improve heater performance during extremely cold weather, (at or below approximately +5° F, -15° C), a new software program is being made available for those affected vehicles where there has been a complaint of insufficient heating of the interior. The condition is mostly noticed when the vehicle is stationary with the engine at idle or travelling at very slow speeds (e.g. stop and go traffic).

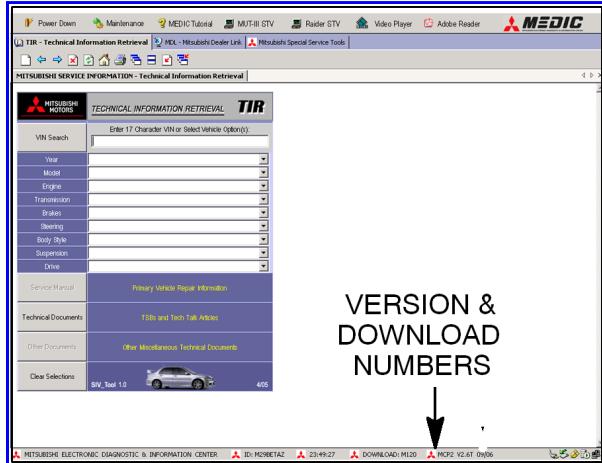
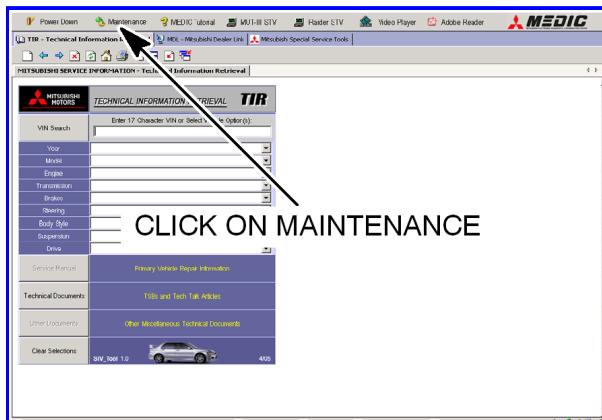
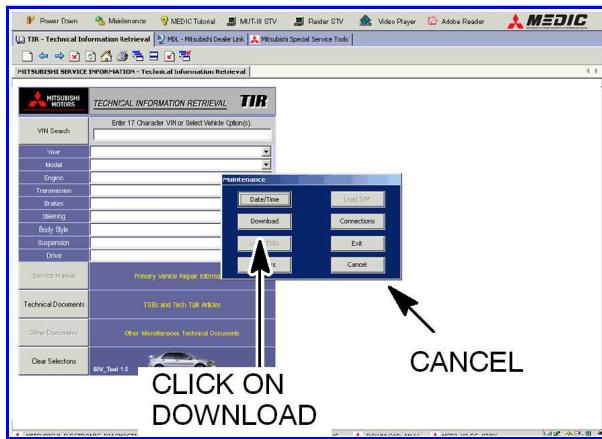
If your **MEDIC-II Download is below M210**, update your MEDIC-II as follows.

3. On the MEDIC-II main screen, click on "Maintenance".

4. Click on "Download". After the download completes, click on "Cancel" to exit the "Maintenance" window.

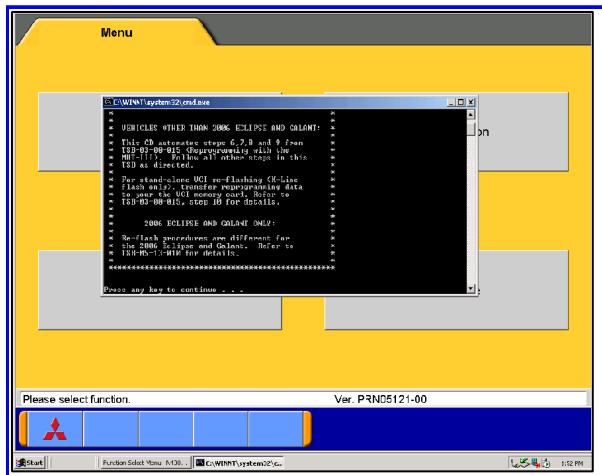
d. If the database version is less than N08032, you must transfer the new reprogramming data from the Reflash Update CD 03/08 to the MUT-III hard drive as follows:

1. Install **Reflash Update CD 03/08** into the PC's DVD-ROM drive.
2. Follow the instructions on the screen. The system will automatically transfer the reprogramming data onto the PC's hard drive.
3. Continue to the Reprogramming Procedure on page 4.

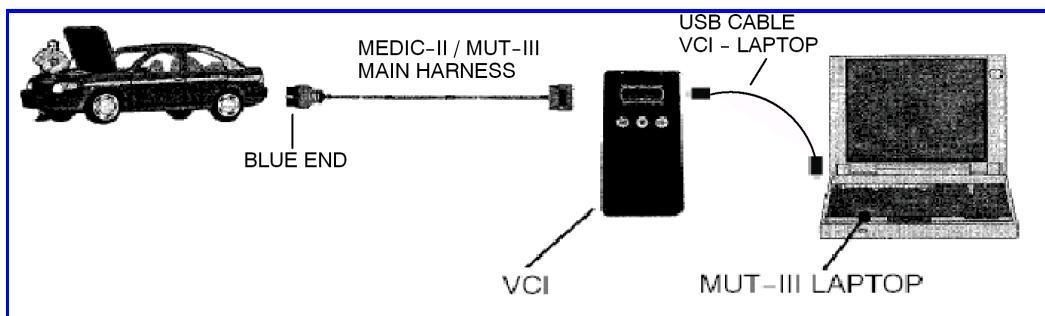
Connect the equipment as follows:

- Turn the laptop computer on. If the battery charge indicator in the lower right hand corner of the screen does not show a full charge, it is recommended that either the laptop battery be charged prior to beginning, or that reprogramming be completed with the A/C power adaptor connected to the laptop.
- Connect the USB cable to the VCI.
- When the laptop displays the MUT-III main screen, connect the USB cable to the laptop.
- Connect the MUT-III main harness with the blue DLC connection to the VCI.
- Connect the blue connector of the MUT-III main harness to the vehicle's data link connector.
- Turn the VCI power switch ON. Verify that the indicator lamp in the upper right corner of the screen is green.

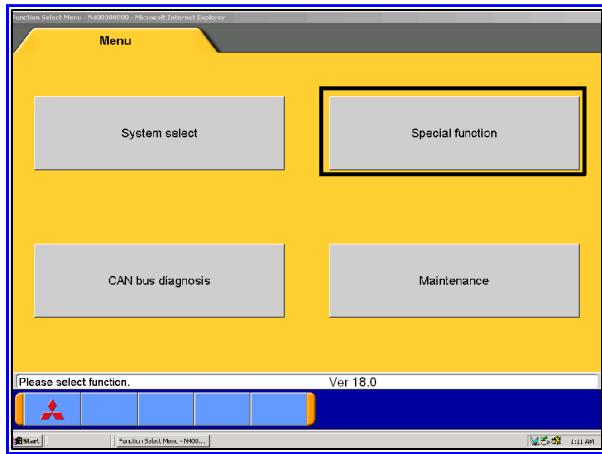
1. Conduct the following steps to reprogram the ECM.
 - a. Turn the ignition key or knob (F.A.S.T. equipped) to the ON position. If the vehicle is equipped with the F.A.S.T. System, the fob must remain in the vehicle for the entire procedure.

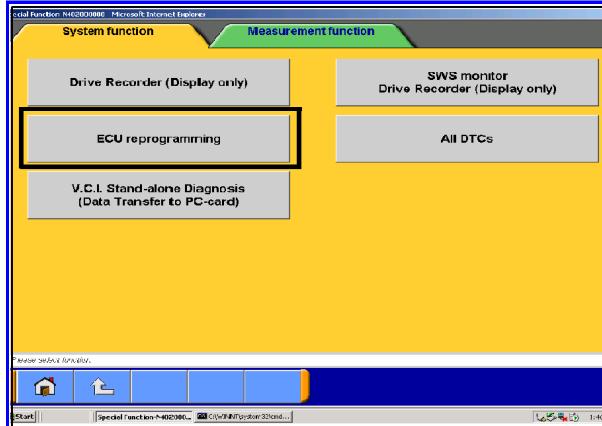
- b. Select "Special Function."

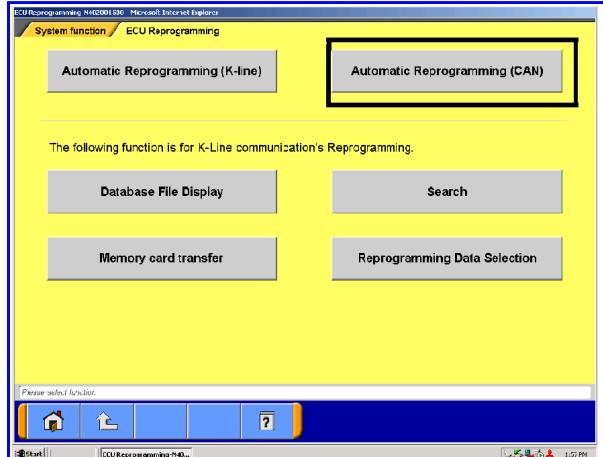
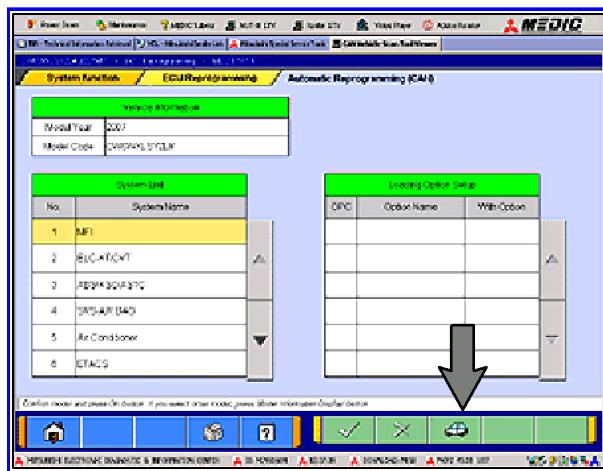
- c. Select "ECU reprogramming."

- d. Select "Automatic Reprogramming (CAN)."

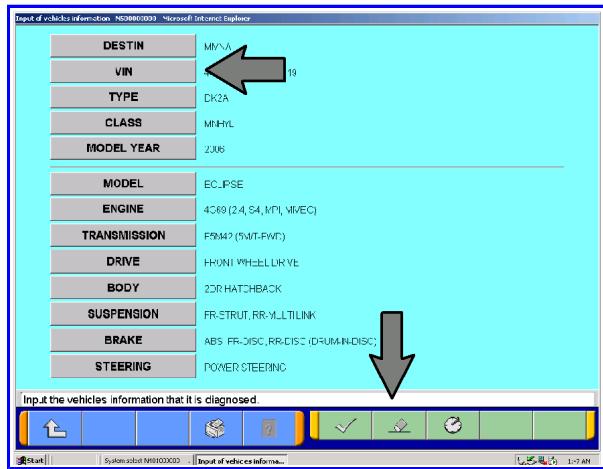
e. Click on the car icon at the bottom of the page.

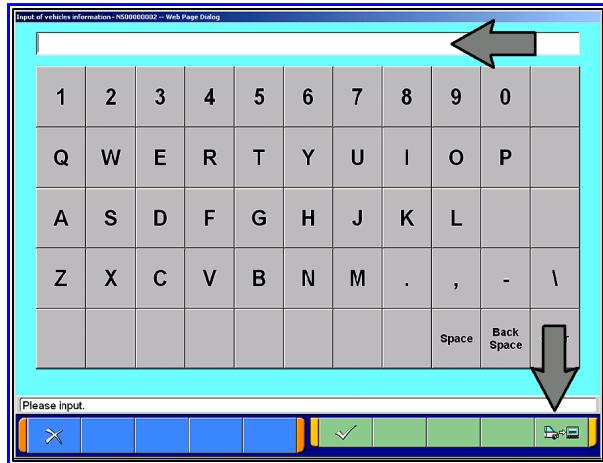
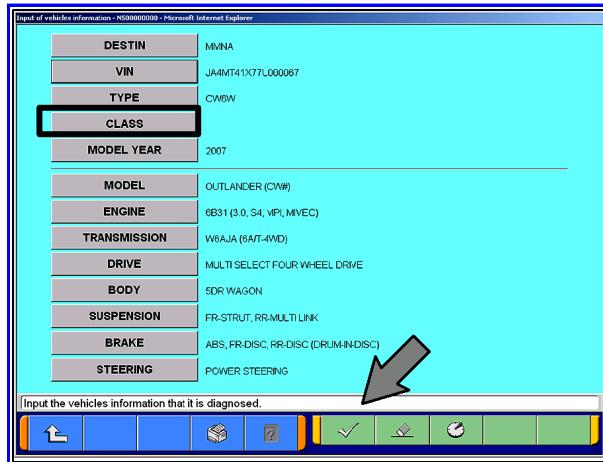
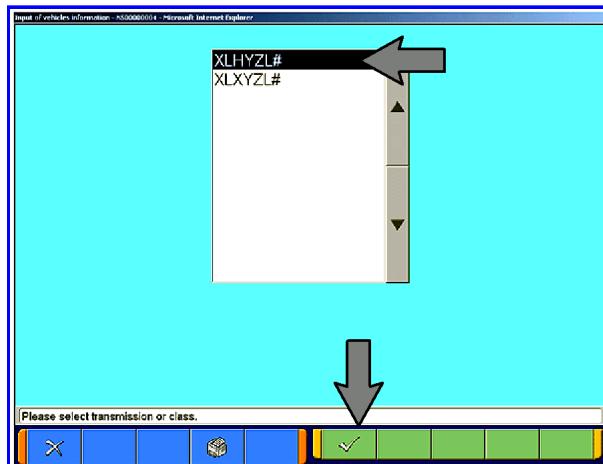
f. If the VIN listed does not match the vehicle you are working on, click on the Eraser Icon at the bottom of the page.

Select VIN by clicking on the button.

g. Click on the icon in the lower RH corner of the screen to have the MUT-III automatically read the VIN. If a message appears saying that the VIN cannot be input automatically, manually type the 17 digit VIN into the VIN field.

Make sure the VIN is correct and click on the check mark.

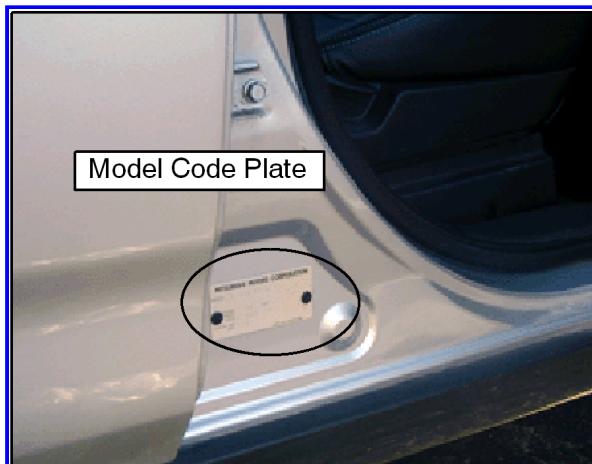
h. If it was not completed automatically, input the vehicle class. Click on the CLASS button, select the appropriate class from the menu and then click the check mark at the bottom of the page. Vehicle class can be found on the Vehicle Information Code Plate riveted to the base of the RH b-pillar (see photo below). The class is part of the model code.

Click the check mark to enter the class.

Confirm that all of the data is correctly entered and click the check mark at the bottom of the page

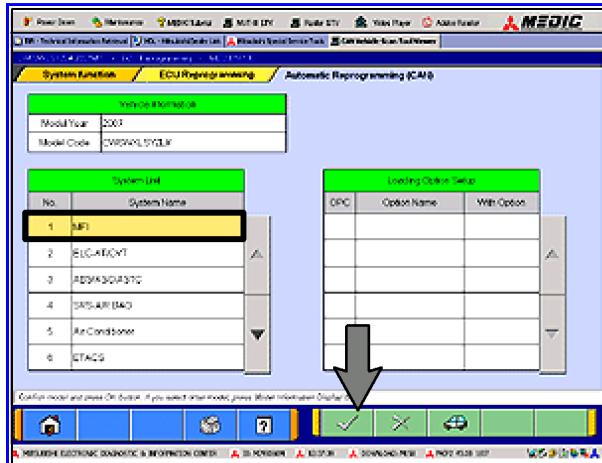
i. MFI should already be highlighted. If not, click on it to highlight it.

Click on the check mark at the bottom of the page.

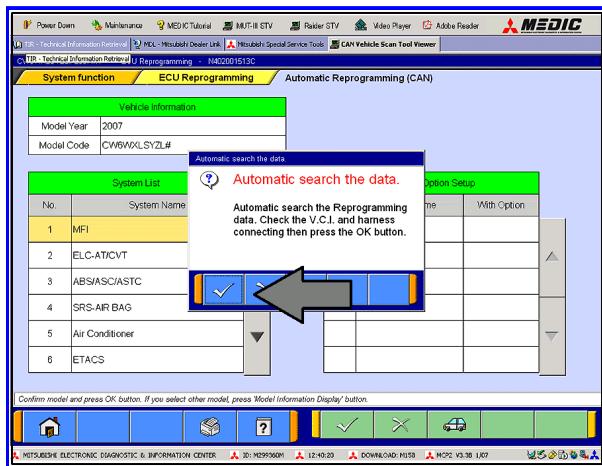
j. A message will advise you that the system will "Automatic Search the data."

Click on the check mark to continue.

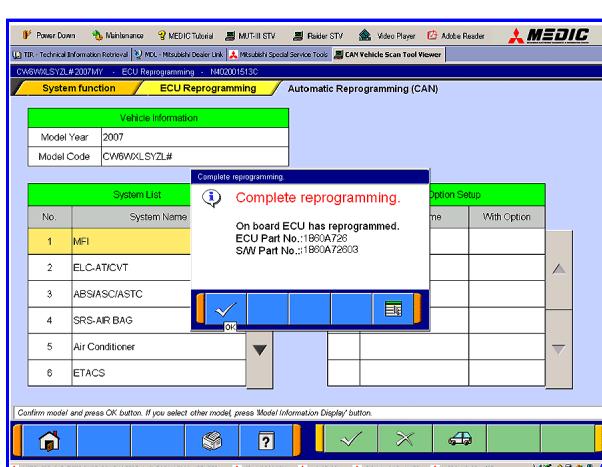
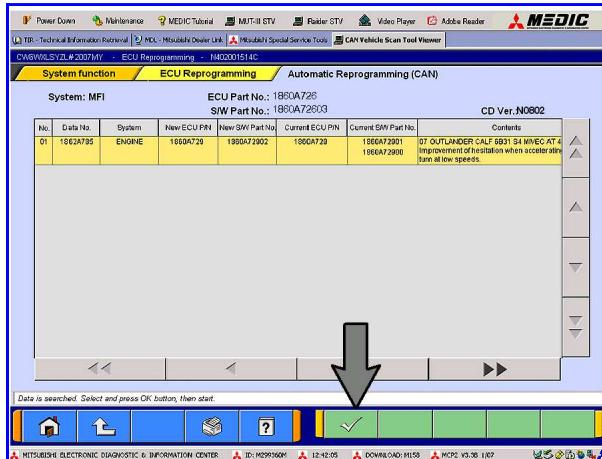
k. The CAN database screen will display.

(If more than one row is displayed in the table, select the appropriate ECM part number.)

Click on the check mark to continue.

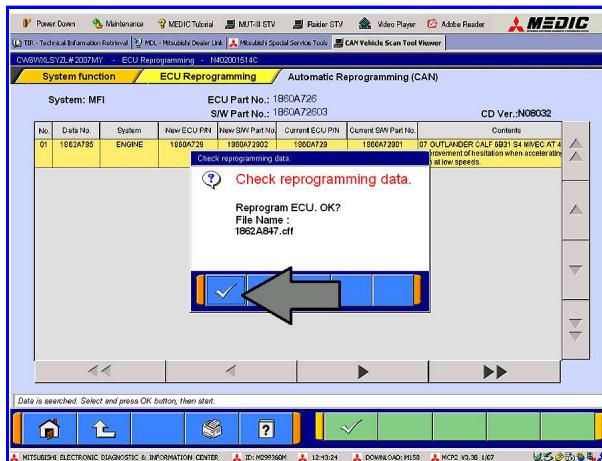
I. Click on the check mark to begin reprogramming.

NOTE: It will take up to 5 minutes to complete the reprogramming.

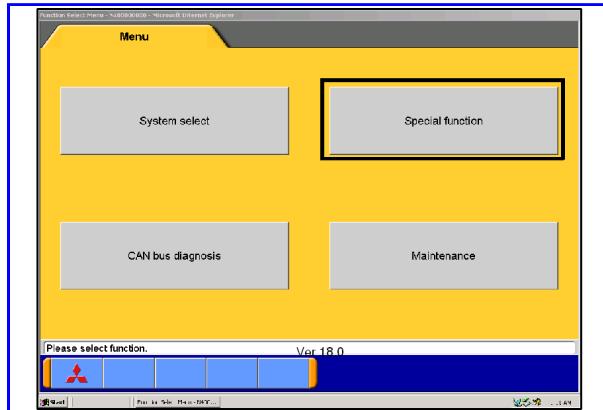
2. Using the MUT-III, check and erase ALL DTCs from all systems as follows.

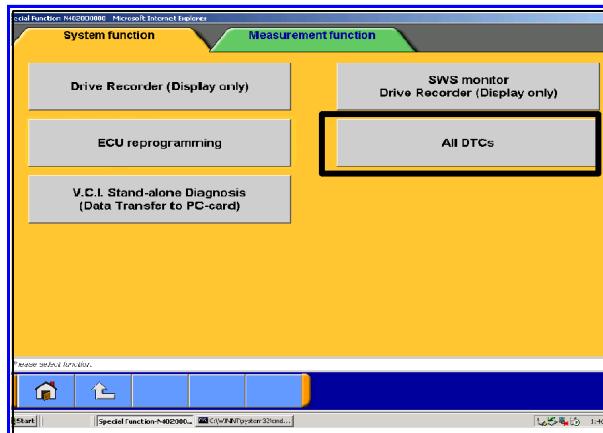
a. Select "Special Function."

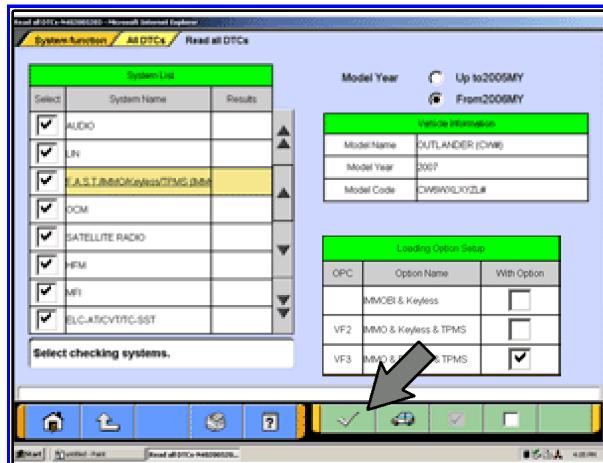
b. Select "All DTCs," then select ERASE AND READ ALL DTCs.

c. Inspect the list on the left side of the screen and ensure that the correct options ONLY are checked. DTCs may be set if the the options are incorrectly entered.

Note that some selections (e.g. ABS/ASC/ASTC) are underlined. Certain models require you to select the correct optional equipment. If required, click on all underlined items in the System List and check the correct equipment from the Loading Option Setup (if necessary) list. Continue clicking the underlined items and selecting the correct Loading Option until the check mark at the bottom becomes active (not "grayed out").

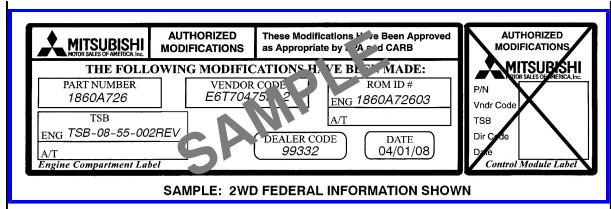
3. If DTCs remain, diagnose and repair the condition as per the Service Manual. If no additional DTCs are listed, click the check mark to clear the window and then click the Home icon in the lower left of the screen to return to the main menu.
4. Using a ball-point pen, enter the appropriate Engine Control Module (ECM) part number, vendor number, New S/W Part No., this technical service bulletin number (**TSB-08-55-002REV**), your dealer code, and the current date on the Engine Compartment / Control Module Label (p/n MSSF-024G-00). The label is available from your facing PDC.

The Control Unit Label is NOT used for this reflash. It should be discarded.

5. Carefully remove all dirt and oil from a vacant area near the VECI label on the underside of the hood, and affix the *Engine Compartment Label* (LH side, above) to that area.
