MEDIC
UPDATE
TECHNICAL SERVICE BULLETIN

SUBJECT:		No: TSB 08-13-007	
ENGINE CONTROL MODULE REPROGRAMMING FOR DTCS P0300 - P0306 AND ROUGH IDLE		DATE: March, 2008	
MODEL: 2007-08 Outlander			
CIRCULATE TO:	<input type="checkbox"/> GENERAL MANAGER	<input checked="" type="checkbox"/> PARTS MANAGER	<input type="checkbox"/> TECHNICIAN
<input checked="" type="checkbox"/> SERVICE ADVISOR	<input checked="" type="checkbox"/> SERVICE MANAGER	<input checked="" type="checkbox"/> WARRANTY PROCESSOR	<input type="checkbox"/> SALES MANAGER

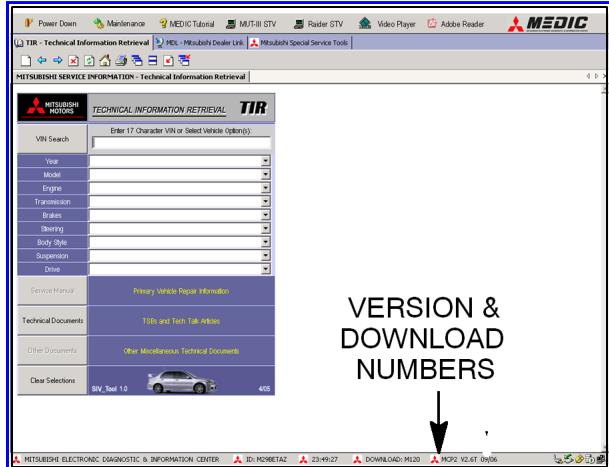
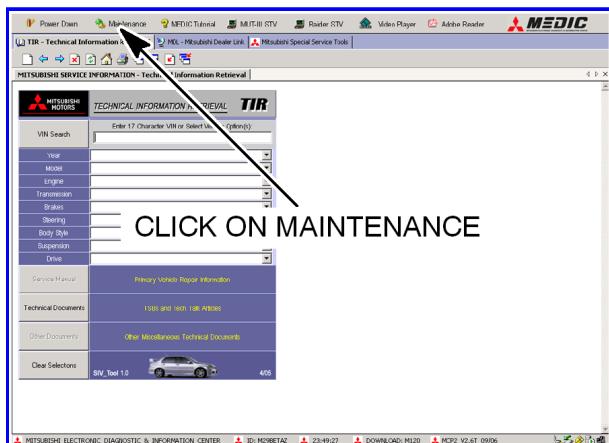
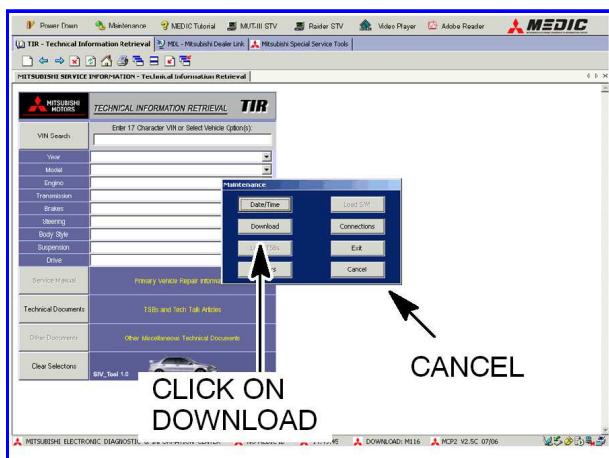
3. On the MEDIC-II main screen, click on "Maintenance".

4. Click on "Download". After the download completes, click on "Cancel" to exit the "Maintenance" window.

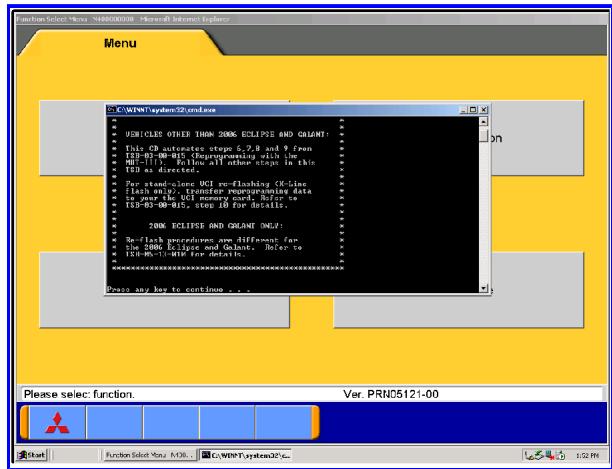
d. If the database version is less than N08032, you must transfer the new reprogramming data from the Reflash Update CD 03/08 to the MUT-III hard drive as follows:

1. Install **Reflash Update CD 03/08** into the PC's DVD-ROM drive.
2. Follow the instructions on the screen. The system will automatically transfer the reprogramming data onto the PC's hard drive.
3. Continue to the Reprogramming Procedure on page 4.

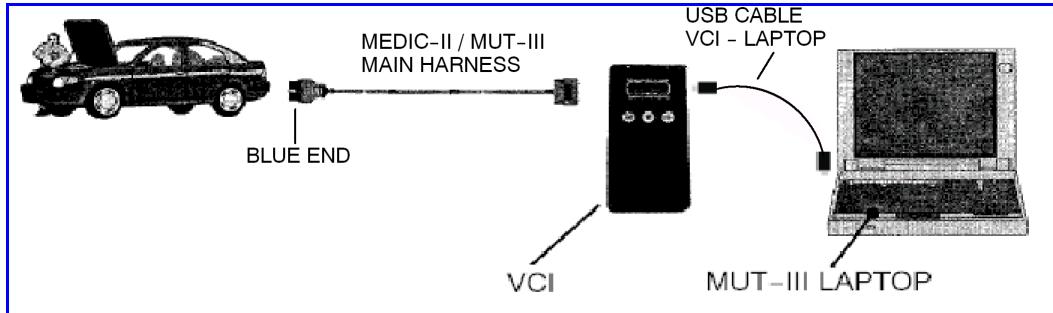
- Turn the laptop computer on. If the battery charge indicator in the lower right hand corner of the screen does not show a full charge, it is recommended that either the laptop battery be charged prior to beginning, or that reprogramming be completed with the A/C power adaptor connected to the laptop.
- Connect the USB cable to the VCI.
- When the laptop displays the MUT-III main screen, connect the USB cable to the laptop.
- Connect the MUT-III main harness with the blue DLC connection to the VCI.
- Connect the blue connector of the MUT-III main harness to the vehicle's data link connector.
- Turn the VCI power switch ON. Verify that the indicator lamp in the upper right corner of the screen is green.

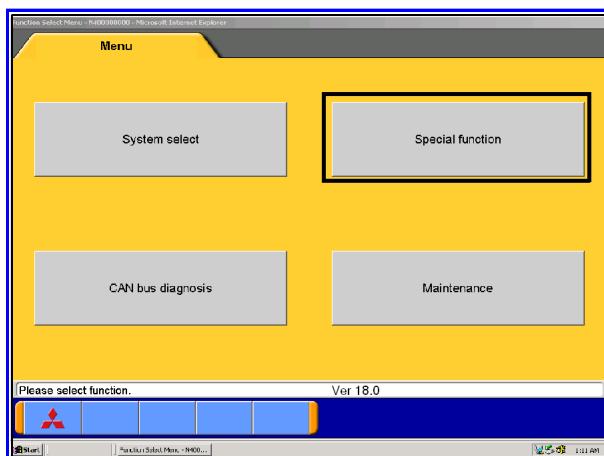
b. Select "Special Function."

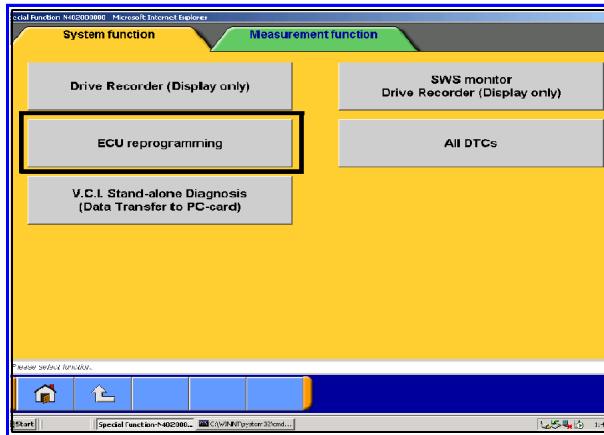
c. Select "ECU reprogramming."

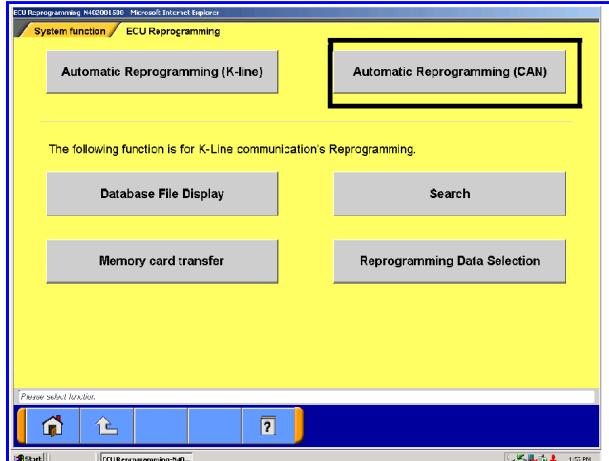
d. Select "Automatic Reprogramming (CAN)."

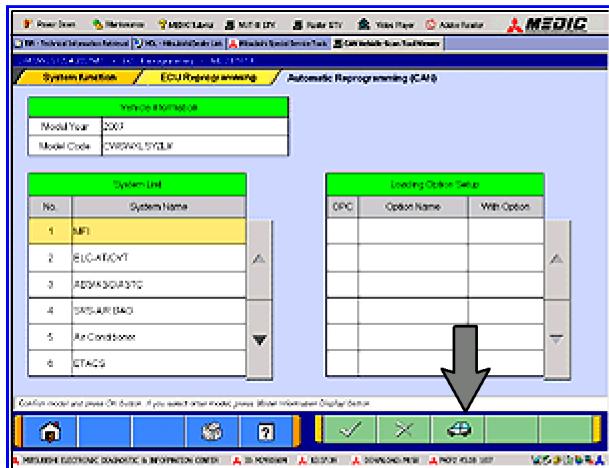
e. Click on the car icon at the bottom of the page.

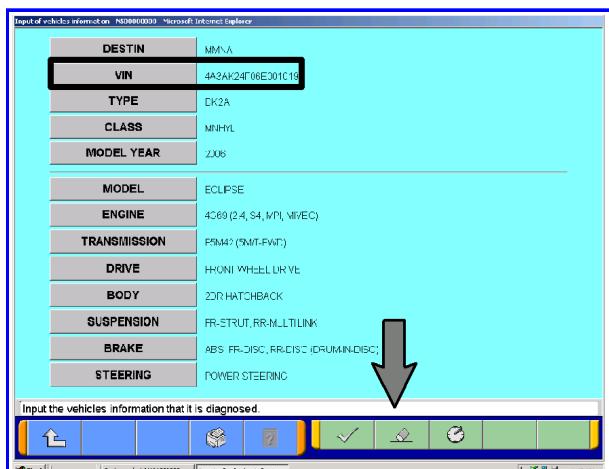
f. If the VIN listed does not match the vehicle you are working on, click on the Eraser Icon at the bottom of the page.

Select VIN by clicking on the button.

g. Click on the icon in the lower RH corner of the screen to have the MUT-III automatically read the VIN. If a message appears saying that the VIN cannot be input automatically, manually type the 17 digit VIN into the VIN field.

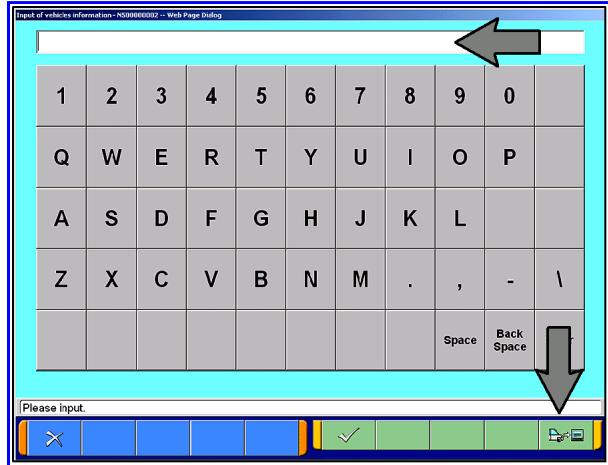
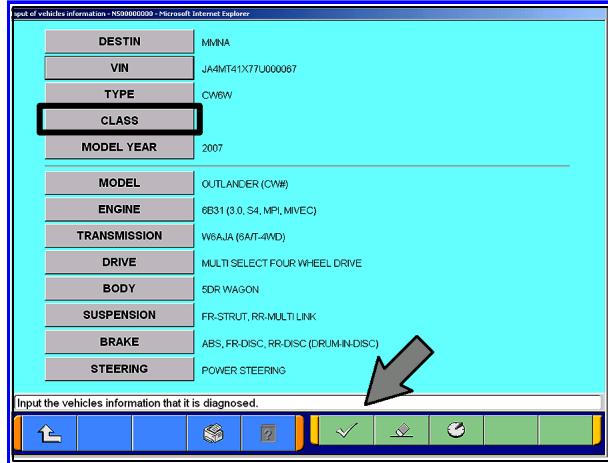
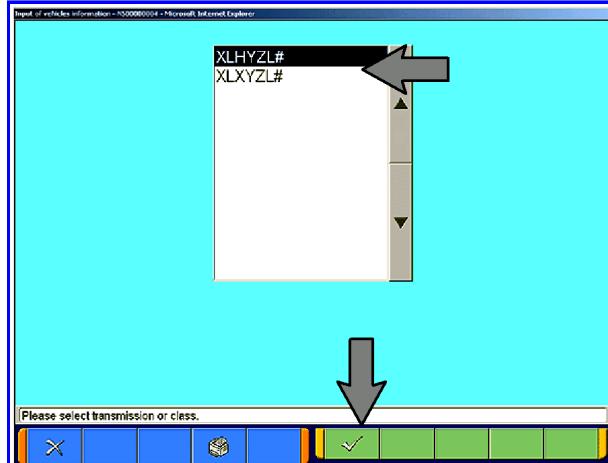
h. If it was not completed automatically, input the vehicle class. Click on the CLASS button, select the appropriate class from the menu and then click the check mark at the bottom of the page. Vehicle class can be found on the Vehicle Information Code Plate riveted to the base of the RH b-pillar (see photo below). The class is part of the model code.

Click the check mark to enter the class.

Confirm that all of the data is correctly entered and click the check mark at the bottom of the page

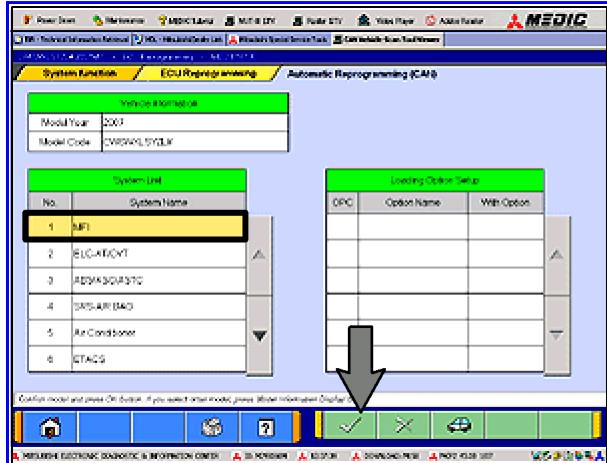
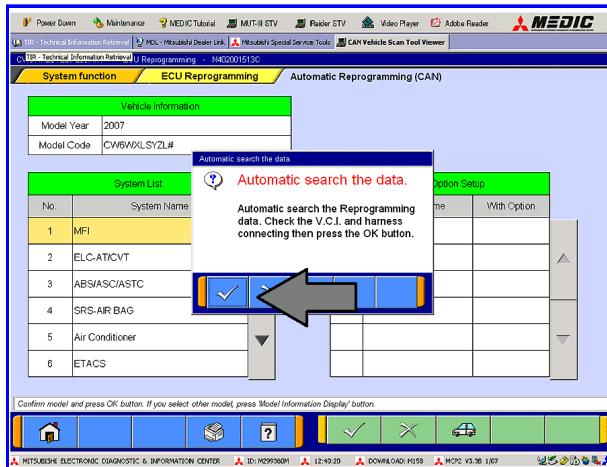
j. A message will advise you that the system will "Automatic Search the data."

Click on the check mark to continue.

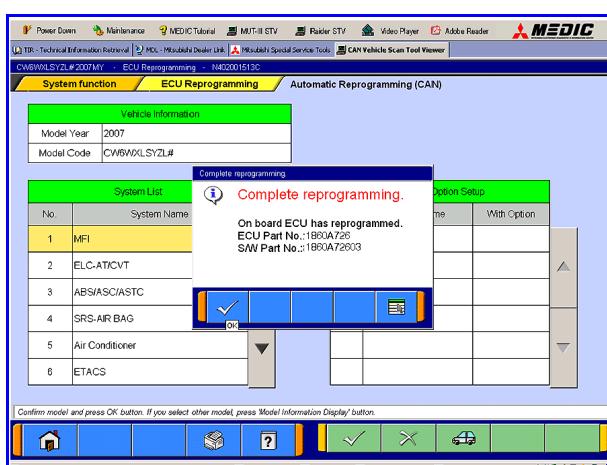
NOTE: If a "Complete Reprogramming" message does not appear, continue with step k.

If a "Complete Reprogramming" message is displayed, the ECM is already reprogrammed for this concern. If this message displays, do not continue with this reprogramming procedure.

Click the check mark to clear the window, then click on the Home icon at the lower left corner of the screen to return to the System Select main page.

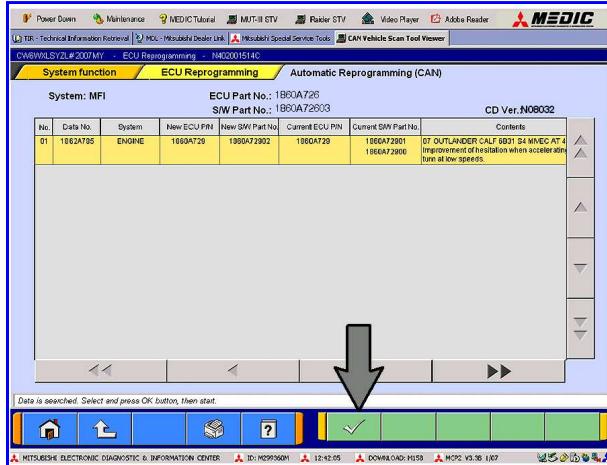
I. Click on the check mark to begin reprogramming.

NOTE: It will take up to 5 minutes to complete the reprogramming.

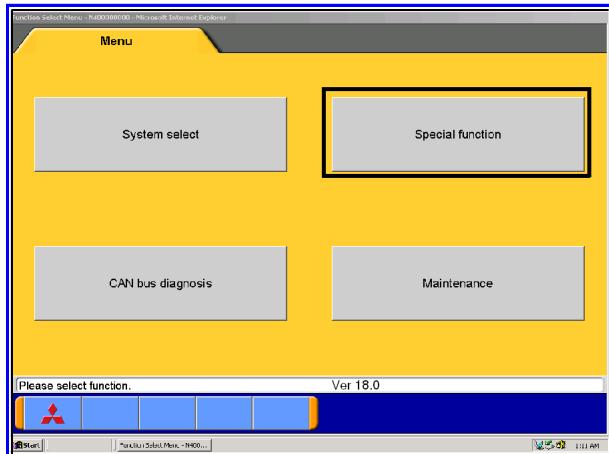
a. Select "Special Function."

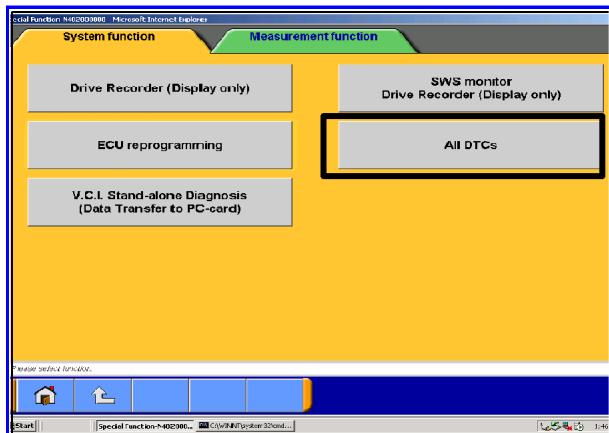
b. Select "All DTCs," then select ERASE AND READ ALL DTCs.

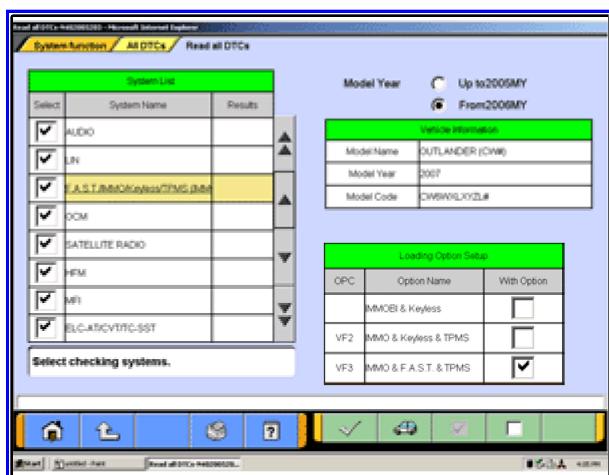
c. Inspect the list on the left side of the screen and ensure that the correct options ONLY are checked. DTCs may be set if the the options are incorrectly entered.

Note that some selections (e.g. ABS/ASC/ASTC) are underlined. Certain models require you to select the correct optional equipment. Click on all underlined items in the System List and check the correct equipment from the Loading Option Setup list (if necessary). Continue clicking the underlined items and selecting the correct Loading Option until the check mark at the bottom becomes active (not "grayed out").

Click the check mark at the bottom of the page for DTC erasing and reading to begin.

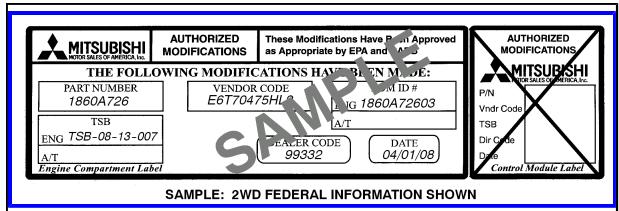
- If DTCs remain, diagnose and repair the condition as per the Service Manual. If no additional DTCs are listed, click the check mark to clear the window and then click the Home icon in the lower left of the screen to return to the main menu.
- Using a ball-point pen, enter the appropriate Engine Control Module (ECM) part number, vendor number, New S/W Part No., this technical service bulletin number (**TSB-08-13-007**), your dealer code, and the current date on the Engine Compartment / Control Module Label (p/n MSSF-024G-00). The label is available from your facing PDC.

The Control Unit Label is NOT used for this reflash. It should be discarded.

5. Carefully remove all dirt and oil from a vacant area near the VECI label on the underside of the hood, and affix the *Engine Compartment Label* (LH side, above) to that area.
