Technical Service Bulletin

SUBJECT:		No: TSB-22-55-001
A/C INOPERATIVE WITH DTC B20C8-14		DATE: February 2022
MODEL: 2022 Outlander		
CIRCULATE TO:	<input type="checkbox"/> GENERAL MANAGER	<input checked="" type="checkbox"/> PARTS MANAGER
<input checked="" type="checkbox"/> SERVICE ADVISOR	<input checked="" type="checkbox"/> SERVICE MANAGER	<input checked="" type="checkbox"/> WARRANTY PROCESSOR
		<input checked="" type="checkbox"/> TECHNICIAN
		<input checked="" type="checkbox"/> SALES MANAGER

This reflash is to correct the IPDM (Intelligent Power Distribution Module) software. The air conditioner is not operative with the A/C switch on and illuminated (see image below). DTC B20C8-14 ECV (Electrical Control Valve) is stored in the IPDM E/R. Please perform this reflash first, then proceed to diagnosing other codes if they persist.

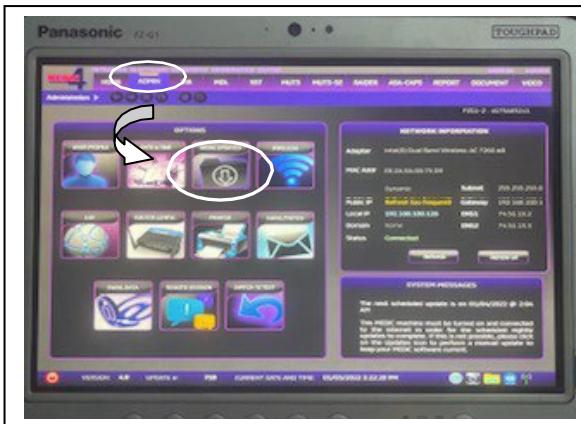
3. Select the MEDIC 3.5/4 Admin tab and click on "Updates".

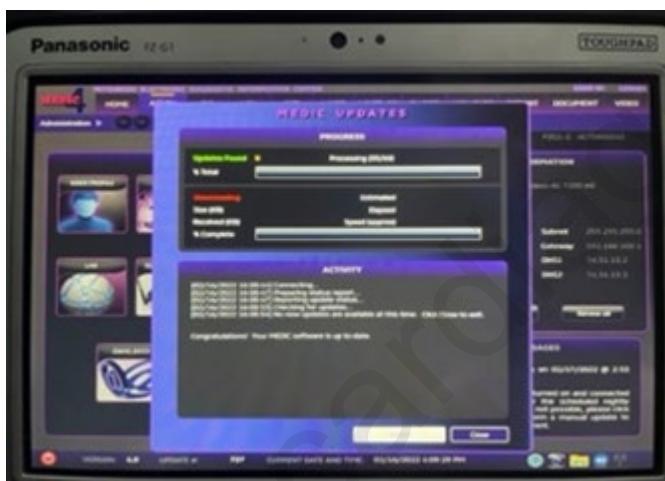
4. If the MEDIC update screen advises updates are available, click the "Begin" button. After all updates are complete, **GO TO THE REPROGRAMMING PROCEDURE**.

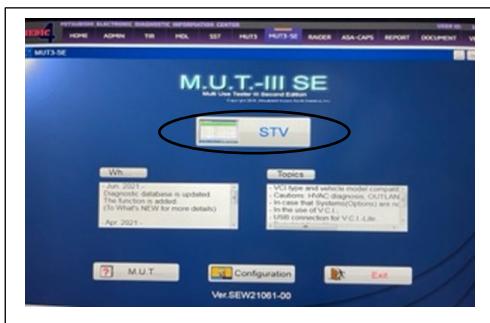
5. Click "STV".

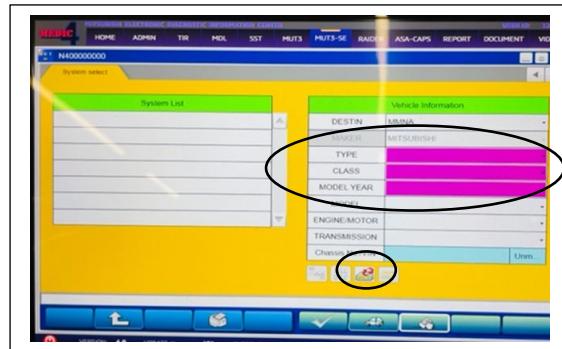
a. Fill in the vehicle information and click the ECU reprogramming button.

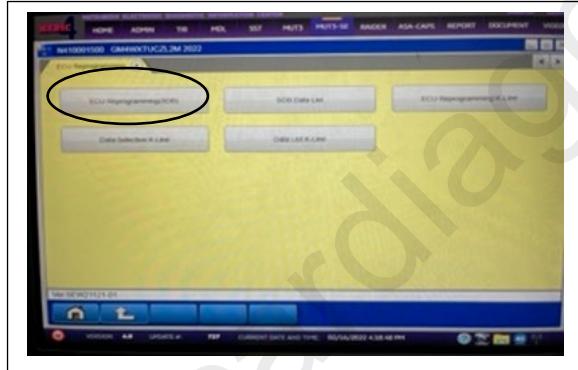
b. Click "ECU Reprogramming (SDB)" and press the OK button".

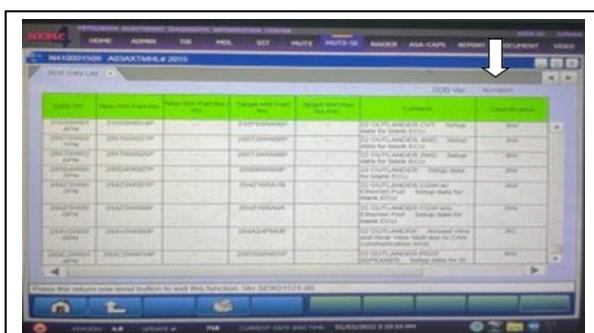
c. Confirm that the database number displayed in the upper right above the chart is **N220101** or higher

- If the database number displayed on your MUT3-SE is **N220101** or greater, continue to the next section.
- If the reprogramming database number displayed on your MUT3-SE is lower than **N220101**, then the MUT3-SE database needs to be updated.

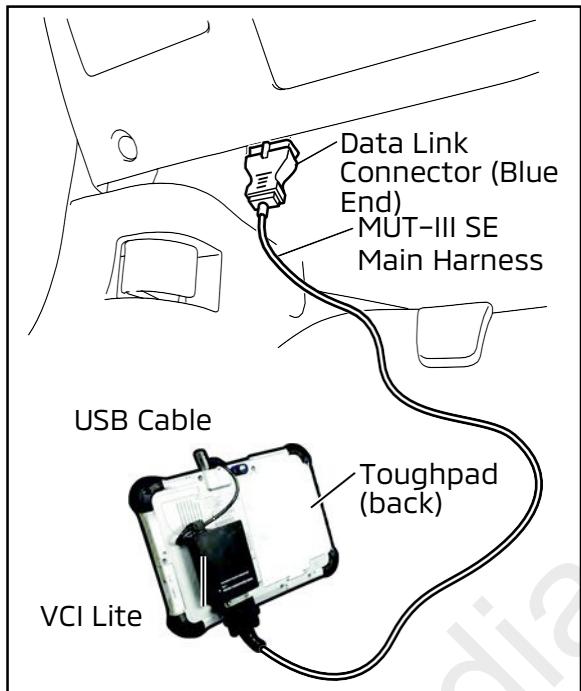
1. Connect the equipment as follows:

NOTE: VCI Lite and MEDIC 4.0 Toughpad shown for illustration purposes only.

- Turn the MEDIC PC/tablet on. If the battery indicator in the lower right hand corner of the screen does not show a full charge, it is recommended that either the battery be charged prior to beginning or be used with the A/C power adaptor connected.
- Connect the USB cable to the VCI/VCI Lite. When the laptop/tablet displays the MUT-III SE main screen, connect the USB cable to the device.
- Connect the MUT-III SE main harness with the blue DLC connection to the VCI/VCI Lite. Connect the blue connection of the MUT-III SE main harness to the vehicle's data link connector.
- For VCI only (p/n MB991824): Turn the VCI power switch ON. Verify that the indicator lamp in the upper right corner of the screen is green.

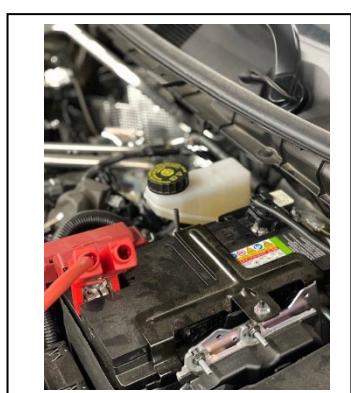
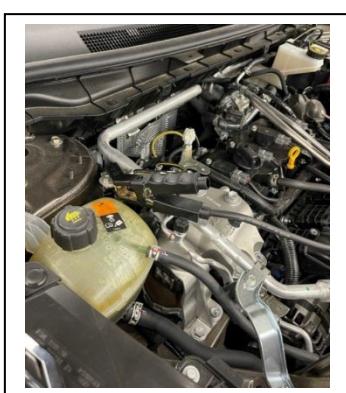
NOTE: Due to limited space it may be easiest to connect cable onto negative ground post and ground strap as shown below.

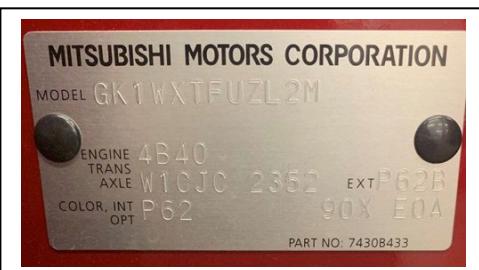
4. The System Select screen opens and populates with some basic information from the vehicle. Look at the label on the passenger side B pillar to identify the appropriate class. (See B pillar label below; class is labeled as "model"). If necessary, select the correct class from the drop-down list.

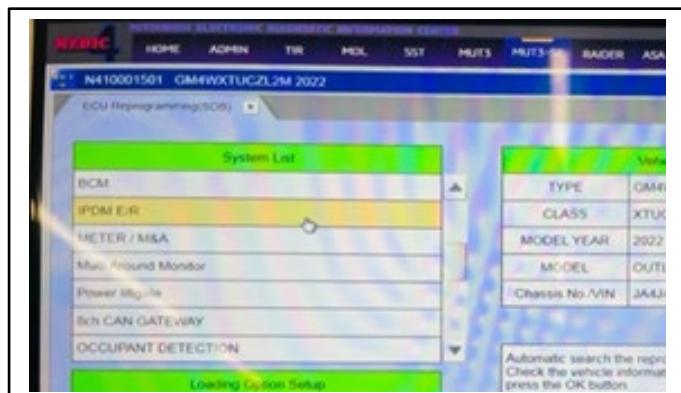
- a. Select ECU Reprogramming (SDB).

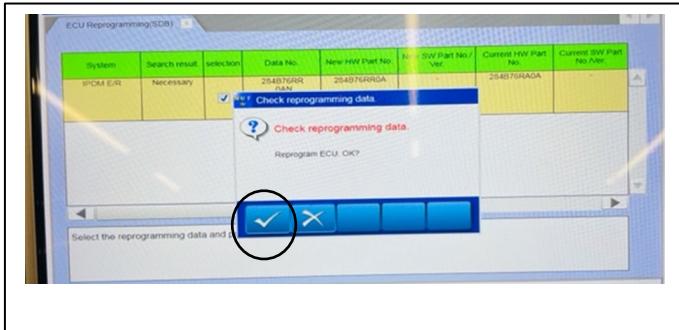
- b. Select "IPDM E/R" from Systems List and click the OK button.

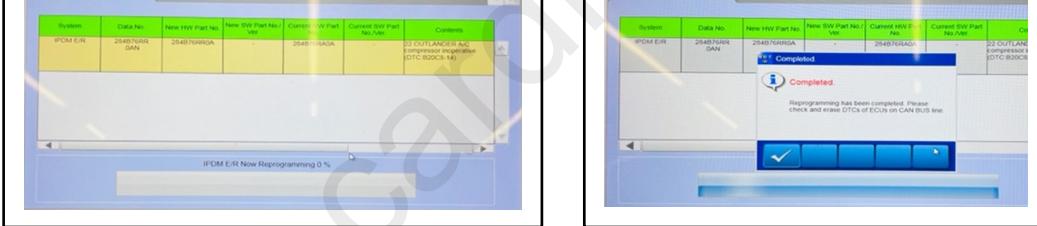
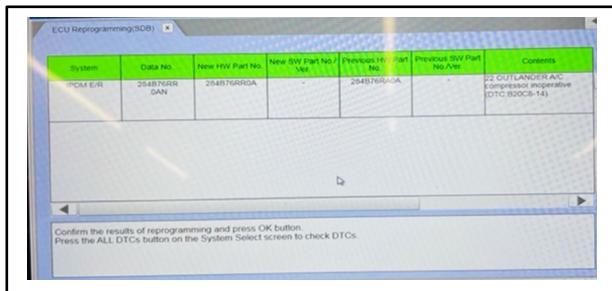
e. Reprogramming will begin and a progress bar will appear followed by a notification upon successful completion.

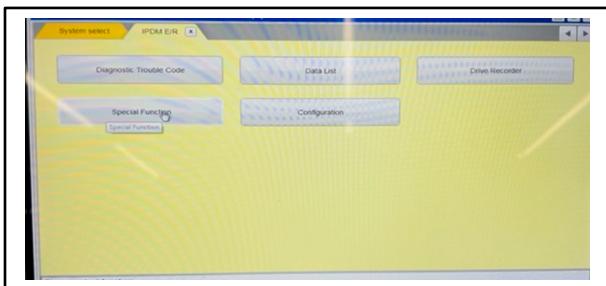
a. Select IPDM E/R in the System List.

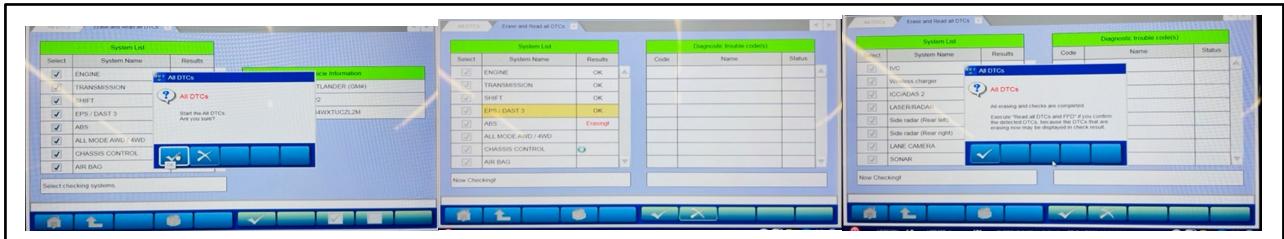
e. Select Erase and Read all DTCs.

f. Select OK to start the All DTCs and ensure the erasing and checks are completed.

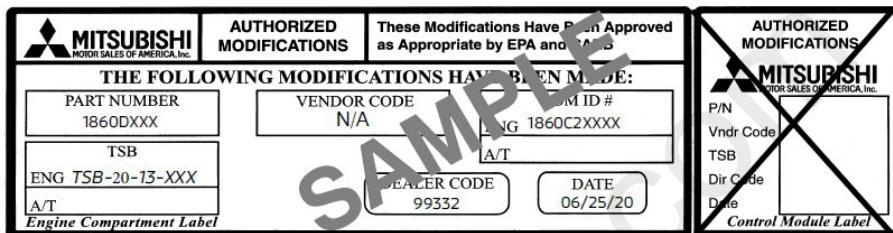
7. Using a ball-point pen, enter the appropriate ECU part number, Software Part Number (ROM ID#), this Technical Service Bulletin number, your dealer code, and the current date on the Engine Compartment/Control Module Label (p/n MSSF024G00). The Vendor Code is not applicable. The label is available from your facing PDC.
