Technical Service Bulletin

SUBJECT:		No: TSB-22-13-001
CHECK ENGINE LIGHT ILLUMINATES OR ENGINE MALFUNCTION POWER REDUCED SERVICE NOW WARNING MESSAGE APPEARS WHILE IDLING OR DRIVING		DATE: January 2022
		MODEL: 2022 Outlander
CIRCULATE TO:	<input type="checkbox"/> GENERAL MANAGER	<input checked="" type="checkbox"/> PARTS MANAGER
<input checked="" type="checkbox"/> SERVICE ADVISOR	<input checked="" type="checkbox"/> SERVICE MANAGER	<input checked="" type="checkbox"/> WARRANTY PROCESSOR
		<input checked="" type="checkbox"/> SALES MANAGER

PURPOSE

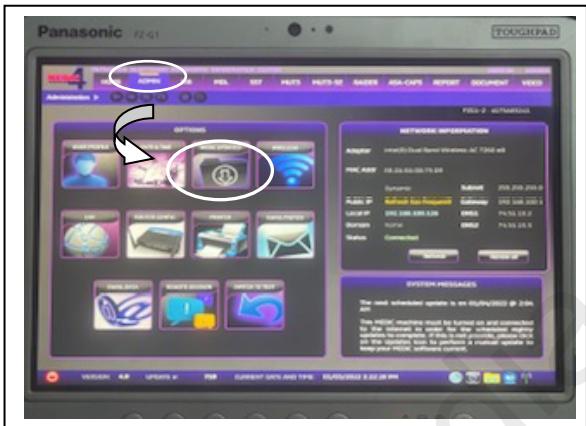
3. Select the MEDIC 3.5/4 Admin tab and click on "Updates".

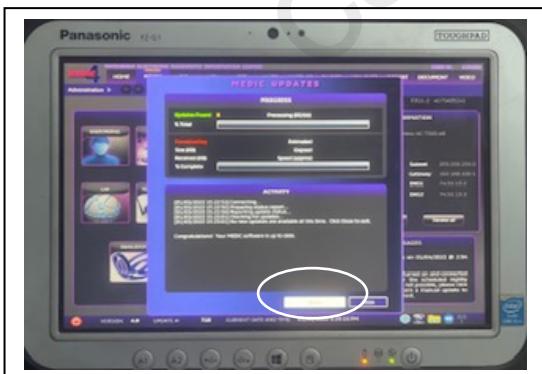
4. If the MEDIC update screen advises updates are available, click the "Begin" button. After all updates are complete, **GO TO THE REPROGRAMMING PROCEDURE**.

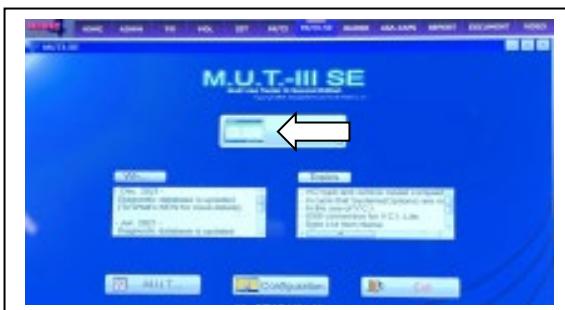
a. Click "STV".

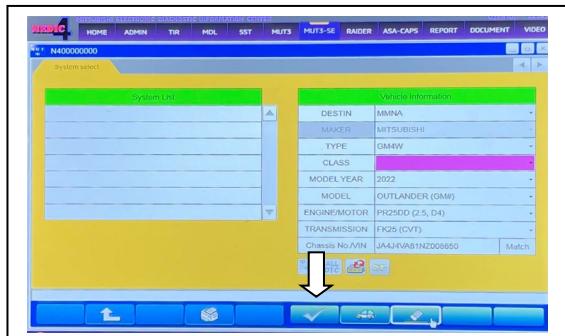
b. Click the "ECU Reprogramming" button.

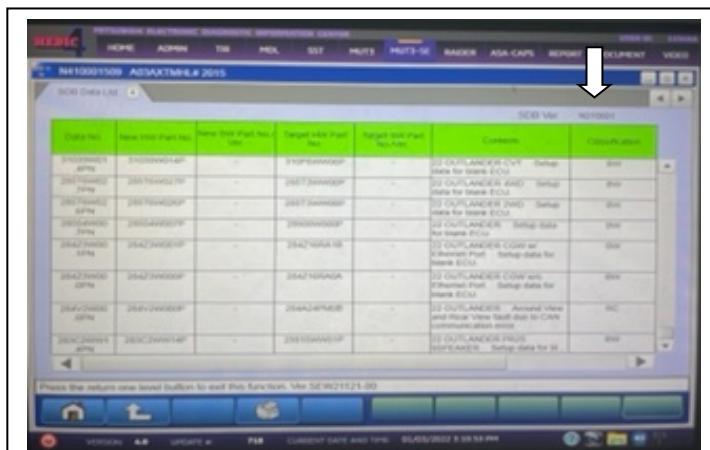
d. Confirm that the database number displayed in the upper right above the chart is **N211201** or higher

- If the database number displayed on your MUT3-SE is **N211201** or greater, continue to the next section.
- If the reprogramming database number displayed on your MUT3-SE is lower than **N211201**, then the MUT3-SE database needs to be updated.

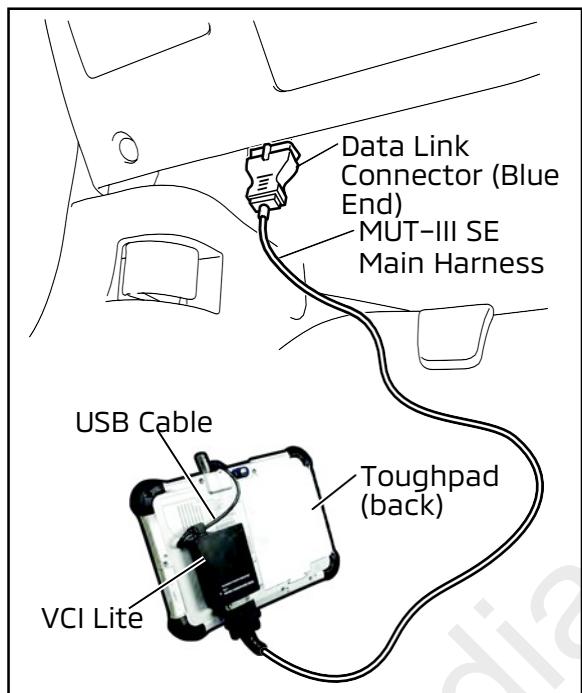
1. Connect the equipment as follows:

NOTE: VCI Lite and MEDIC 4.0 Toughpad shown for illustration purposes only.

- Turn the MEDIC PC/tablet on. If the battery indicator in the lower right hand corner of the screen does not show a full charge, it is recommended that either the battery be charged prior to beginning or be used with the A/C power adaptor connected.
- Connect the USB cable to the VCI/VCI Lite. When the laptop/tablet displays the MUT-III SE main screen, connect the USB cable to the device.
- Connect the MUT-III SE main harness with the blue DLC connection to the VCI/VCI Lite. Connect the blue connection of the MUT-III SE main harness to the vehicle's data link connector.
- For VCI only (p/n MB991824): Turn the VCI power switch ON. Verify that the indicator lamp in the upper right corner of the screen is green.

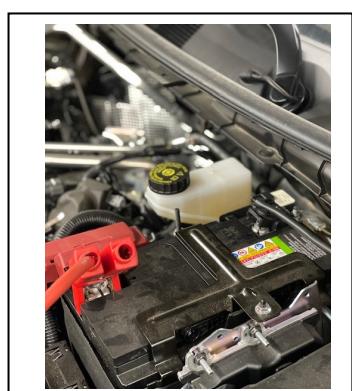
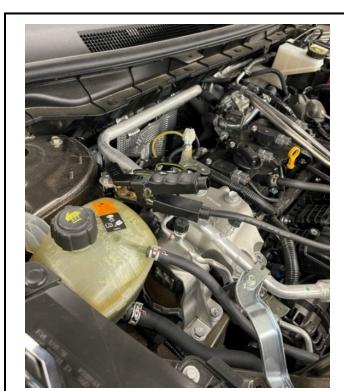
NOTE: Due to limited space it may be easiest to connect cable onto negative ground post and ground strap as shown below.

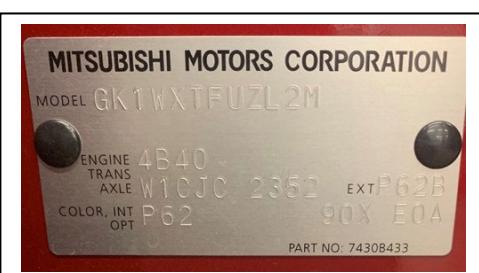
4. The System Select screen opens and populates with some basic information from the vehicle. Look at the label on the passenger side B pillar to identify the appropriate class. (See B pillar label below; class is labeled as "model"). If necessary, select the correct class from the drop-down list.

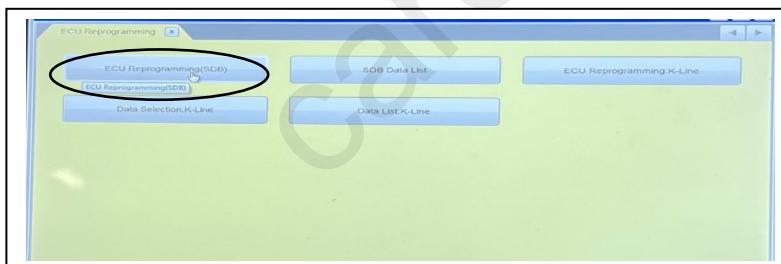
5. Verify that the ECU has not already been updated to the latest S/W number shown in the **"ECU Reprogramming Chart"** in this TSB. If the ECU is at the latest level, reprogramming **is not** necessary. If reprogramming **is** necessary, proceed with the following steps.

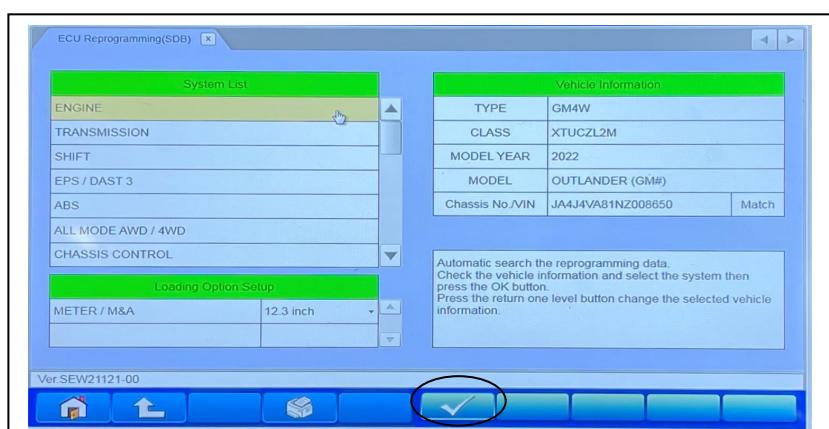
a. Select ECU Reprogramming (SDB).

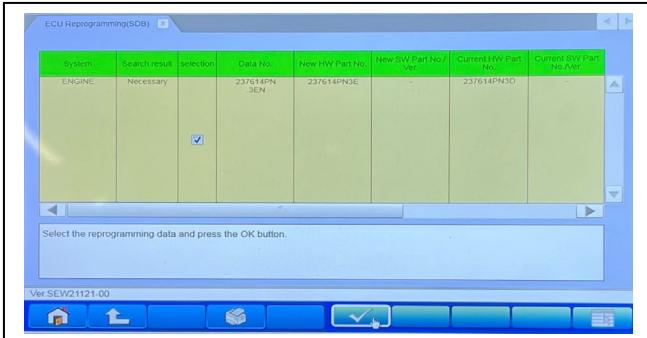
b. Select "Engine" from Systems List and click the OK button.

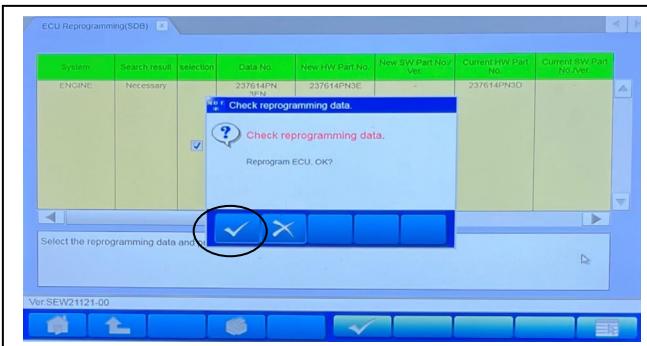
c. Click the Selection box and the OK button.

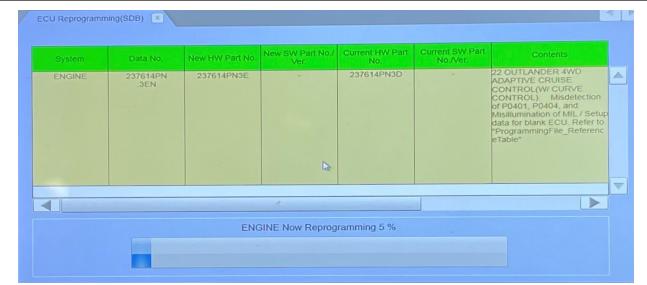
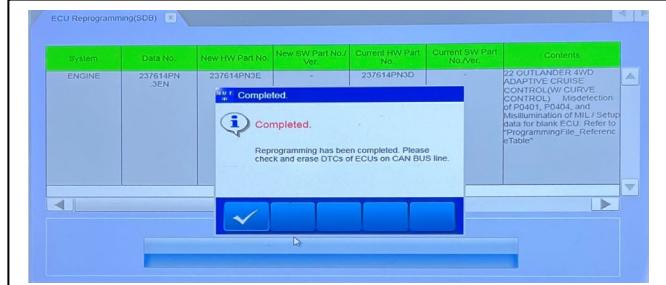
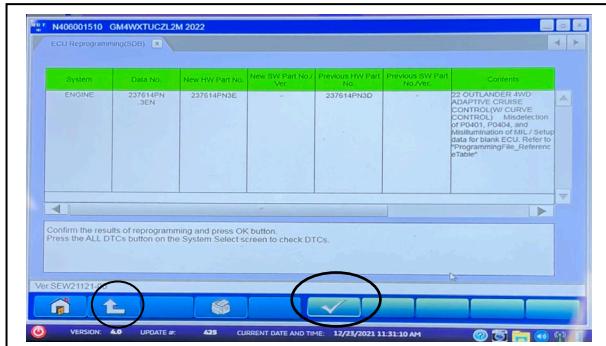
f. Reprogramming will begin and a progress bar will appear followed by a notification upon successful completion.

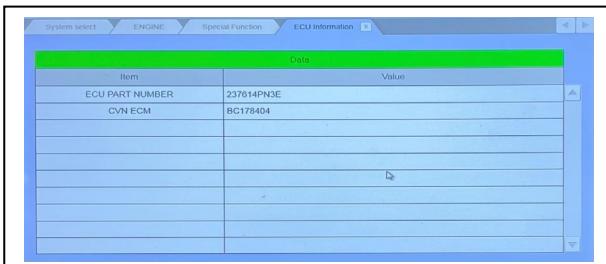
6. Confirm the reprogramming results and press the OK button. Return to the System Select screen by pressing the arrow button.

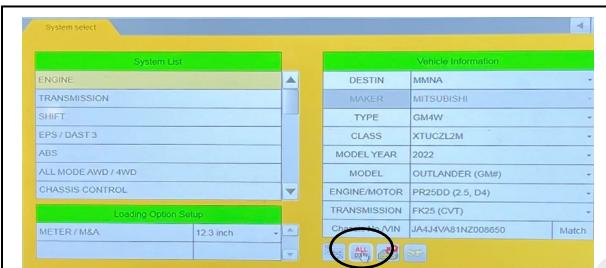
- a. Select the ECU Information Tab to view the data.

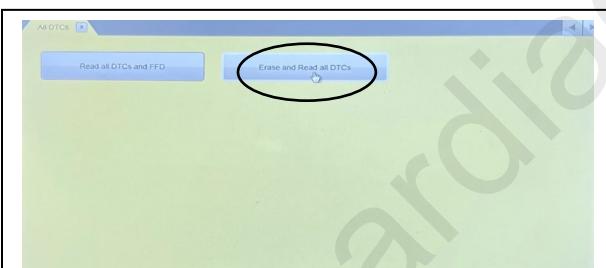
- b. Press the ALL DTCs button on the System Select tab to check DTCs.

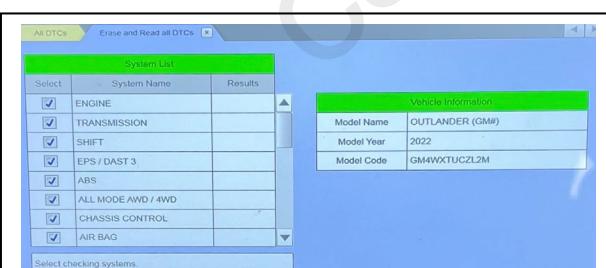
- c. Press the Erase and Read all DTCs button.

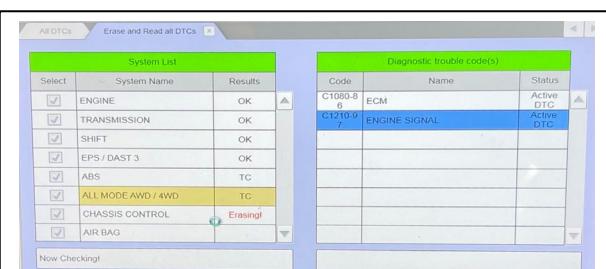
- d. Select all systems.

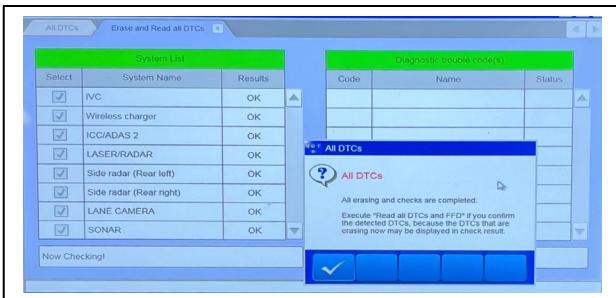
- e. The results are displayed during the erase and read process.

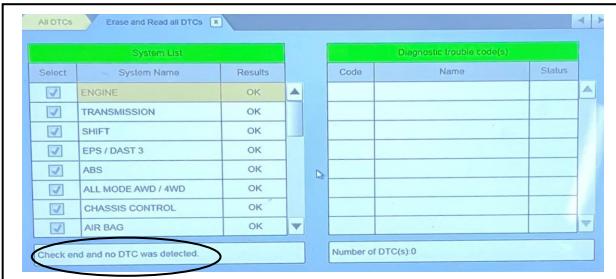
f. Confirm that the erasing and checks have been completed and that no DTCs were detected.

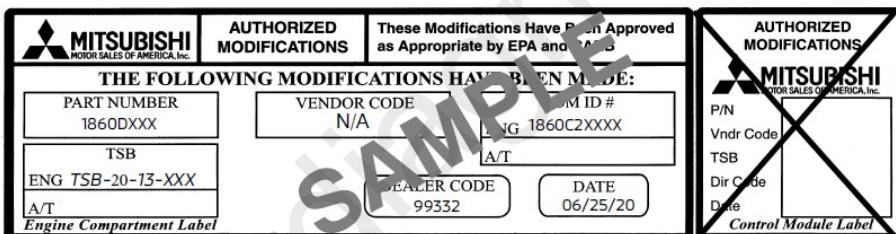
7. Using a ball-point pen, enter the appropriate ECU part number, Software Part Number (ROM ID#), this Technical Service Bulletin number, your dealer code, and the current date on the Engine Compartment/Control Module Label (p/n MSSF024G00). The Vendor Code is not applicable. The label is available from your facing PDC.
