7. Under Coat

A: SPECIFICATION

Under Coat

BODY STRUCTURE

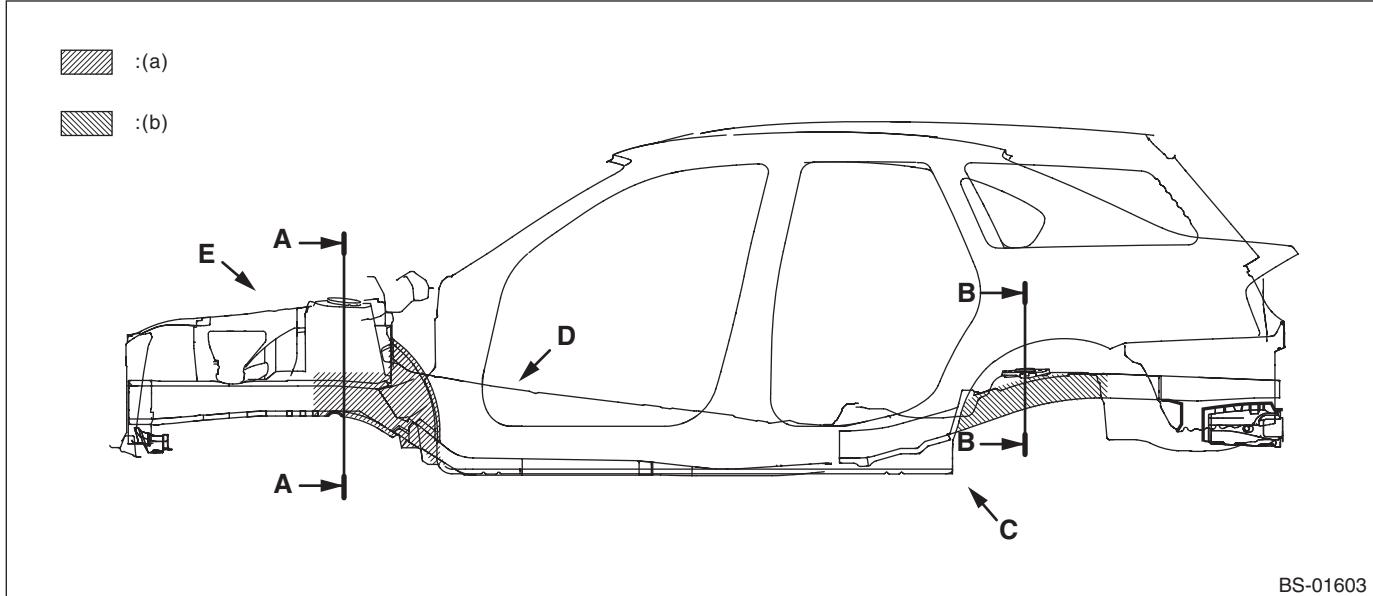
- Side view

(a) Under coat application locations

(b) Under coat application locations
(Film thickness = 600 μm or more)

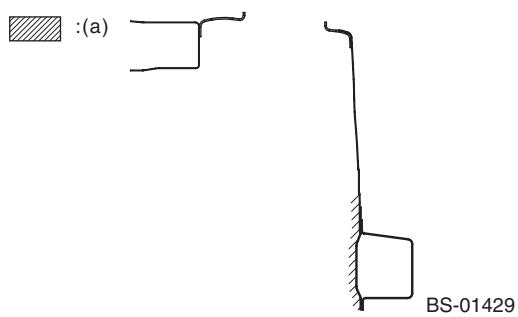
Cross section A — A

(a) Under coat application locations

(b) Under coat application locations
(Film thickness = 600 μ or more)

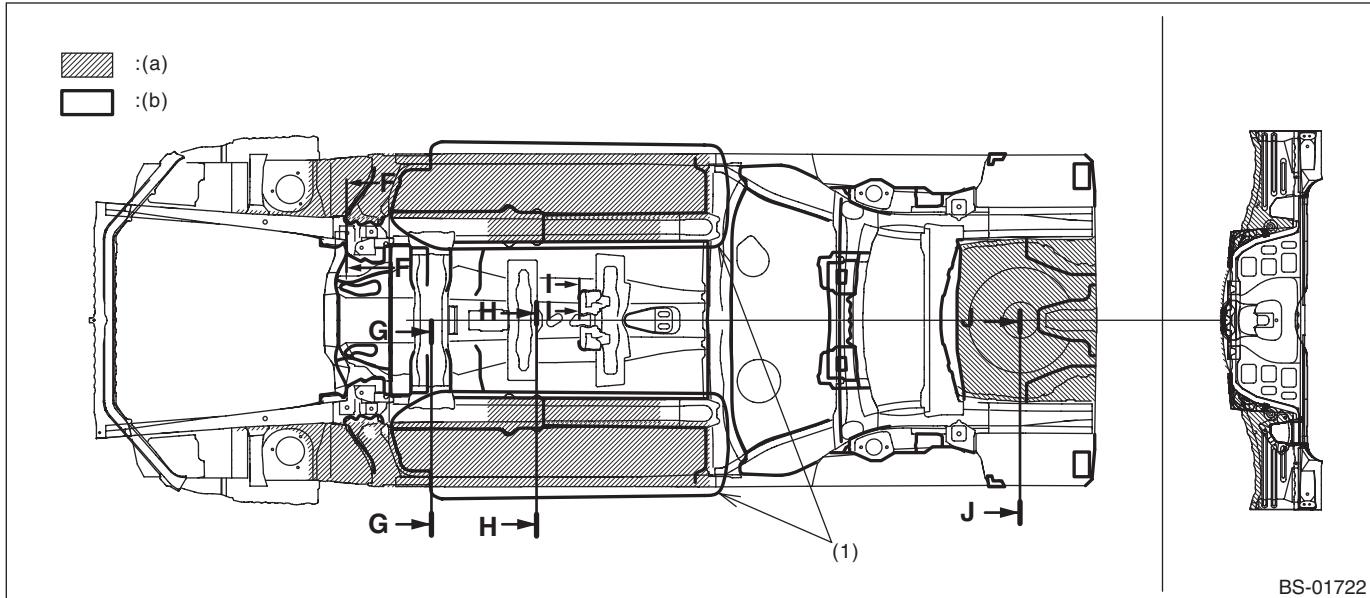
- Bottom view/rear view

(1) For models with an under cover, no under coat is required in this area.

(a), (b) Under coat application locations

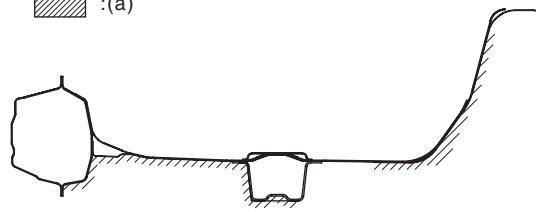
Section H — H (rotated 90°)

:(a)

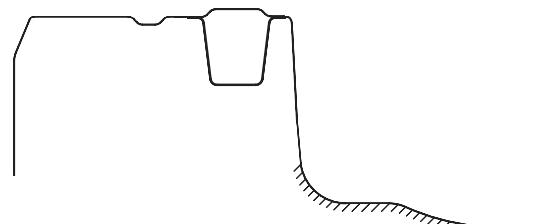
Section J — J (rotated 90°)

:(a)
