## 7-19. Rear Side Frame Upper Rear (total replacement)

## A: REMOVAL

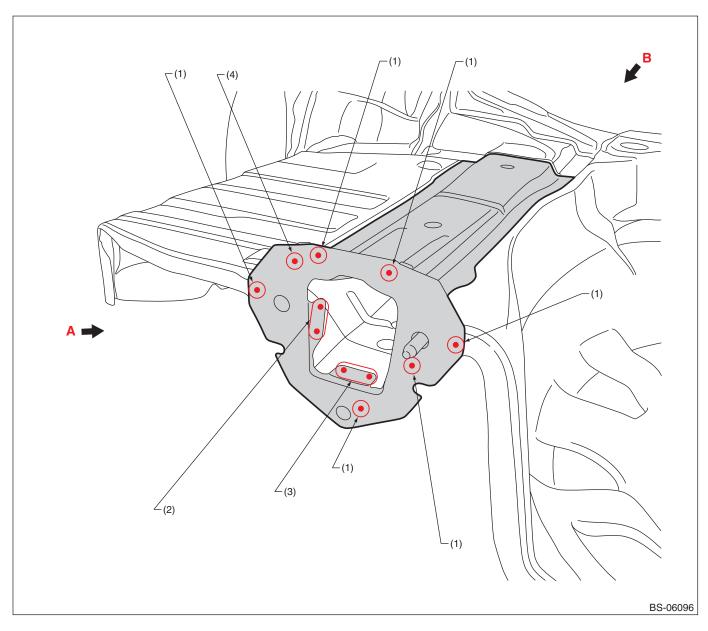
• Overall view (Rear skirt removal condition)

- (1) 1 point (outside  $\cdot$  1)
- (2) 2 points (outside · 1)
- (3) 2 points (bottom · 1)
- (4) 1 point (outside · 1) (only LH)

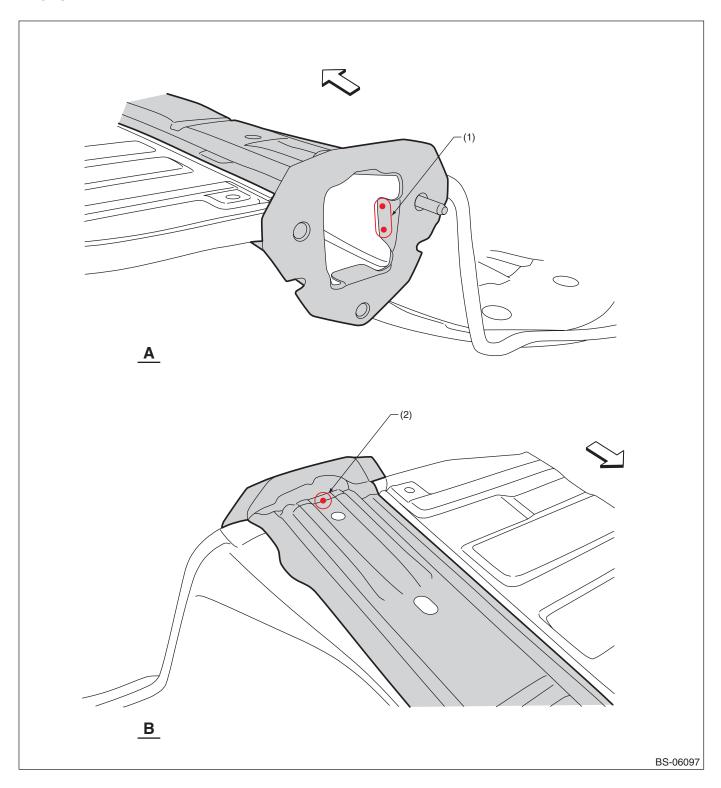
(1) 2 points (outside · 1, belt sander)

(2) 1 point (inside  $\cdot$  1)

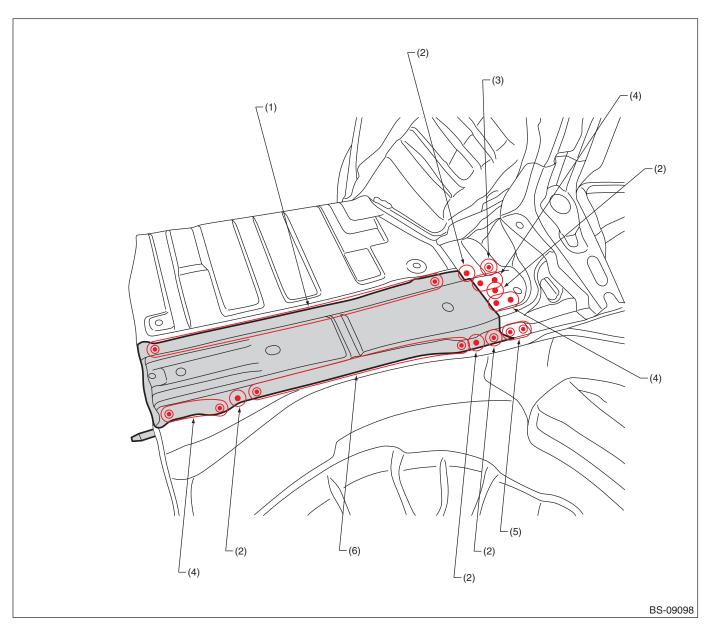
- (1) 9 points (top · 1)
- (2) 1 point (top · 1)

- (3) 1 point (top · 2)
- (4) 2 points (top · 1)

- (5) 2 points (top · 2)
- (6) 7 points (top · 1)
