| <b>DTC</b> | <b>B1197/75</b> | <b>Short in Rear P/T Squib (LH) Circuit (to Ground)</b> |

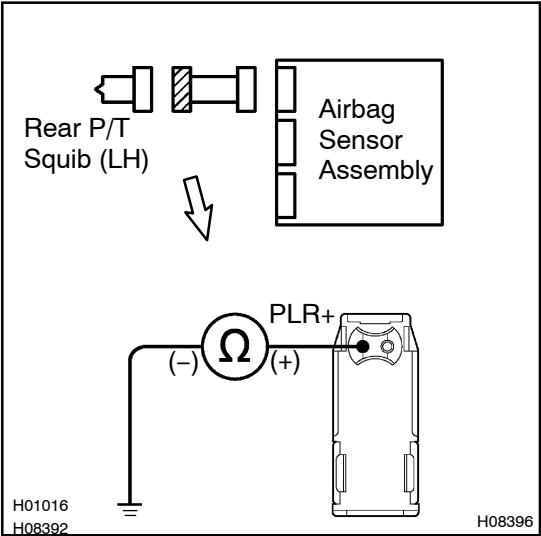
| <b>2</b> | <b>Check rear P/T squib (LH) circuit.</b> |

For the connector (on the rear seat belt pretensioner side) between the rear seat belt pretensioner (LH) and the airbag sensor assembly, measure the resistance between PLR+ and body ground.

**Resistance: 1 MΩ or Higher**

**Repair or replace harness or connector between rear seat belt pretensioner (LH) and airbag sensor assembly.**

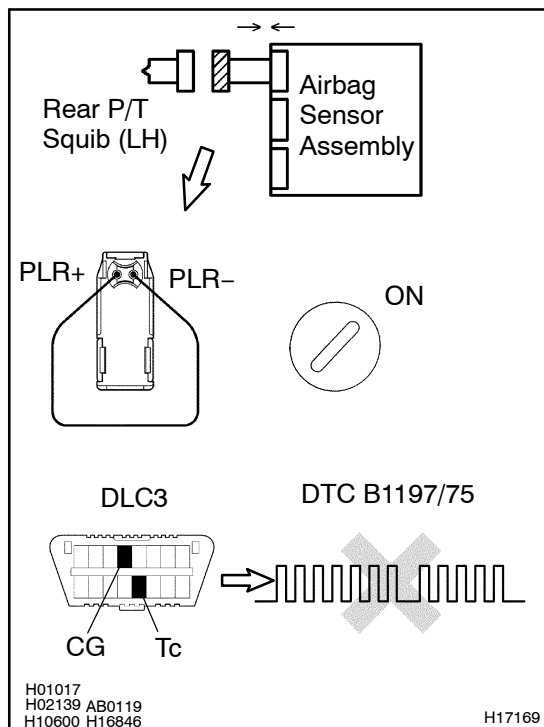
### 3 Check airbag sensor assembly.

- Connect the connector to the airbag sensor assembly.
- Using a service wire, connect PLR+ and PLR- of the connector (on the rear seat belt pretensioner side) between the rear seat belt pretensioner (LH) and the airbag sensor assembly.
- Connect negative (-) terminal cable to the battery, and wait at least for 2 seconds.

- Turn the ignition switch to ON and wait at least for 20 seconds.
- Clear the DTC stored in memory (See step 5 on [page DI-484](#)).
- Turn the ignition switch to LOCK, and wait at least for 20 seconds.
- Turn the ignition switch to ON, and wait at least for 20 seconds.
- Check the DTC ([See page DI-484](#)).

**DTC B1197/75 is not output.**

**Replace airbag sensor assembly.**

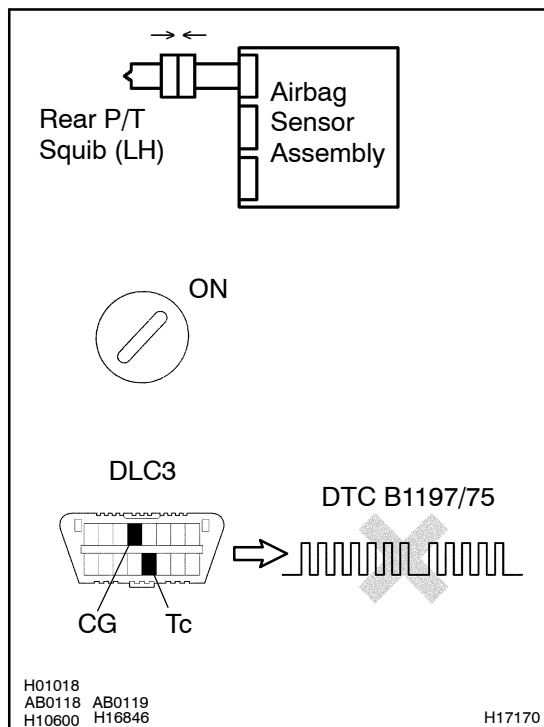
#### 4 Check rear P/T squib (LH).

- Turn the ignition switch to LOCK.
- Disconnect negative (-) terminal cable from the battery, and wait at least for 90 seconds.
- Connect the rear seat belt pretensioner (LH) connector.
- Connect negative (-) terminal cable to the battery, and wait at least for 2 seconds.

- Turn the ignition switch to ON, and wait at least for 20 seconds.
- Clear the DTC stored in memory (See step 5 on [page DI-484](#)).
- Turn the ignition switch to LOCK, and wait at least for 20 seconds.
- Turn the ignition switch to ON, and wait at least for 20 seconds.
- Check the DTC ([See page DI-484](#)).

**DTC B1197/75 is not output.**

**Replace rear seat belt pretensioner (LH).**
